## NORTHRIDGE EARTHQUAKE

## Landslides

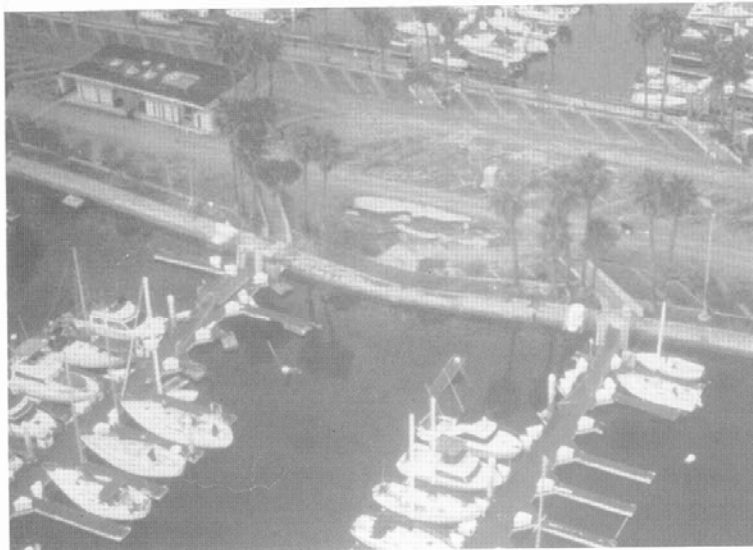
Figure 11. Aerial view of Mole B at King Harbor, Redondo Beach. Note movement of bulkhead wall and ground distress in parking area behind wall. (photo courtesy of Dr. John Tinsley, U.S. Geological Survey)

Further south, liquefaction was reported to have caused a large ground fissure in an artificial beach area between Palawan Way and Panay Way in Marina del Rey. In Redondo Beach, at the Mole B area of King Harbor, liquefaction-induced settlement and lateral spreading of loose sandy fill materials ruptured a number of utility lines and lead to the failure of a bulkhead wall as shown in Figure 11.

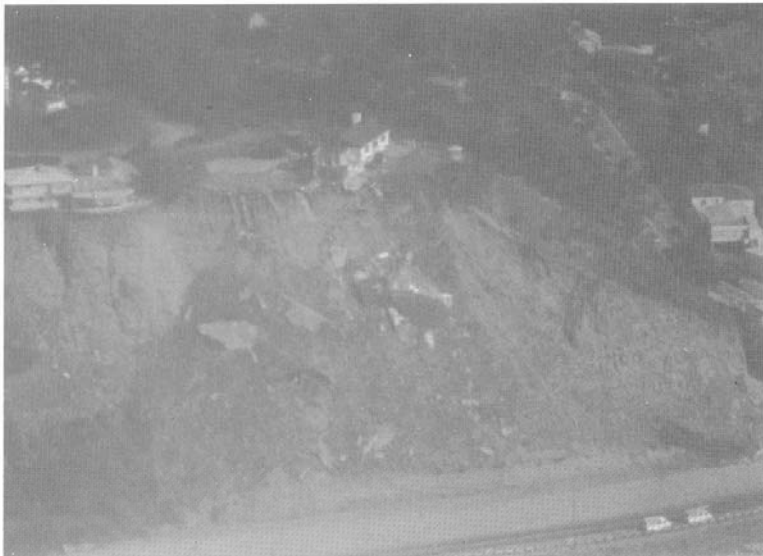
Figure 12. Aerial view of landslide at Pacific Palisades

way along the coastal bluffs of the Pacific Palisades in Santa Monica, between Temescal Canyon Road and Chautauqua Boulevard, for at least 4 days. The most damaging of these landslides occurred just north of Chautauqua Boulevard on the Pacific Coast Highway (Figure 12). The slide carried a portion of a house down the slope, and on adjacent properties, shallow concrete piers and H-piles were observed to be

hanging in mid-air near the crest of the slope. Three homes at the crest of the bluff were condemned. The bluffs consist of Quaternary age deposits of weakly cemented sand and are on the order of 120 to 200 feet in height. The slopes on which the failures occurred are moderately steep (between 45 and 60 degrees), and the failure masses appeared to be only a few yards thick, subparallel to the slope, and had widths on the order of 300 feet. The slide debris was predominantly loose sand. Some evidence of topographic amplification of shaking was also observed in this residential development, as the most severe damage to homes tended to be near the crest of the bluffs.

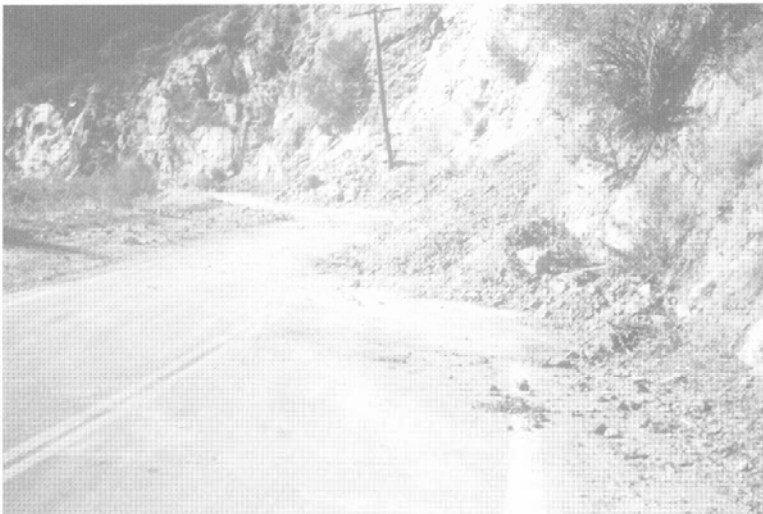
Figure 13. Road closure at Dillon Divide, Little Tujunga Road. (photo courtesy of Ray Salehpour, County of Los Angeles Department of Public Works)

Several earthquake-induced landslides were observed in the Angeles National Forest of the San Gabriel Mountains. Two major rockslides occurred at Dillon Divide, along the Little Tujunga Road that links Interstate 210 and Highway 14 (Figure 13). One of the larger rockslides occurred in a roadcut through fractured granitic rocks. The volume of debris and the large size of the fallen rocks kept the road closed for four days. Once reopened, this road served as a main alternative access to Santa Clarita. At least 10 other slides were observed along the Little Tujunga Road.

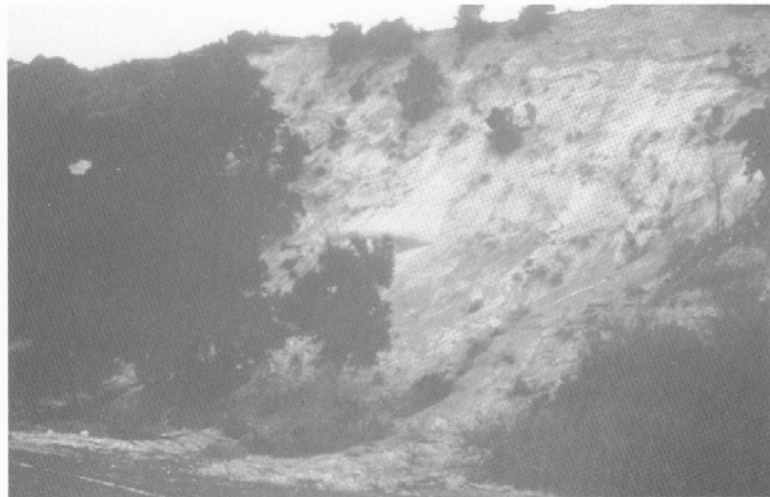
Figure 15. Rockslide along Santa Susana Pass Road, near the pass.

A section of the Santa Susana Pass Road, a two-lane roadway that parallels Highway 118 and connects the San Fernando Valley with Simi Valley, was closed due to slides. The road is approximately 5 miles from the epicenter and is cut into cemented sand and weak sandstone canyon walls that slope at 2H:1V and greater. Slope failures and landslides occurred both downslope and upslope of the road, and varied from 25 feet to more than 100 feet in height (Figure 15). Debris from upslope failures was generally large enough to block the near lane of the road. Blocks as large as 5 feet in diameter were noted and at least one of the slides appeared to be a failure along intersecting joint planes. Downslope failures created extensional cracks 10 to 30 feet away from the edge of the slope and parallel with the road. One larger slide caused vertical subsidence of 5 inches in the roadway and an additional 12-18 inches along the shoulder.

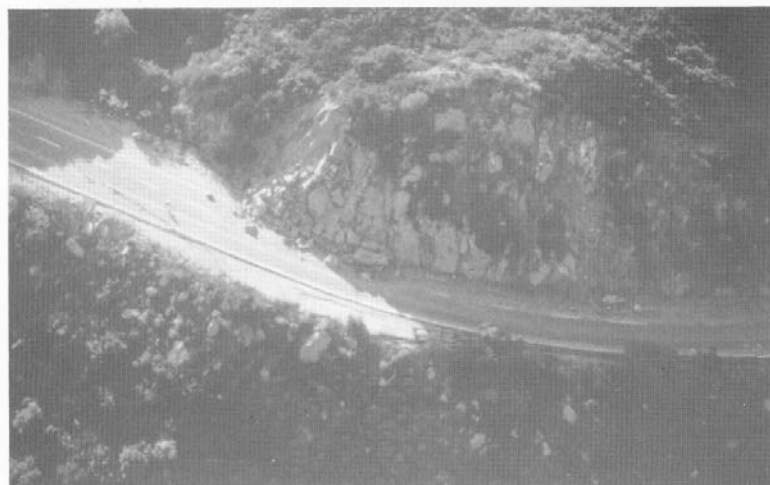
Figure 16. Ravelling along Highway 126, near the Santa Clara River

Several shallow rockslides were also observed along the hills on the north side of Highway 126 between Fillmore and Interstate 5 (Figure 16). At least one of these failures occurred in weathered sandstone. In urban areas, earthquake-induced landsliding was observed in Universal City, where a 24-foot high landslide was observed on Cahuenga Blvd. Preliminary information from the City of Los Angeles Department of Water and Power indicates that landslide activity factored into pipe breaks along Mulholland Drive in Encino and led to its closure after the earthquake.
