*Landfill covers that will permanently contain the residuals of chemical warfare agents and pesticides at the Rocky Mountain Arsenal Superfund site, in Colorado, were designed to perform many functions, including providing a barrier to water infiltration, soil and wind erosion, and intrusion by wildlife. Designed as alternatives to the types of covers normally used at hazardous waste sites, the covers had to be validated beyond a shadow of a doubt before full-scale construction could begin.*

# Covering It All

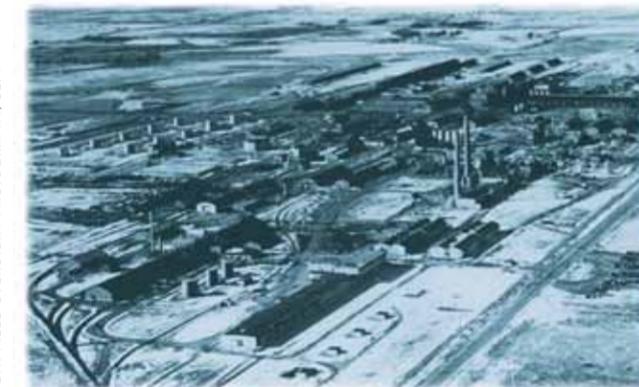
Located 10 mi northeast of Denver, the Rocky Mountain Arsenal, inset, originally encompassed 27 sq mi. The site was used by the army to manufacture chemical warfare agents and incendiary munitions for use in World War II and by the Shell Oil Company to manufacture pesticides. To minimize the amount of fill needed to achieve an overall slope of 3 percent for the integrated cover system that would encase the contaminated soils, a "broken back" design was conceived. This involved long, low-slope drainages that cut through the large cover areas.

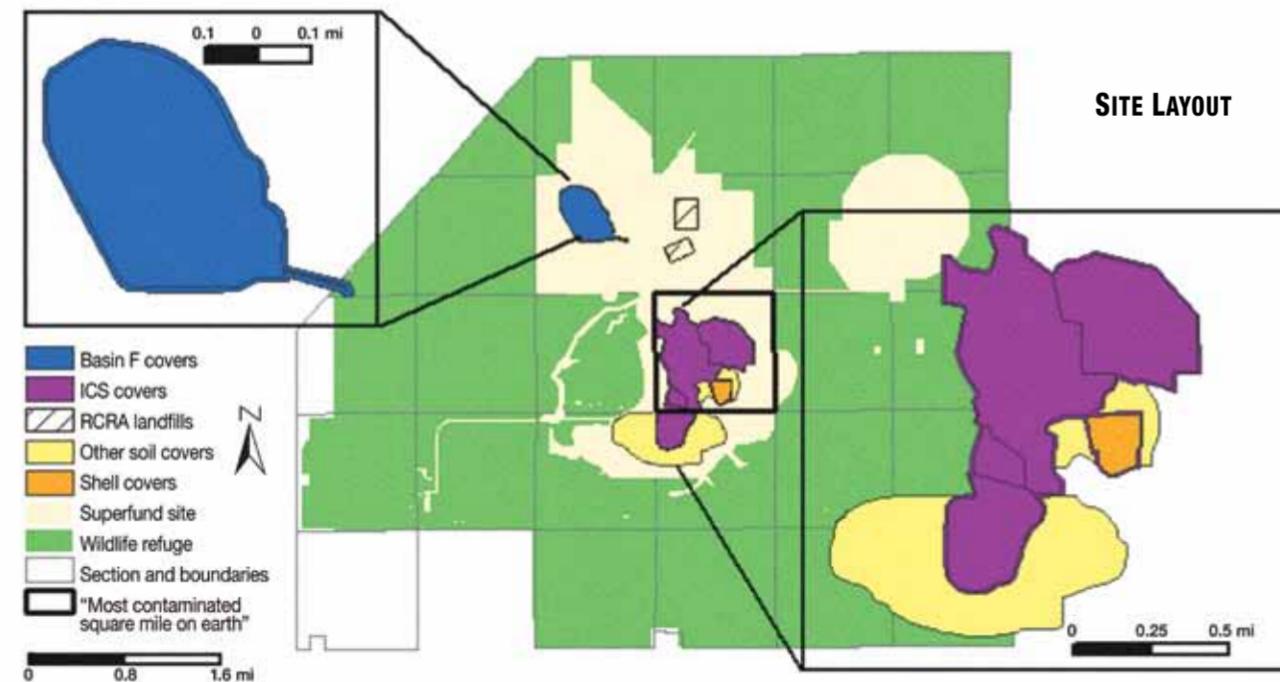
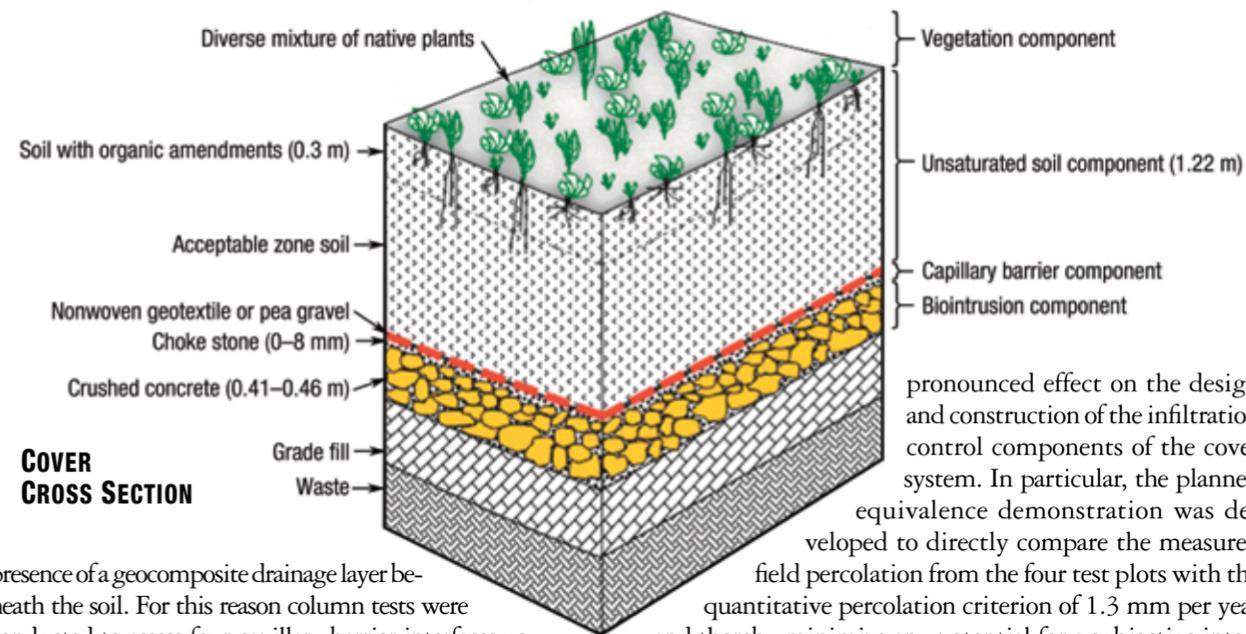
As shown in the figures on pages 68 and 69, the RCRA-equivalent cover systems include the following components, from bottom to top:

- **Biointrusion component:** Designed to prevent biota from accessing underlying contaminated soil, this component was to be constructed of concrete cobbles (at least 16 in. thick) overlain by a layer of aggregate ("choke stone") that would provide a uniform surface for placement of the subsequent capillary barrier material.

- **Capillary barrier component:** This took the form of a nonwoven geotextile for the Shell cover and a layer of well-graded, washed pea gravel 1 to 3 in. thick for the others.

- **Unsaturated soil component:** This 48 in. thick layer of soil with certain geotechnical and agronomic characteristics was excavated from approved borrow areas on-site. An additional 6 in. of soil was added to this layer to address potential soil loss from erosion. The top 12 inches of the total 48 in. thick soil layer was amended to facilitate vegetation growth.

- **Vegetation component:** Included here are native grasses compatible with the short-grass prairie habitat of the surrounding wildlife refuge.

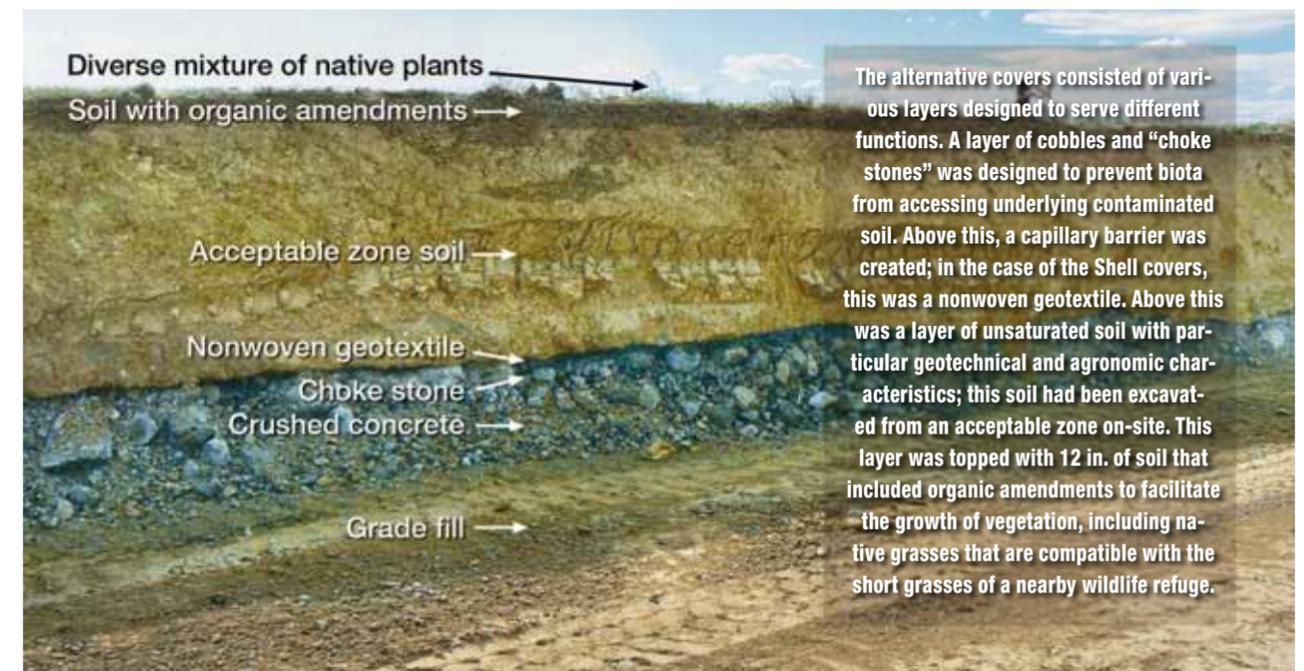
Vegetation, an important component of the covers, is necessary to achieve the various functions of the cover system. In particular, roots help minimize soil loss (an erosion control function), the entire plant aids in removing water through enhanced transpiration (the infiltration control function), and the aboveground portion of the plant provides some control of animal species at the site (the biota control function). For this project, a diverse mixture of native plants was

chosen during design that would maximize water removal, be in keeping with the surrounding wildlife refuge, and remain resilient to possible changes in the environment caused by pathogen and pest outbreaks, such physical disturbances as overgrazing or fire, and climatic fluctuations.
