Case History of a Geosynthetic-Stabilized Base Roadway Founded over Expansive Clay Subgrade

Performance of a geosynthetic-stabilized base roadway founded over an expansive clay subgrade in Texas was evaluated over a period of 4 years. The construction involved three test sections. Two test sections were stabilized using two triangular geogrids of different characteristics and one test section was constructed without geogrid (control section). The geogrid layer was installed between a chemically-treated subbase and a flexible base layer. A comprehensive monitoring program was conducted to evaluate the performance of the roadway under environmental loads. Specifically, vertical movement of the roadway over time induced by recurring heave and settlement of the expansive clay subgrade was monitored. In addition, severity and extent of the environmental longitudinal cracks, identified as the main damage results from the expansive clay subgrade, were documented in each test section using data collected through rigorous visual condition surveys. Environmental conditions of the site, in form of changes in temperature and precipitation, was also closely monitored. Evaluation of the data co

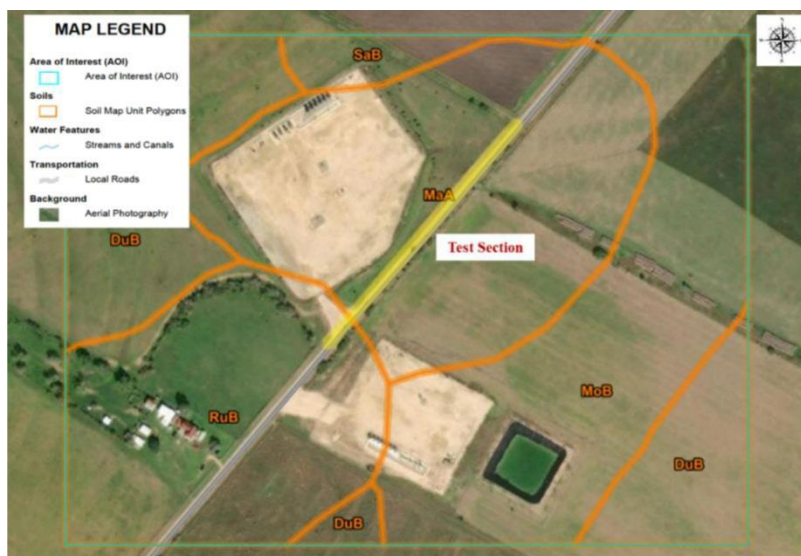
Figure 5: USDA Web Soil Survey soil map.

Subgrade soil: The soil map of test area was obtained from U.S. Department of Agriculture (USDA 2018) Web Soil Survey as shown in Figure 5. Based on the soil survey data reported by USDA for the region around Cabeza Road, the general soil type near the south part of Section 1 is Runge fine sandy loam (RuB) with 1 to 3 percent slopes. The overall soil type for the other parts of the test sections, including Sections 2 and 3 and the north part of Section 1, is Mabank fine sandy loam (MaA) with 0 to 1 percent slopes. Detailed soil properties of these two soil zones are listed in Table 2.

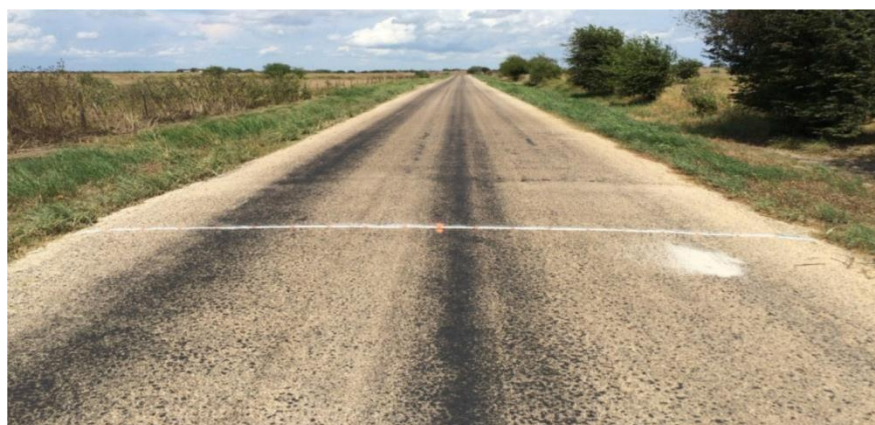
Figure 9. Transverse Section 3 (TS3) located in Control section.

2 (TS3 and TS4) and 3 (TS1 and TS2). Figure 9 presents an example of the marked transverse section located in test Section 2. The vertical movement of the marked sections was monitored using total station. A total of eleven total station surveys were conducted between 2015 and 2018. The first total station survey was conducted on August 31, 2015 and the last survey was conducted on May 9, 2018.

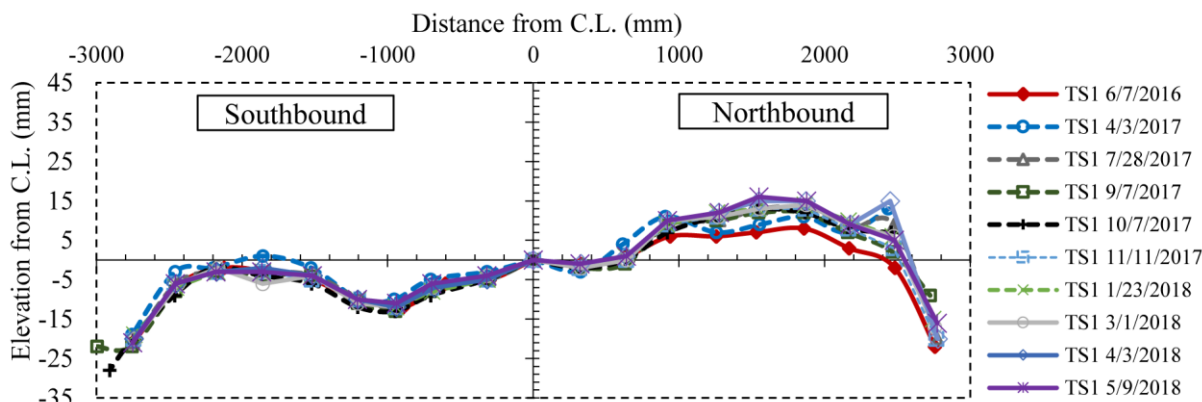
Figure 10. Example of changes in transverse profile of road over time.

Total station data was used to generate transverse section of the road at each marked section. Example plot of the transverse section for marked section 1 (TS1) is shown in Figure 10. The horizontal axis shows the distance from the centerline of the road while the vertical axis

corresponds to the relative elevation of each point compared to the elevation of the centerline. Negative values on the horizontal axis corresponds the south bound, while positive values on the horizontal axis correspond to the north bound. Assuming the elevation of the center point on the road remains unchanged (and equal to zero), transverse section profiles that were generated over time were superimposed in one plot. This presentation of data allowed evaluating differential movements between the center and the edges of the road over time.

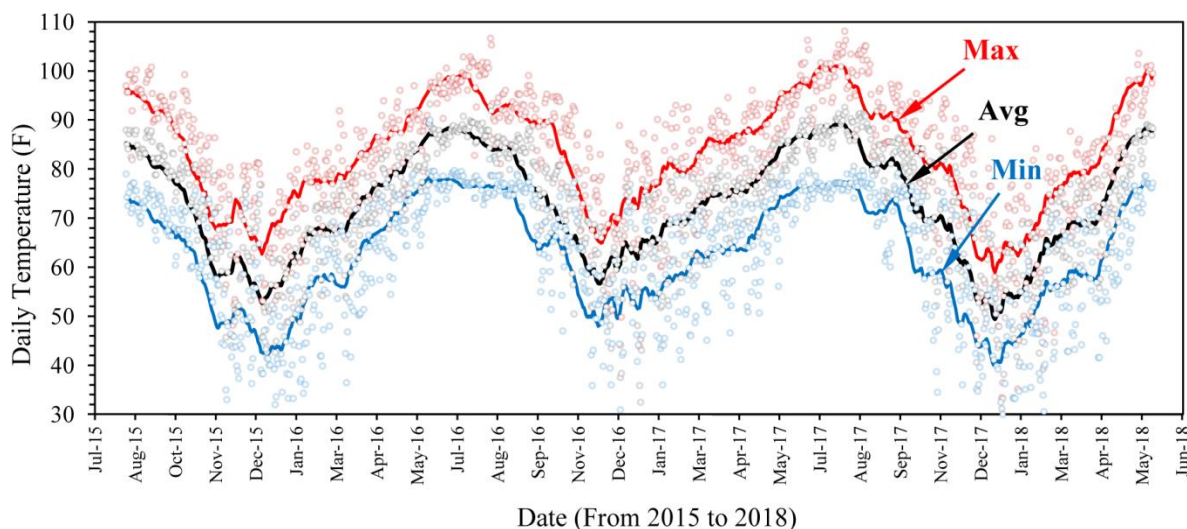
Figure 11. Daily temperature data from North Runge CR319 station.

Figures 11 and 12 present temperature and precipitation data collected from North Runge CR319 station. The horizontal axis of both graphs correspond to months from August 2015 to May 2018. The vertical axis corresponds to the daily temperature (in Fahrenheit) in Figure 11 and daily precipitation (in inches) in Figure 12. Evaluation of the temperature data presented in Figure 11 indicates that the roadway did not experience extreme hot or cold seasons and had

regular cycles of hot and cold climates repeated over the past three years.

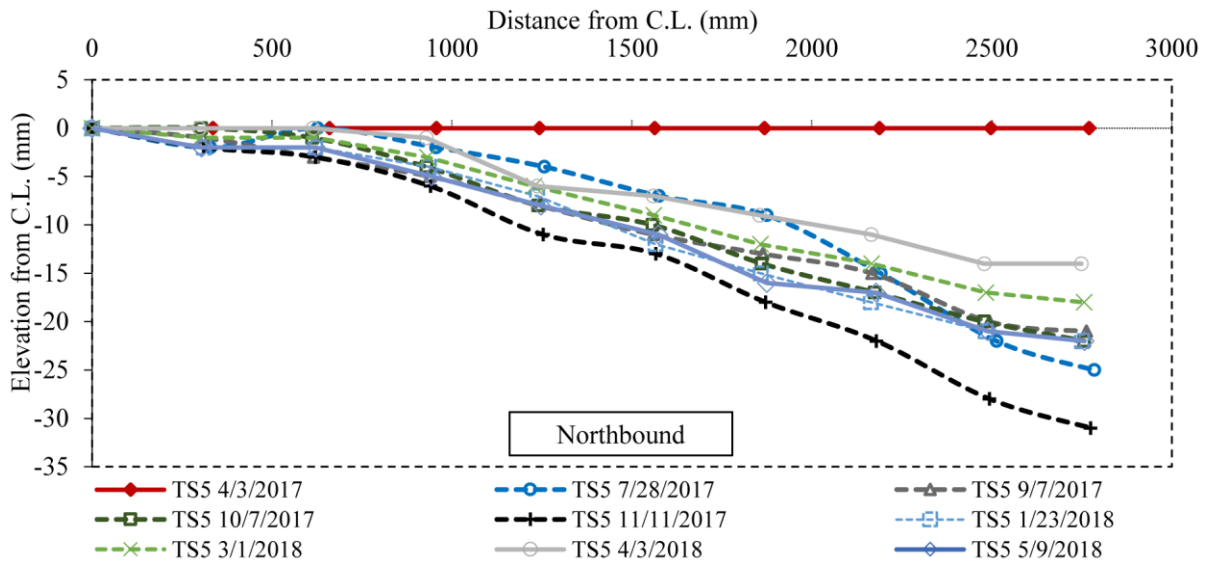
Figure 16. Relative elevation of the road surface the northbound of TS5.

In addition to the evaluation of the transverse section as a whole profile, each point located on the transverse sections can be evaluated separately. For this evaluation, the relative elevation of each point in the first visit was subtracted from the relative elevations obtained in the following visits. Therefore, changes in the elevation of each point on the transverse sections was obtained over time. The center point of each transverse section was referred to as Point 1 and other points were numbered from center to the edge in the order of their distances from the center. An example of this data for the northbound of TS 5 is shown in Figure 17. In general, points near the edge had more fluctuations than points near the center of road. This is consistent with the mechanism introduced by Zornberg et al. (2012) and Roodi et al. (2016) for the development of environmental longitudinal cracks.

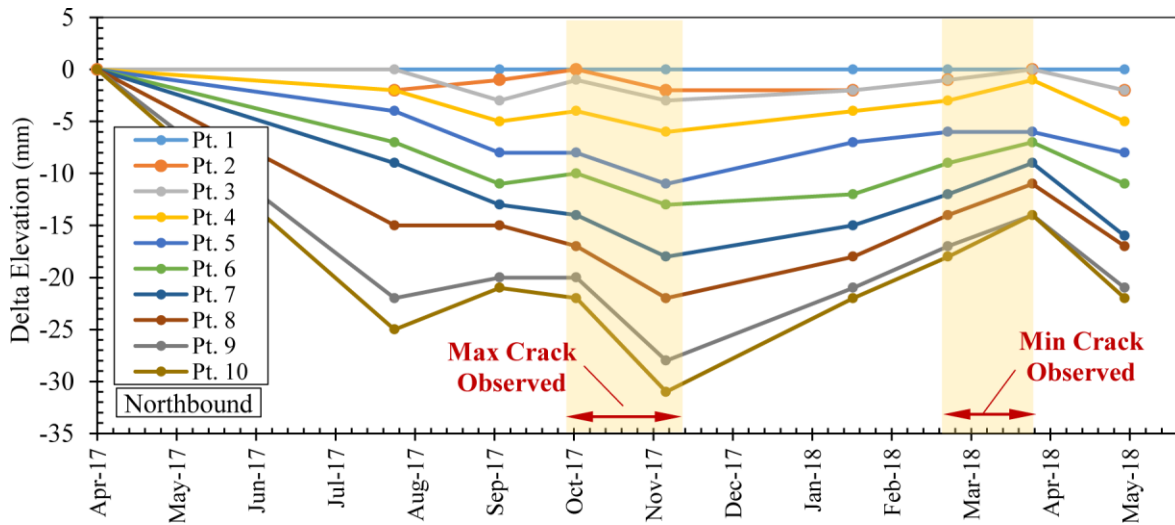
Figure 17. Vertical movements of individual points located on TS5.

Evaluation of the vertical movements presented in Figure 17 between the dates corresponding to the minimum and maximum percentage of longitudinal cracks provides a clear presentation of the previously discussed correlation between the direction of vertical movements and the development of longitudinal cracks. The dates corresponding to the maximum and minimum percentage of longitudinal cracks are highlighted in this figure. A clear rise in the elevation of all points located on this transverse section between the date of maximum crack and the date of minimum crack is observed. Specifically, the magnitude of vertical rise was comparatively larger for points that were located further from the road center (e.g., compare the data for Pts. 9 and 10 with the data for Pts. 4 and 5).

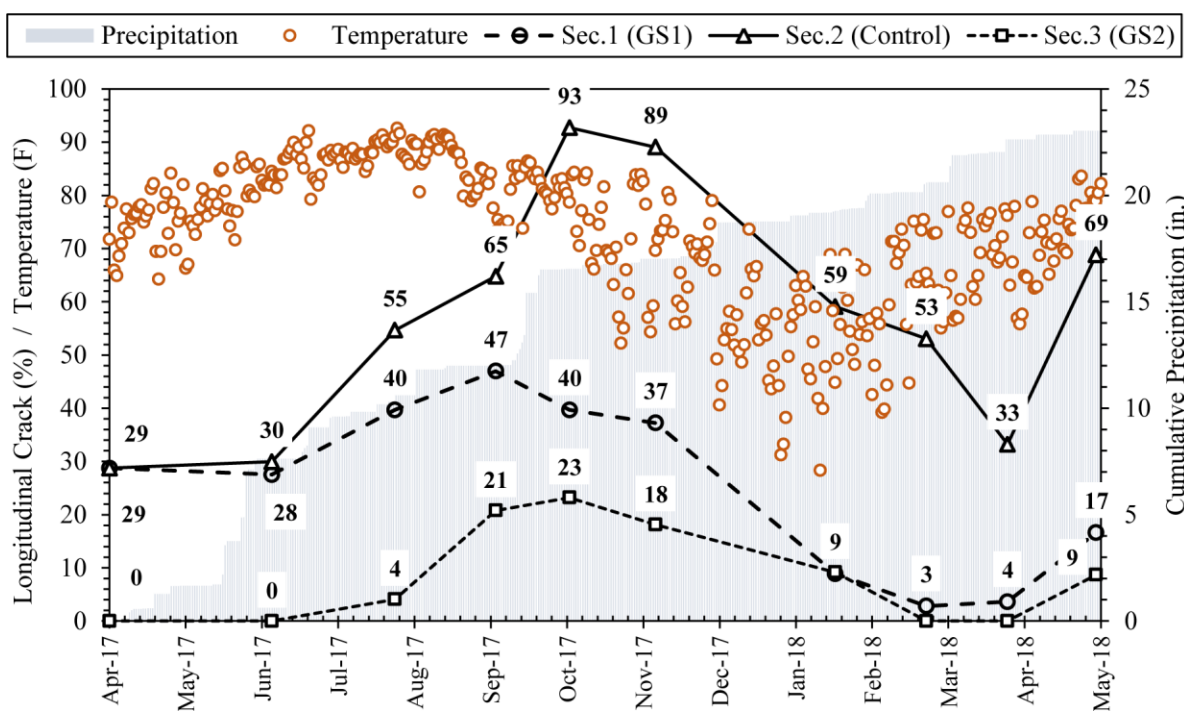
Figure 18. Comparison of longitudinal cracks and environmental data

Correlation between development of environmental longitudinal cracks and environmental data: In this section, longitudinal cracks were superimposed with environmental data (including cumulative precipitation and temperature data) to evaluate the effect of environmental changes on the development of environmental longitudinal cracks (Figure 18).

The primary vertical axis shows the percentage of longitudinal cracks as well as the temperature in Fahrenheit, and the secondary vertical axis corresponds to the daily precipitation in inches. The maximum percentage of longitudinal cracks was found between September and November 2017. According to the environmental data presented in Figure 18, during the months ending to this period of maximum cracking, the road experienced a relatively dry season coincided with a high temperature. This observation can be seen from the flat portion of the cumulative precipitation data between August and October 2017. In addition, the temperature in these months was particularly high. Starting from October 2017, the temperature drops significantly, which have resulted significant reduction in the moisture loss in the subgrade through evaporation; while at the same time additional relatively steady rainfall provided sources for additional subgrade moisture. Potential increase in the subgrade moisture content under the shoulder resulted in the upward movement of the road edge, which in turn resulted partial closing of longitudinal cracks. Consequently, the percentage of longitudinal cracks significantly reduced after October 2017 and the minimum percentage of longitudinal cracks obtained between February and April 2018.
