**TECHNICAL REPORT 5-4829-03-1**  
TXDOT PROJECT NUMBER 5-4829-03

# Soil-Geosynthetic Interaction Test to Develop Specifications for Geosynthetic-Stabilized Roadways

August 2017; Published May 2018

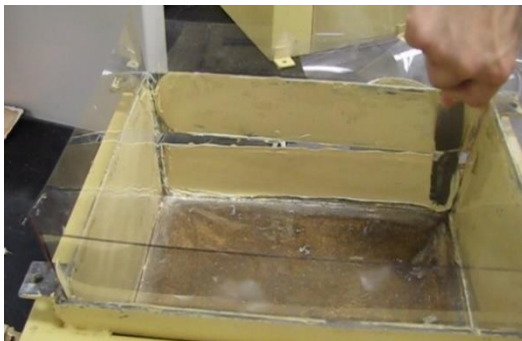
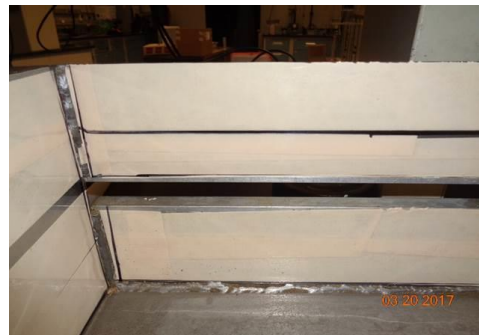
Figure 2.4 Refinement of boundary condition: a) old procedure; b) refined procedure

An additional refinement was made in the boundary condition used on the internal walls of the box. The old procedure (Figure 2.4a), which involved using two layers of Mylar sheets and grease, was replaced by one layer of Mylar sheet attached to the internal walls using double-sided tape (Figure 2.4b). The new procedure reduced the box preparation time. Furthermore, as the grease was not used in the new procedure, the aggregate was protected from mixing with grease, which was found to be one of the sources for scatter in the test results. As the refined procedure provided the same soil-Mylar interface in the boundaries, test results were found not to be sensitive to this boundary condition.

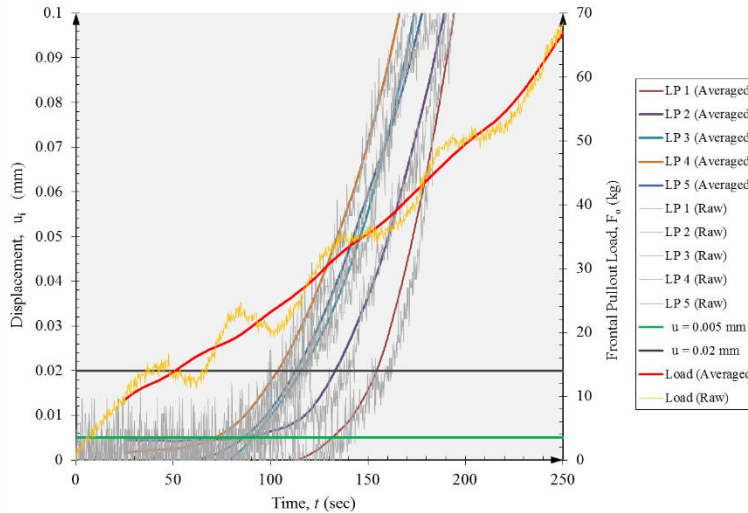
Figure 2.6 Example test results showing the impact of data smoothing procedure

As the raw data recorded by the sensors involved inevitable noises, data smoothing procedures were used to minimize the impact of noises on interpretation of the data. The data smoothing procedure adopted in this project involved a moving average technique in which each data point was replaced by a value that was obtained by averaging the data over a larger time span. The effect of data smoothing procedure was evaluated by comparing the  $K_{SGC}$  values obtained using the raw data with those obtained using various averaging spans. Specifically, the averaging span was changed from 10 points to 300 points and changes in the  $K_{SGC}$  value were evaluated. After extensive evaluation of the data recorded for various geosynthetic products, a moving average span of 250 data points was adopted in the final data analysis procedure. Figure 2.6 presents an example plot of the raw data versus the smoothed data using a moving average of 250 data points.

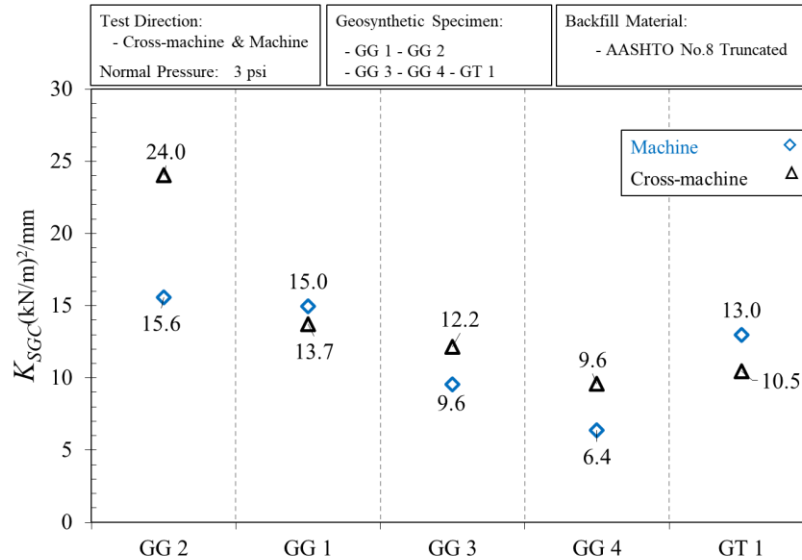
Figure 3.10 Comparison of  $K_{SGC}$  values obtained for the baseline geosynthetics in cross-machine and machine directions using AASHTO No. 8-Truncated backfill materials under 3 psi

Figure 3.10 presents the  $K_{SGC}$  values obtained in both machine and cross machine directions of the five baseline geosynthetics using AASHTO No.8-Truncaed backfill materials and under a normal pressure of 3 psi. Although the  $K_{SGC}$  value obtained for each geogrid in the machine direction was different than its  $K_{SGC}$  in the cross-machine direction, ranking of the geogrids was found to be the same in both directions. For geogrids GG 3 and GG 4, the  $K_{SGC}$  value in the machine direction was found to be slightly smaller than that in the cross-machine direction. The  $K_{SGC}$  value of geogrid GG 1 in the machine direction was found to be approximately the same as that in the cross-machine direction.

The second direction for testing GG 2 (as a triangular geogrid) was selected as the diagonal direction. The  $K_{SGC}$  value obtained for this geogrid in the diagonal direction was found to be considerably smaller than that in the cross-machine direction. This might be partially attributed to the differences in the physical and mechanical characteristics of the geogrid in the two directions, and can also be partially attributed to that geogrid specimens tested in the diagonal directions were collected from a different manufactured roll than the specimens tested in the cross-machine direction.

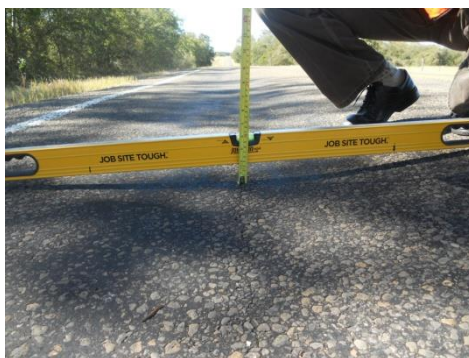
Figure 4.1 Measurements of rutting in the FM2 pavement

- ***Shallow Rutting and Deep Rutting:*** Rutting was measured as the percentage of the section's total wheel paths area in different severity levels. While shallow rutting is defined as 0.25 to 0.49 in. (6 to 13 mm), deep rutting is determined as 0.5 to 0.99 in. (13 to 25 mm). Severe rutting refers to rut depths as great as 1.0 to 1.99 in. (25 to 51 mm), and failure rutting refers to rut depths exceeding 2.0 in. (51 mm). In this study, rutting of test sections was measured using a 6-foot straight edge and a steel ruler. An example of rutting measurement on the FM2 pavement is illustrated in Figure 4.1.

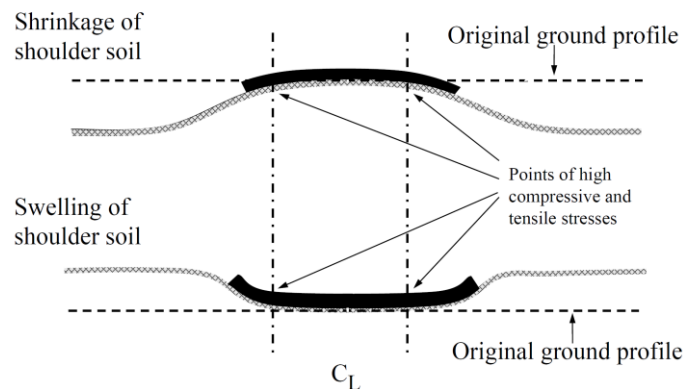
Figure 4.4 Conceptual model for generating environmentally induced longitudinal cracks in pavements

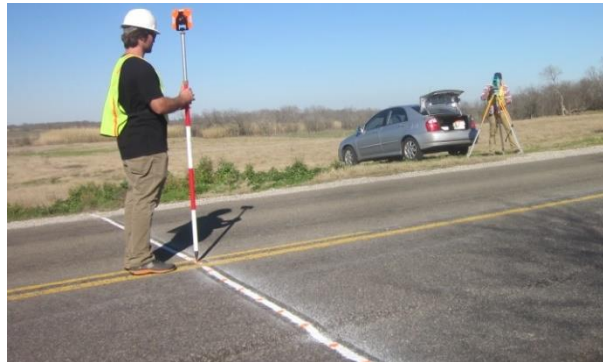
*Figure 4.6 Using total station and prism to monitor vertical deformation of the marked transverse sections*

In order to read elevation of the marked transverse sections, a total station was installed on the roadside less than 200 ft away from the marked sections. Then the instrument was pointed at each orange mark along the transverse sections, and the coordinates of the point were recorded. Transverse profile of the road could be obtained by analyzing the recorded coordinates and connecting them accordingly. Transverse profiles were obtained over time for the marked sections on a regular basis and changes in the elevations were evaluated.

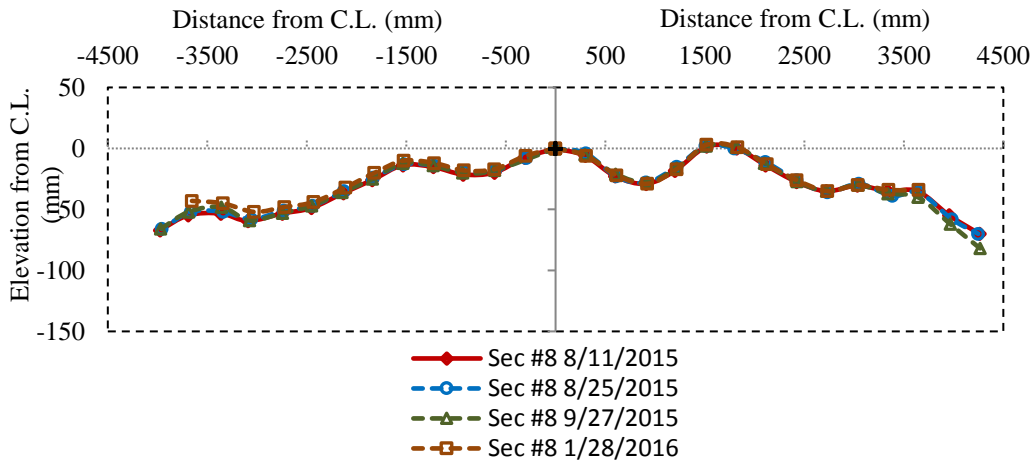
Figure 4.8 Example transverse profile of the road surface generated using total station data

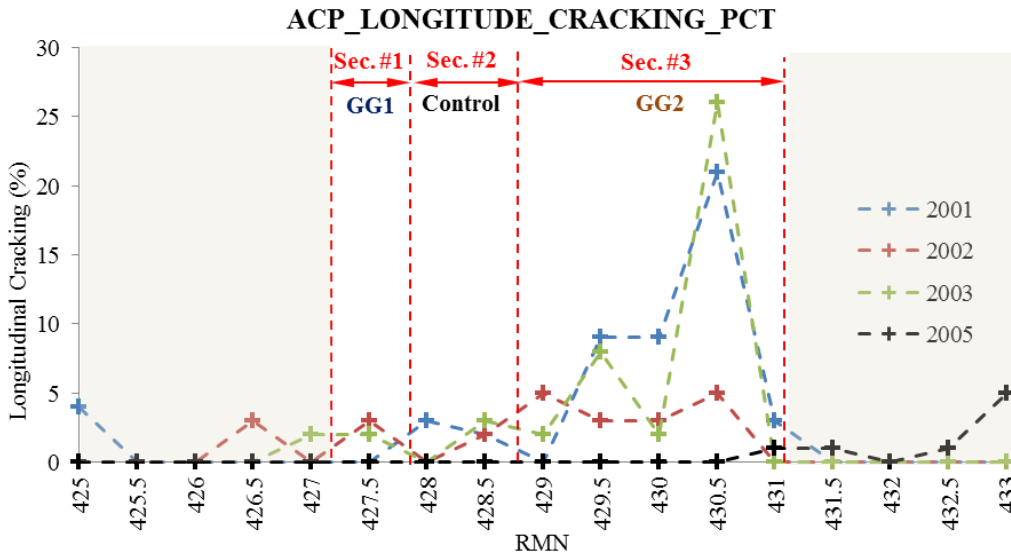
Figure 4.9 Example analysis for comparative evaluation of performance in geosynthetic-stabilized versus non-stabilized test sections using PMIS data

Figure 4.9 illustrates an example of the analysis that was conducted for comparative evaluation of performance in geosynthetic-stabilized versus non-stabilized test sections using the collected PMIS data. In this example, average percentage of longitudinal cracks for Data Collection Sections is illustrated on the vertical axis and the TRM numbers are presented on the horizontal axis. Limits of the three test sections are also specified in this graph. Evaluation of the data presented in this graph for various years provides insight on comparative performance of geosynthetic stabilized versus non-stabilized test sections as well as on the comparative performance of various types of geosynthetic reinforcements.

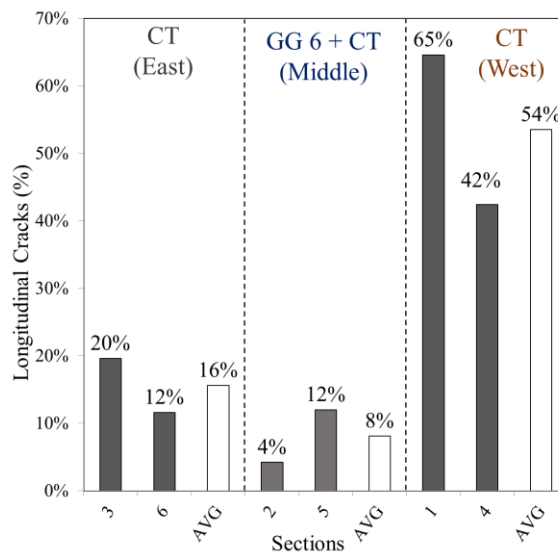
Figure 4.18 Percentage of environmental longitudinal cracks at the FM1644 test sections

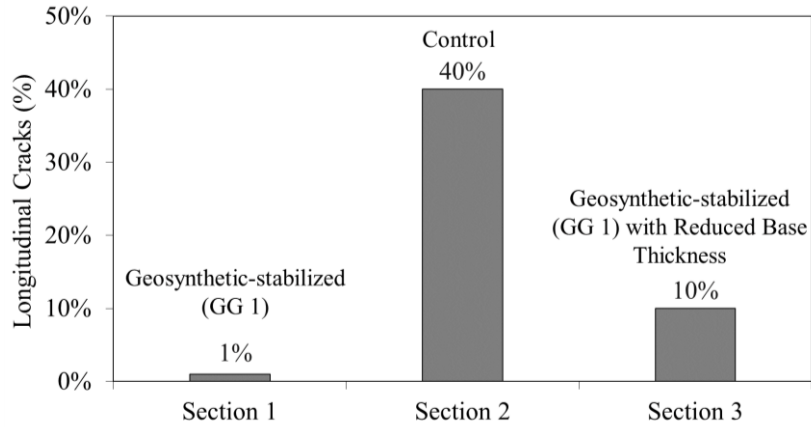
Figure 4.21 Percentage of environmental longitudinal cracks at FM 1915 test sections

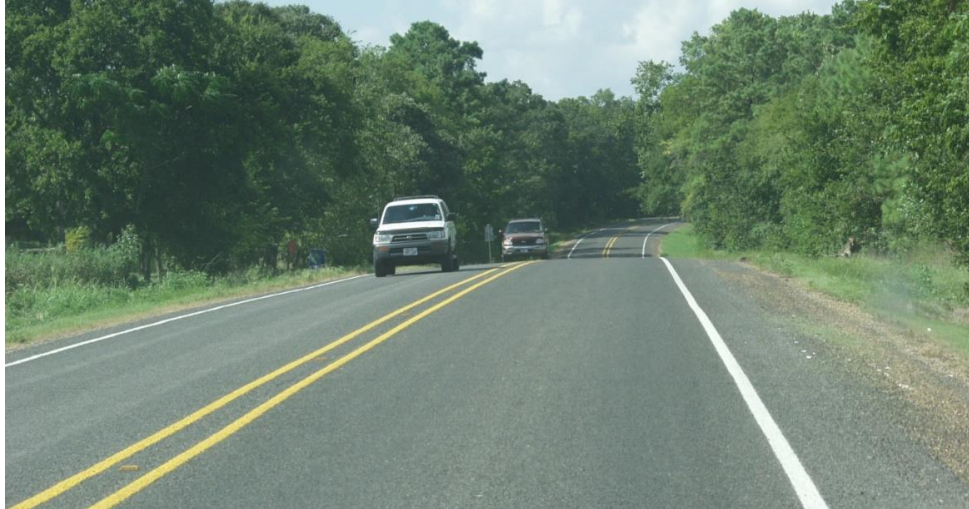
*Figure 4.25 Example picture of the field performance of the test section stabilized using GG 1 at FM 1774*

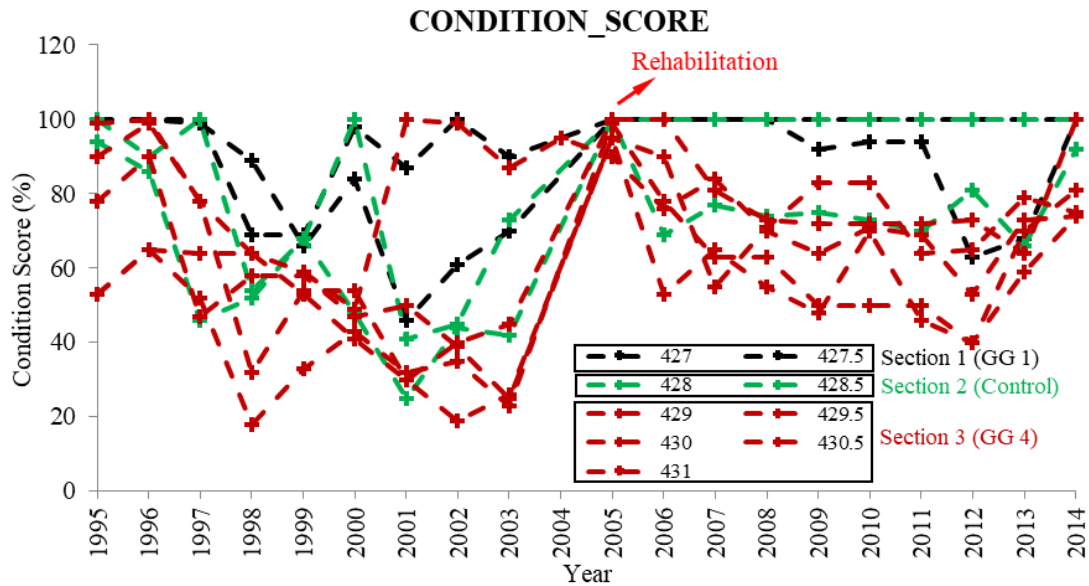
Figure 4.26 Condition score of the test sections at FM 1774 from 1995 to 2014

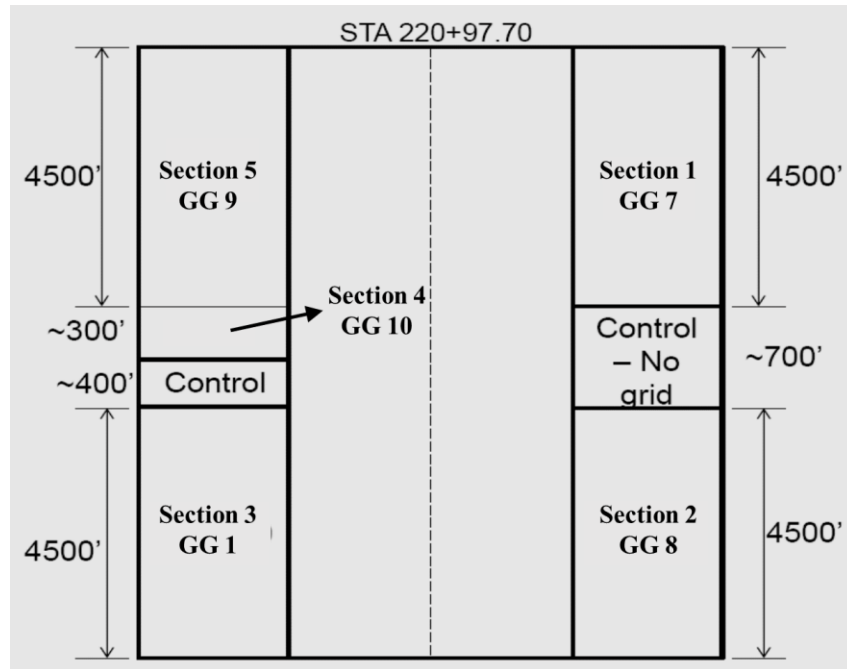
Figure 4.28 Layout of test sections at SH 21

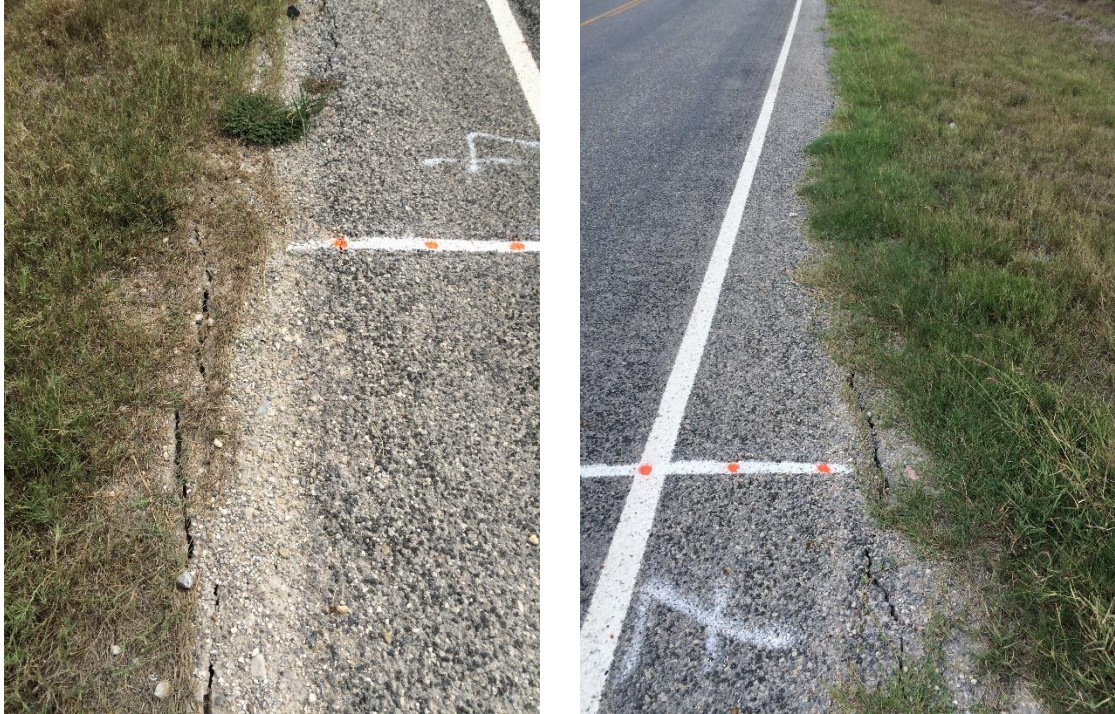
*Figure 4.34 Example pictures of the longitudinal cracks developed at the edges of test sections at FM 2924*

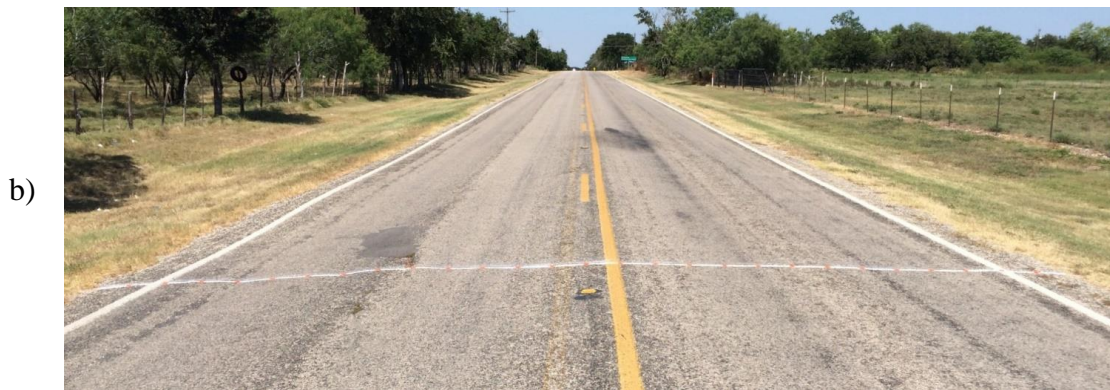
Figure 4.39 Transverse Section 3 at FM 1979: a) variation of the elevation from 2015 to 2017 from data recorded using total station; b) picture of the transverse section

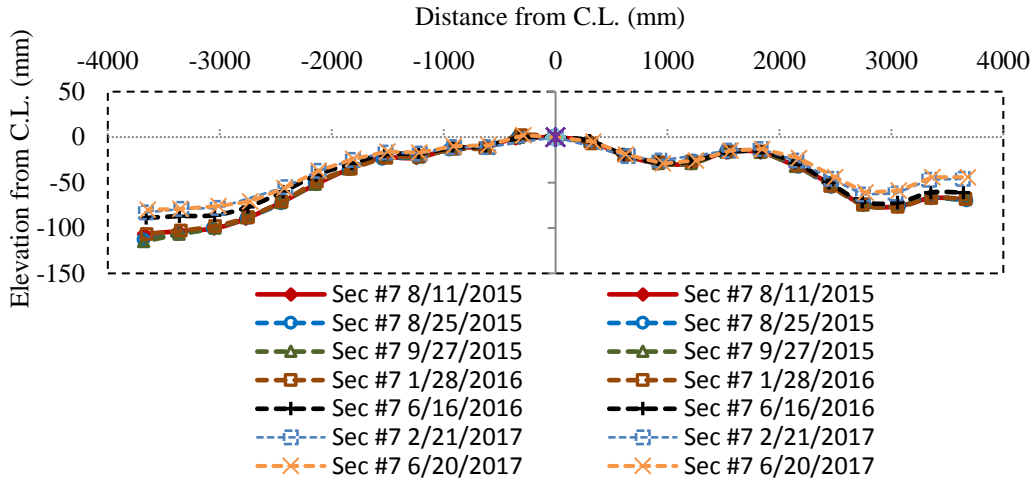
Figure 4.40 Variation of the road elevation at Transverse Section 7

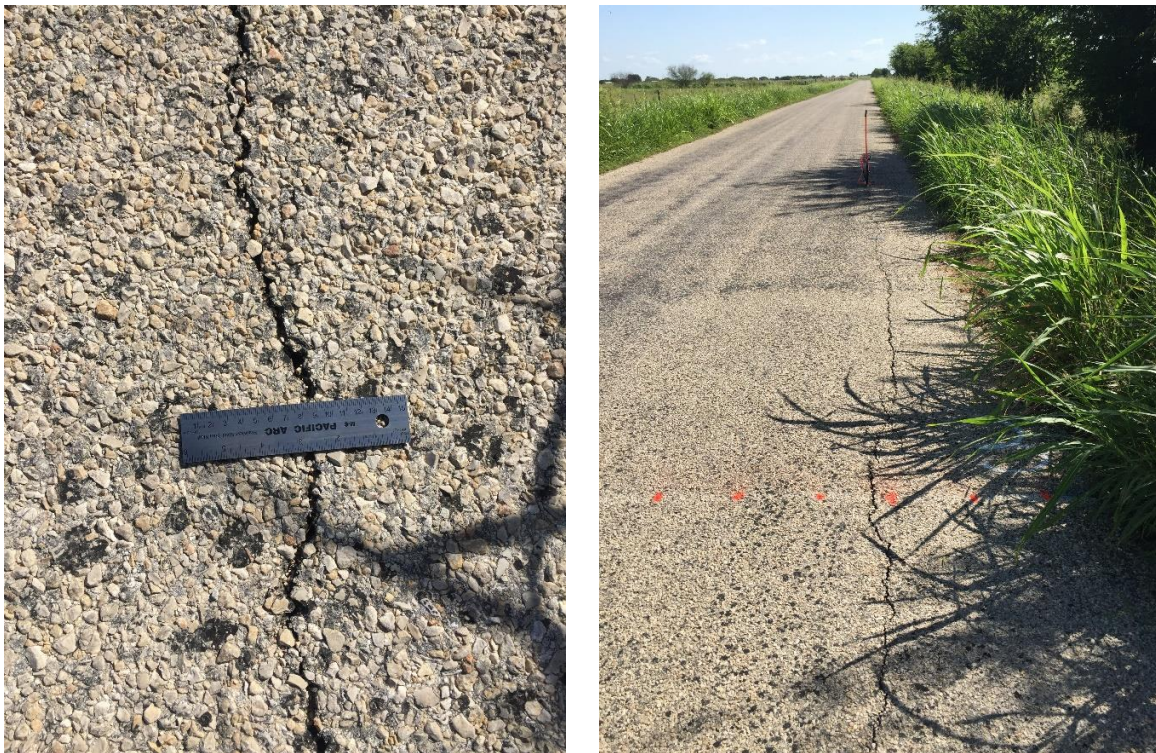
Figure 4.46 Example pictures of longitudinal cracks in control section at Cabeza Rd.

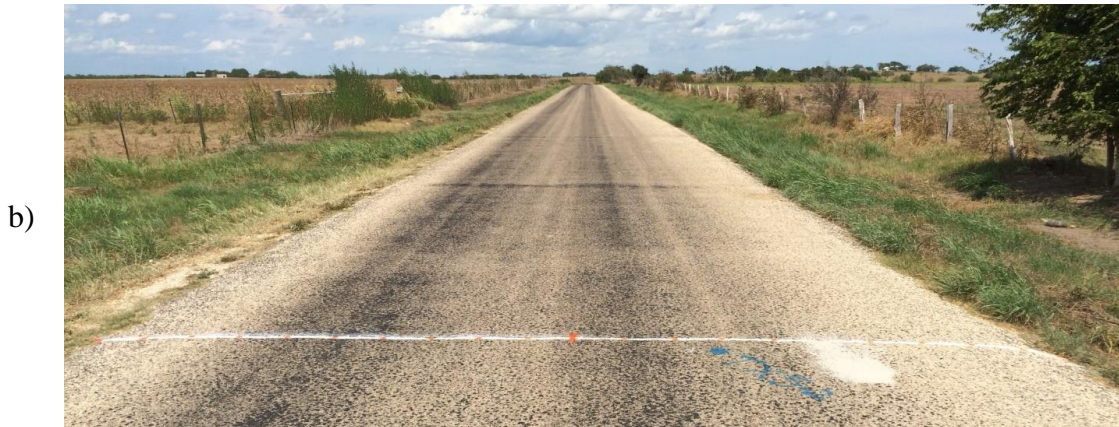
Figure 4.47 Transverse Section 5 at Cabeza Rd. located within test Section 3: a) variation of the elevation from 2015 to 2016 from data recorded using total station; b) picture of the transverse section

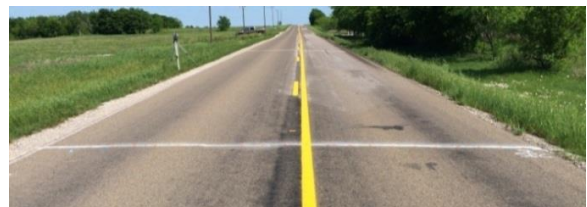
Section 7

Figure 4.49 Results of total station surveys and road conditions at FM 972

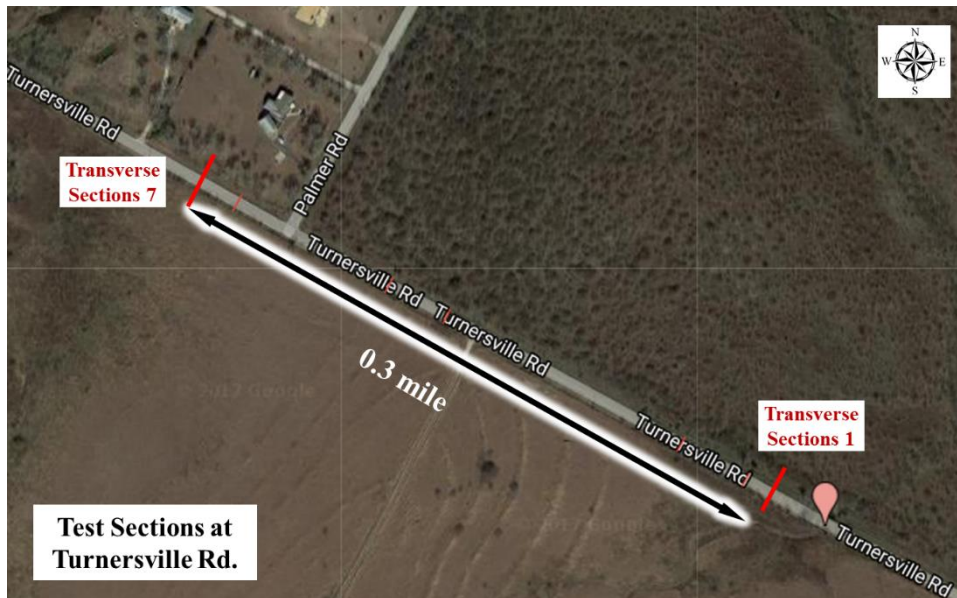
Figure 4.50 Layout of test sections at Turnersville Road

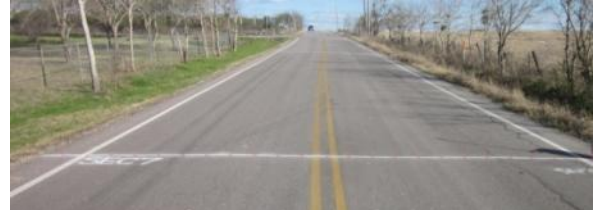
Section 7

Figure 4.51 Results of total station surveys and road conditions in Turnersville Road

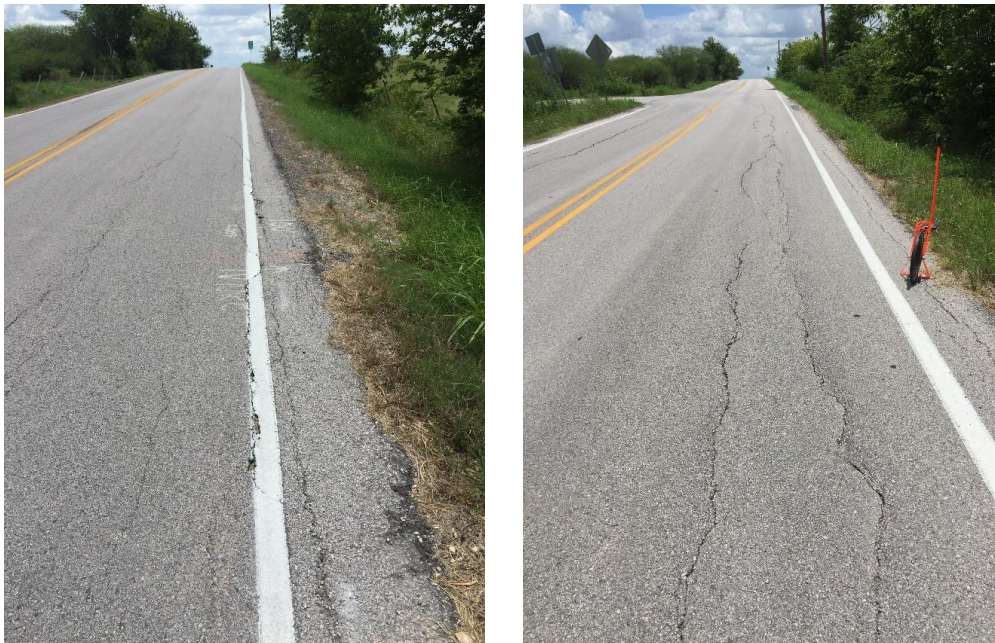
Figure 4.53 Example pictures of longitudinal cracks observed at Turnersville Road test sections in 2017
