1. Report No. FHWA/TX-10/0-5517-1		2. Government Accession No.		3. Recipient's Catalog No.	
4. Title and Subtitle Mechanical Properties of Tire Bales for Highway Applications				5. Report Date October 2008; Revised December 2009

## **Mechanical Properties of Tire Bales for Highway Applications**

CTR Technical Report:	0-5517-1
Report Date:	October 2008; Revised December 2009
Project:	0-5517
Project Title:	Beneficial Use of Scrap Tire Bales in Highway Projects
Sponsoring Agency:	Texas Department of Transportation
Performing Agency:	Center for Transportation Research at The University of Texas at Austin

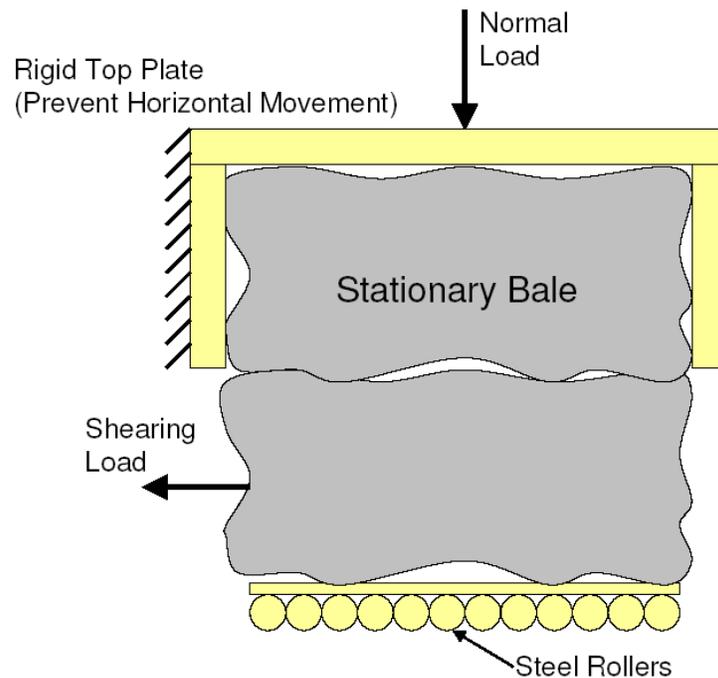
*Figure 2.4: Illustration of the Testing Setup for Zornberg et al. (2005)*

Assuming that the tire bale remains intact during the life of the structure, the most critical weak planes exist along the perimeter of the bale. Simm et al. (2004) estimated the strength along the bale interface by stacking two bales, holding the bottom bale in place, and dragging the top bale along the bottom bale. It was calculated that the friction angle along the interface was approximately  $35^\circ$  based on the normal load along the interface (the weight of one bale) and the shearing load applied to the bale. A series of similar direct shear tests were reported by Zornberg et al. (2005) in which two bales were stacked upon each other, and placed on top of a steel plate supported by steel rollers (Figure 2.4). The normal load was varied along the top bale which was held in place, and the force required to pull the bottom bale out of the arrangement was measured. The authors mention that the test did not perform as expected and that the two bales tended to rotate rather than the bottom bale displacing relative to the top bale. Linear failure envelopes (shearing stress by the normal load) presented by the authors were characterized with Mohr-Coulomb parameters; a friction angle of  $25^\circ$ – $30^\circ$  and a cohesion of 50 psf.

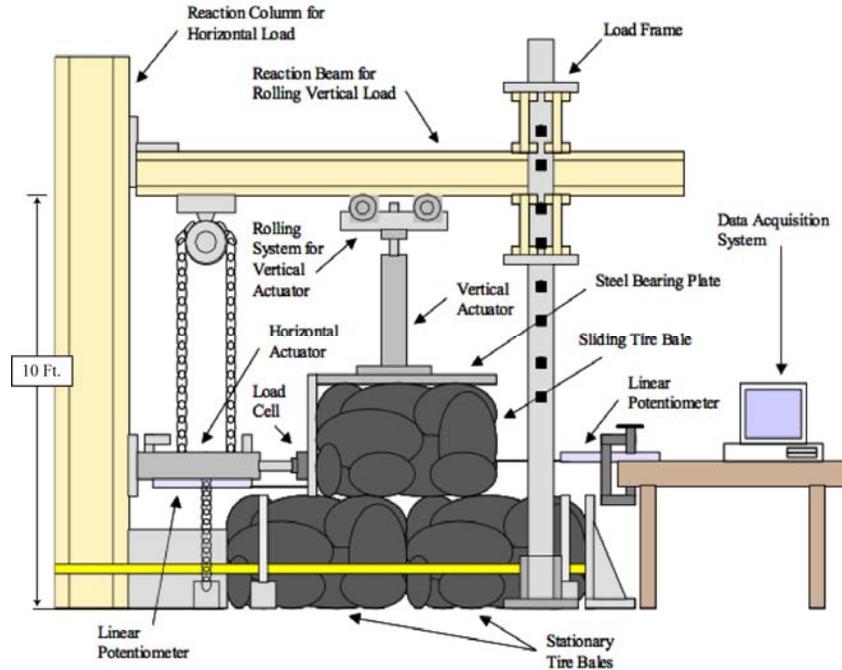
Figure 2.5: Testing Setup for LaRocque (2005)

A more stable testing setup was designed by LaRocque (2005), which consisted of stacking three bales in a pyramid arrangement, applying a variable normal load to the top bale, and measuring the force required to push the top bale past the stationary bottom bales (Figure 2.5). A roller joint was placed at the top of the normal load actuator so that large displacements along the interface could be achieved. Failure was defined as the horizontal load that initiated sliding along the interface, or rigid movement of the top bale. The strength along the interface was defined with a friction angle of  $36^\circ$  and cohesion of 30 psf.

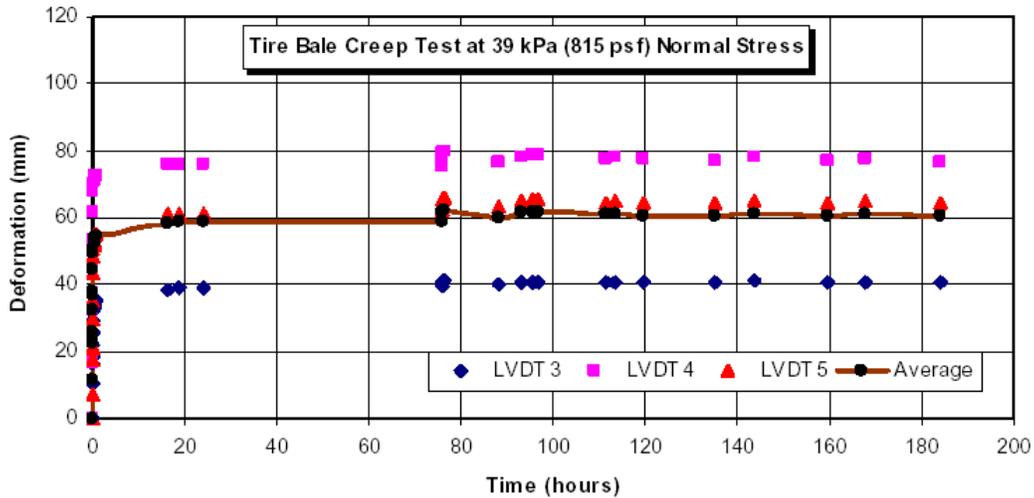
Figure 2.11: Creep Test Results from Single Bale Arrangement (Zornberg et al. 2005)

As an extension of the compression testing, sustained loading (creep) tests were conducted by Zornberg et al. (2005) and LaRocque (2005) to determine the amount of vertical deformation caused by sustained normal loading. Typical results from the testing are shown in Figure 2.11 and 2.12 from the research programs. Zornberg et al. (2005) reported that 95% of the compression occurred within the first 24 hours, with creep strains never exceeding 1.5 mm for sustained loadings of 314 and 815 psf. The creep strain rate was estimated to be approximately

0.005% of creep strain per day. LaRocque (2005) reported maximum creep strains of less than 0.053% of the original bale height after 72 hours of sustained loading at 400 psf.

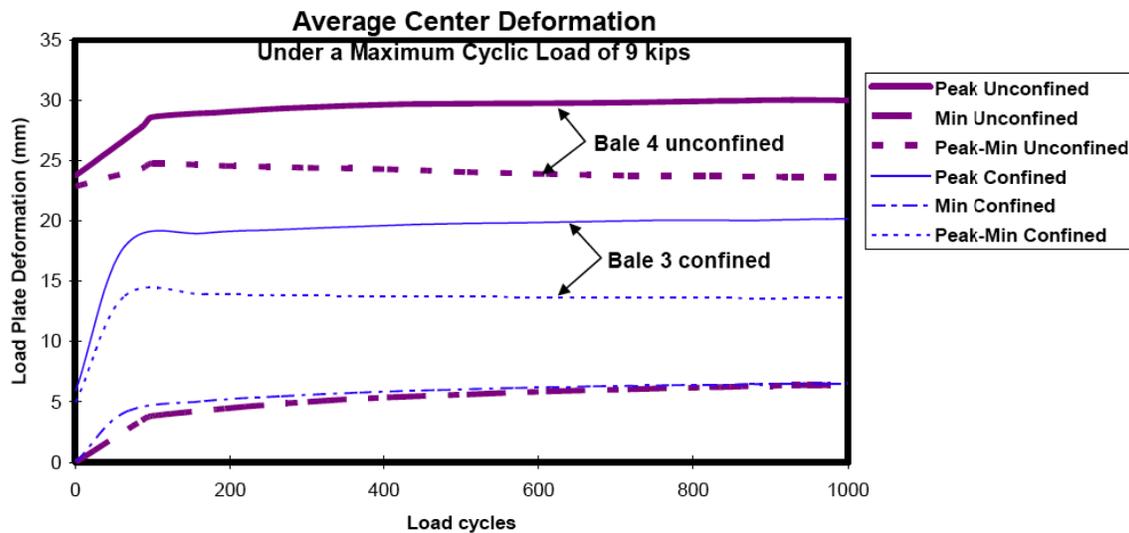
Figure 2.13: Cyclic Compression Testing Results for a Single Bale (Zornberg et al. 2005)

Zornberg et al. (2005) also reported the results of cyclic compression testing for a single tire bale in which a load of 9000 pounds was applied at a  $1\pm 0.5$  Hz frequency for 1000 cycles. Bales were tested under both unconfined and confined conditions as described previously. The results of the tests are shown in Figure 2.13. The maximum deformation was reached after approximately 100 cycles for both the unconfined and confined cases. It is evident that the deformations of the confined bale were less than that of the unconfined bale, which is in agreement with the data reported for cyclic testing. The minimum deformations, which represent the permanent deformations of the bales, were similar for both confined and unconfined conditions.

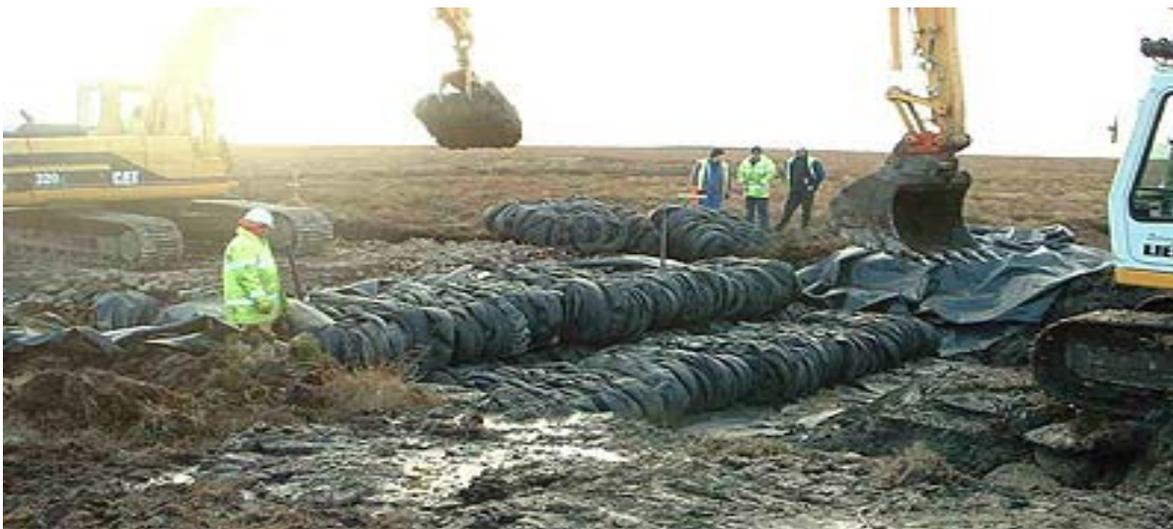
*Figure 2.14: Lightweight Tire Bale Road Construction  
([www.angloenvironmental.com/tyre\\_blocks\\_anglo.php](http://www.angloenvironmental.com/tyre_blocks_anglo.php))*

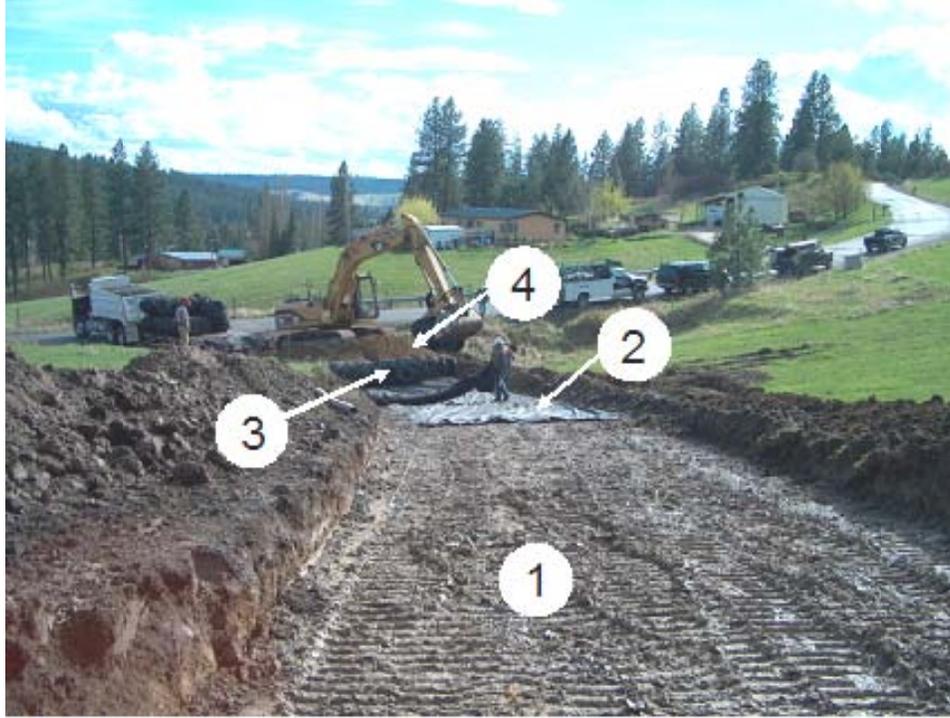
*Figure 2.16: Photograph of a Roadway with a Single Layer Tire Bale Subgrade  
([www.lstire.com/images/bale\\_job\\_during\\_resized.jpg](http://www.lstire.com/images/bale_job_during_resized.jpg))*

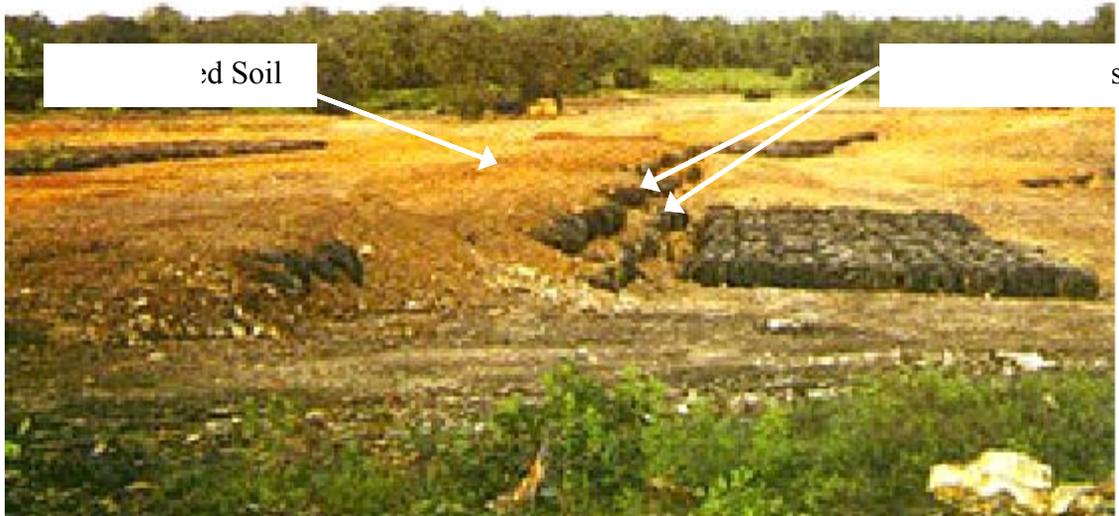
*Figure 2.19: Tire Bales Used as a Fill Material in the Outer Shell of an Earthen Dam  
(<http://www.eagle-equipment.com/enviroblock.html>)*

Numerous proposed uses of tire bales used as fill material in earthen dams are reported in the literature. The most notable was a project reported by Rooke (2001) in which tire bales were to be used as a fill material around a compacted clay core dam. It was estimated that approximately 4.5 million tires would be used in the project and the impounded water would improve the communities' fire insurance rating of about \$200,000. Data pertaining to the performance or construction of the dam has not yet been found. However, one reference did provide a few photographs of the construction of the dam, which used 1 million scrap tires ([www.eagle-equipment.com](http://www.eagle-equipment.com)). A photo of the tire bale fill layers between compacted soil layers, which formed the outer shell of the clay core dam, is shown in Figure 2.19.

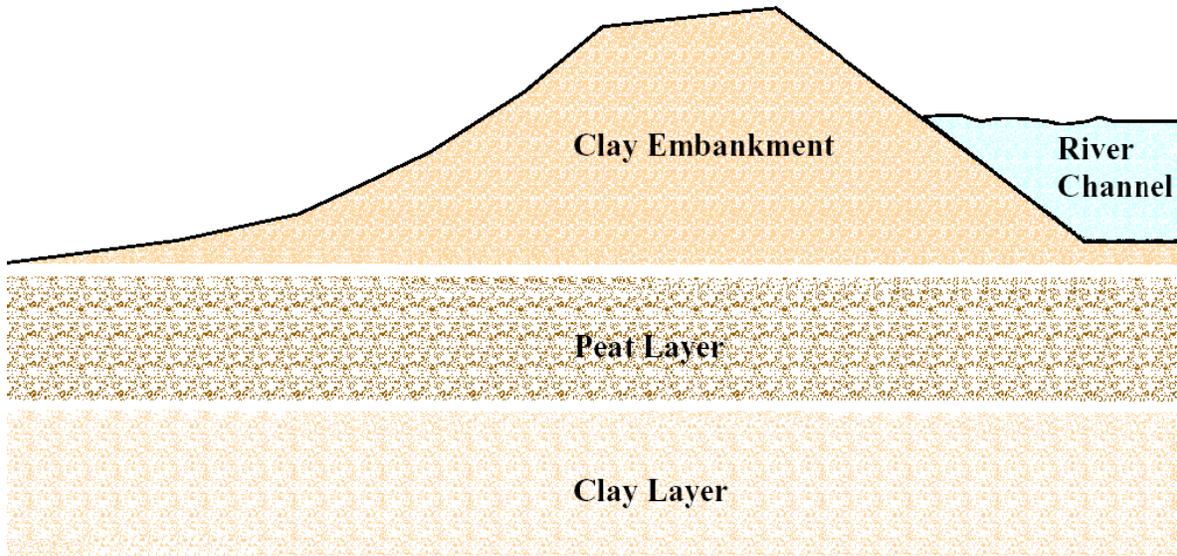
Figure 2.20: Existing Soil Profile under the Flood Embankment (Simm et al. 2004)

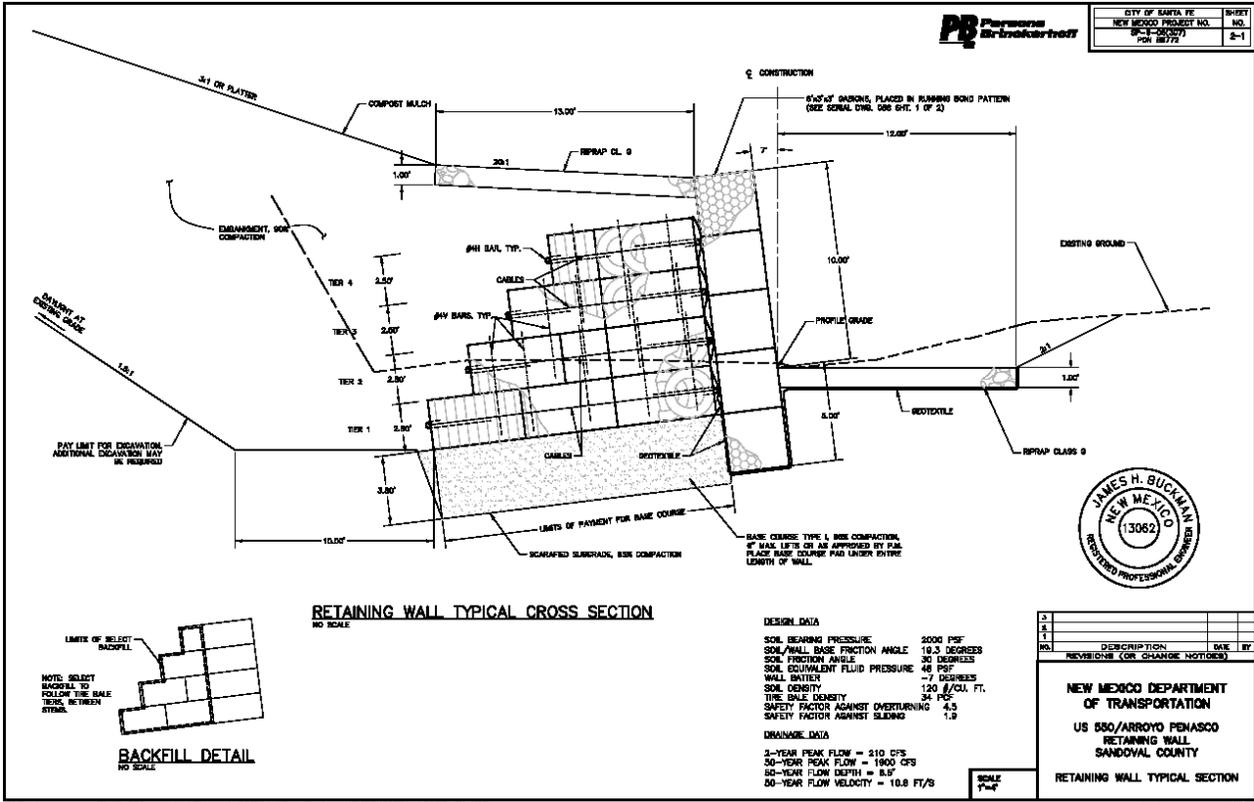
Figure 2.23: First Layer of the Tire Bale Gabion Retaining Wall (Duggan 2007)

Tire bales can also be used as modular blocks to construct a gravity retaining wall, as illustrated by numerous retaining walls built by the New Mexico Department of Transportation (Duggan 2007, Hudson 2008). For both walls, the tire bales replaced the expensive gravel fill commonly used in a gabion gravity wall. A schematic of the tire bale wall constructed along US 550 is shown in Figure 2.23. The use of tire bales reduced the weight and size of the wall needed while still providing adequate factors of safety against sliding and overturning. It was also noted that the wall was less labor intensive to build as compared to a traditional gabion wall. In order to reduce the voids between bales, and also limit the movements along the interfaces of the bales, steel bars were used to tighten the layers of tire bales together as well as hold the bales in place, as shown in Figure 2.24.

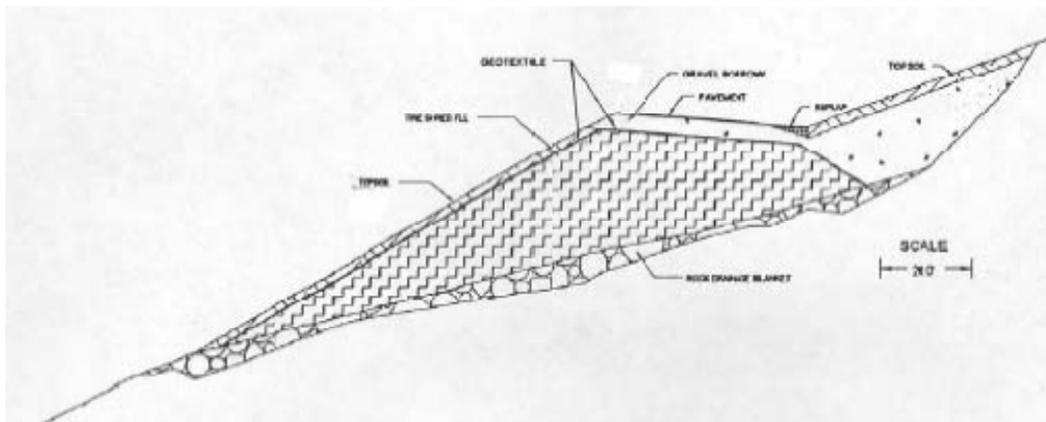
*Figure 3.2: Illustration of Tire Shred Fill for Il Waco, Washington Highway Remediation Project (Wappett 2004)*

Five months after the completion of the fill, significant settlements were measured and liquid petroleum products were detected seeping from the base of the tire shred mass. The tire shred section was subsequently removed, with over 13,000 tons of tires and contaminated material removed, at a cost of \$3.2 million (WA DOT 2003).

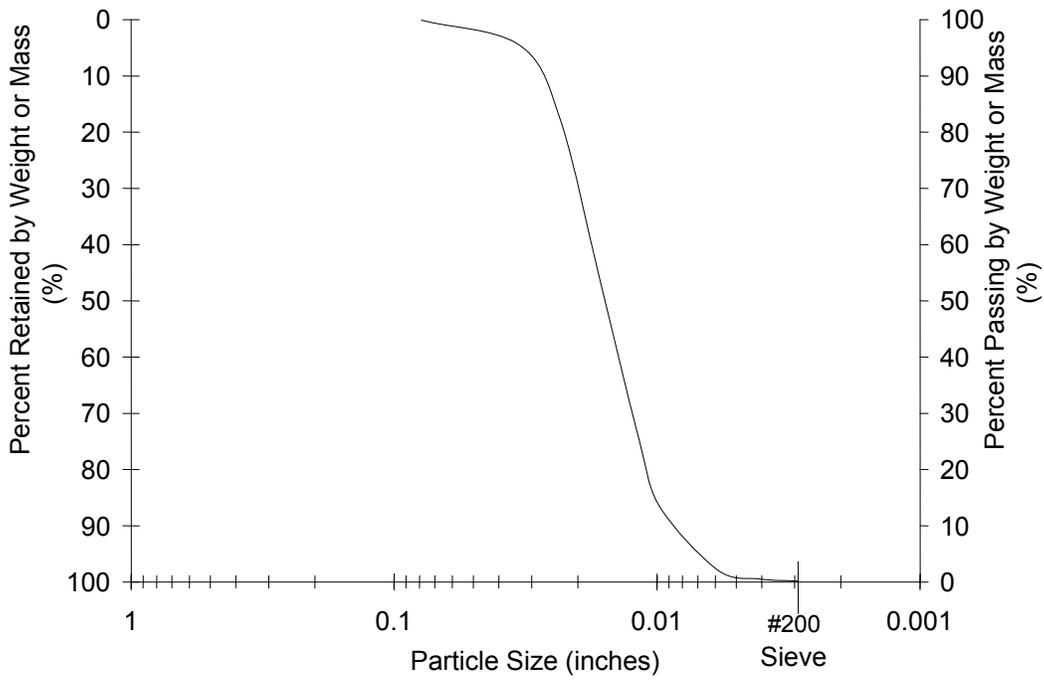
Figure 4.2: Sieve Analysis Results for the Sand Fill

The sand used for the testing programs was a uniformly graded sand (SP), as defined by the Unified Soil Classification System. This sand is commercially available as fill sand from Travis Aggregates (Location: Manor, Texas, Phone: (512) 276-9900). Results from a sieve analysis on the sand (ASTM D422-63) are presented in Figure 4.2. Results from direct shear tests (ASTM D3080-04) conducted on the sand under dry conditions (water contents less than 4%) are presented in Figure 4.3. The direct shear testing was conducted with a ShearTrac II-D direct shear apparatus (Manufacturer: Geocomp Corporation, Phone: 800-822-2669). The sand was compacted to a dry unit weight 103 pcf, the same weight of the sand used for the tire bale-sand interface testing presented in Chapter 6. Additional direct shear testing was conducted on sand compacted to a unit weight of 93 pcf to determine the effect of remolding on the sand, and to determine the variability of the sand strength with density. The strength of the sand was found to be represented by a friction angle of 21° for a unit weight of 93 pcf and 30° for a unit weight of 103 pcf.

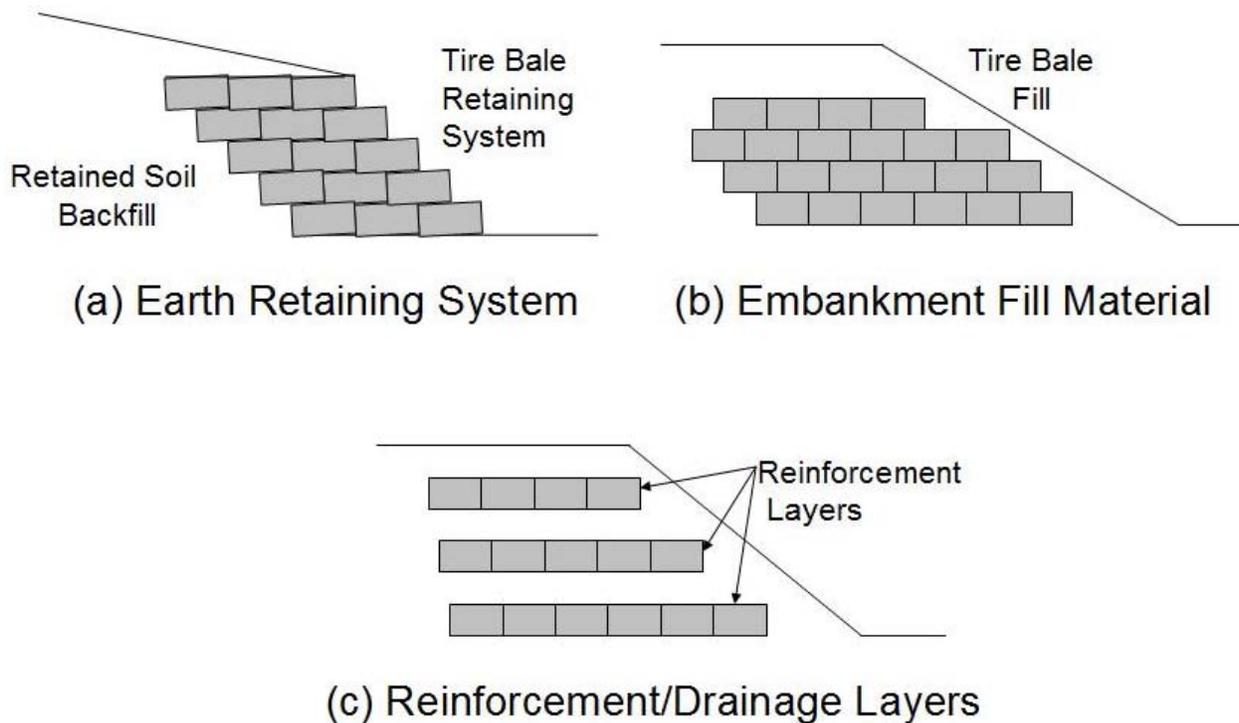
Figure 6.1: Illustrations of Proposed Uses of Tire Bales in Highway Structures

Proper design of tire bale structures requires that engineers are able to perform stability analyses to ensure an adequate factor of safety. The stability analyses must utilize the strength of the tire bales, which must be properly characterized and known for the conditions of the structure. For short term conditions, it is assumed that the tire bales act as discrete blocks and sliding along the interfaces is the controlling mode of failure. The following chapter outlines the testing procedure and results obtained from a large scale direct shear test developed to determine the interface strength of tire bales for different design conditions (Figure 6.1).

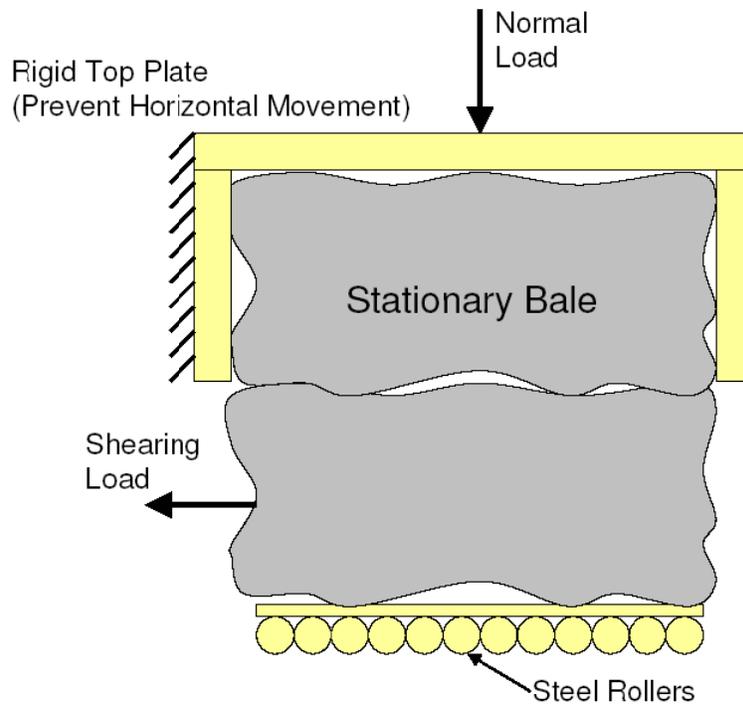
Figure 6.2: Direct Shear Testing of the Tire Bale Interface Using Two Tire Bales

Any testing procedure to determine the interface strength of the tire bales is a difficult process due to the large size of the bales and loads that must be applied. Initial interface strength testing involved stacking two bales (Figure 6.2) and applying a normal and shear load to one bale while holding the other stationary. This method was found to be too difficult due to instability and rotation of the bales (rather than sliding along the interface) after small displacements (Zornberg et al. 2005). This method of testing also limited the total displacement of the mobile bale to a few inches and made the calculation of the contact area (which changed with displacement) difficult.

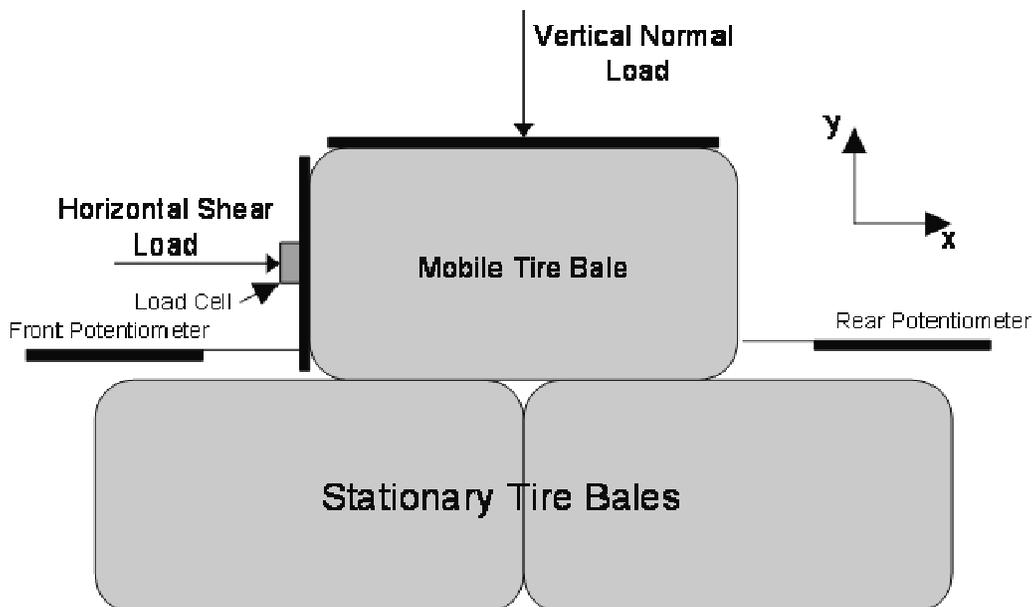
Figure 6.3: Schematic of the Large Scale Direct Shear Test Setup

A large scale direct shear testing procedure developed at the University of Texas at Austin (Zornberg et al. 2004, LaRocque 2005) required that the bales be placed in an initial brick, or pyramid, fashion (Figure 6.3). The bottom two bales were held stationary as the top bale was displaced horizontally with a hydraulic piston. This test is similar to that of a soils direct shear test, in which the material is forced to fail horizontally along a defined shear plane.

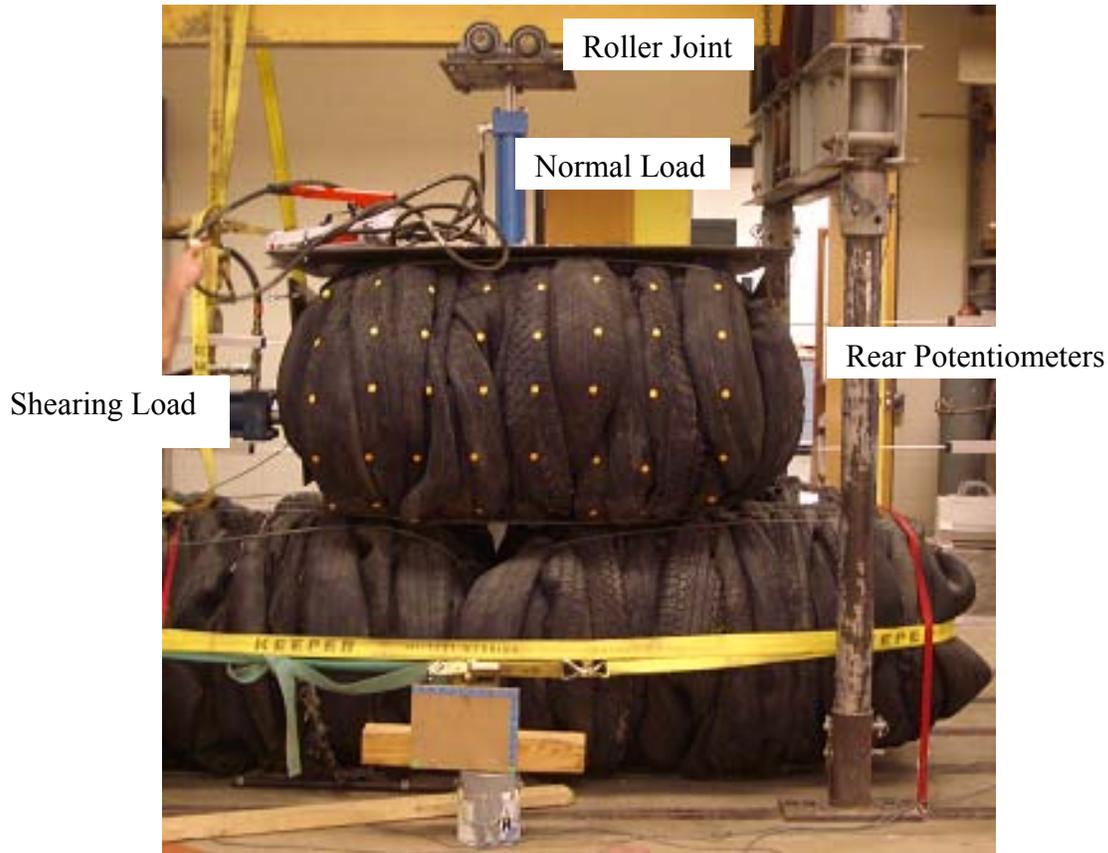
*Figure 6.4: Large Scale Direct Shear Test Setup with Instrumentation*

The normal load was applied by a hydraulic actuator mounted to a rigid top plate and placed on the top mobile bale. The normal load reacts against a roller joint along the load frame so that large displacements (as much as 24 inches) could be achieved (Figure 6.4). Potentiometers were placed at the front and rear of the mobile bale to measure the horizontal displacements, and a load cell was used to measure the vertical shearing load applied to the bale.

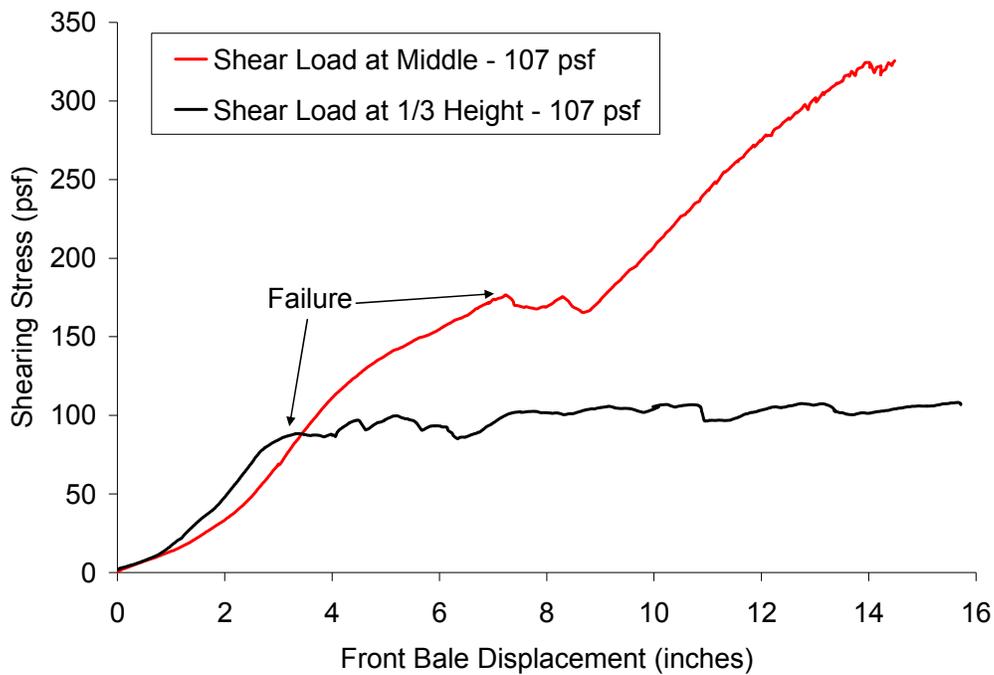
Figure 6.5: Shearing Stress versus Bale Displacement for Shearing Loads Applied at Different Points Along the Height of the Bale

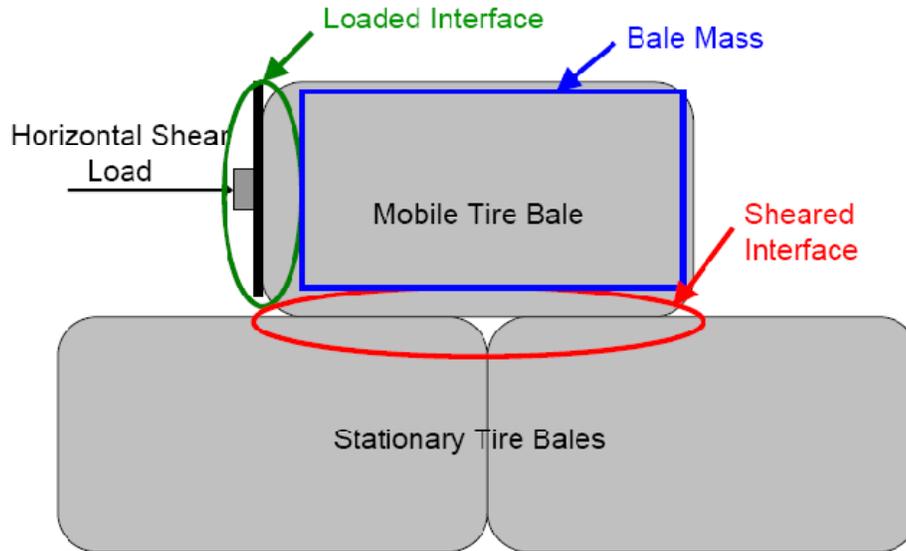
Figure 6.7: Illustration of the tire bale interface and tire bale mass

which can be characterized as an irregular and variable surface. The two interfaces of interest for this test are the horizontally loaded interface (where the shearing load is applied) and the sheared interface along which the bale displacement occurs. The tire bale mass is defined as any tire material confined within the baling wires.

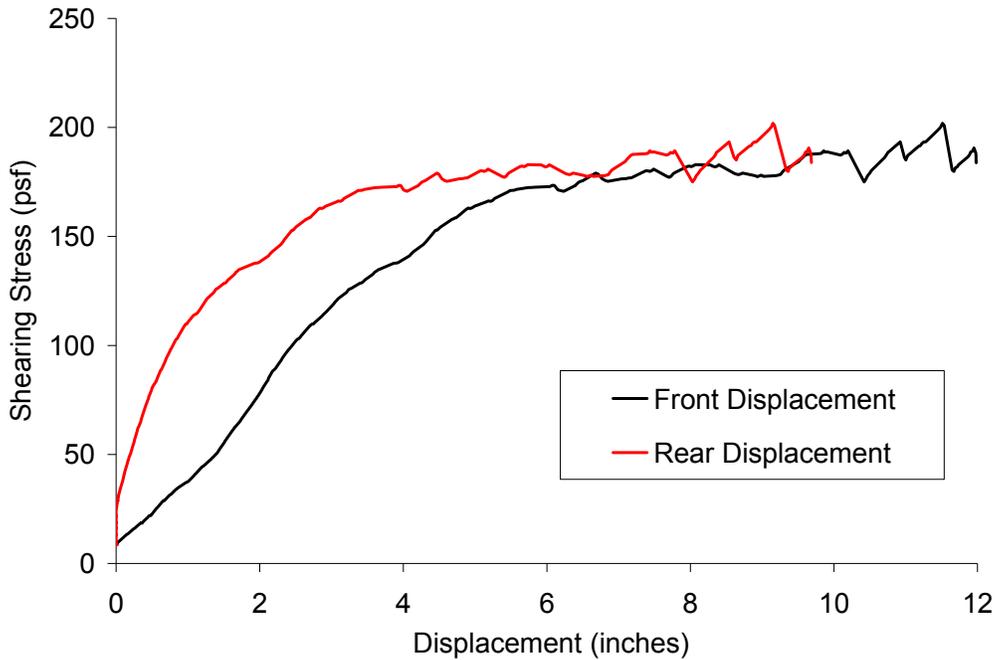
*Figure 6.8: Interface Shearing Stress versus Tire Bale Displacement for the Dry Tire Bale Interface*

A series of stress-displacement curves were plotted for each of the interface tests to observe the development of shearing resistance along the interface as well as determine the failure stresses along the interface. The front displacement of the bale was used to plot the curves since it was maintained at a constant rate throughout the test and because the rear displacement also included compressions of the bale (Figure 6.12). An example of the stress-displacement curves plotted using both the front and rear displacement is shown in Figure 6.8 to illustrate the difference in curve shape when considering the displacements. Although the failure loads would be approximately the same, using the back displacement does not properly represent the total displacement of the bale required to mobilize the interface strength.

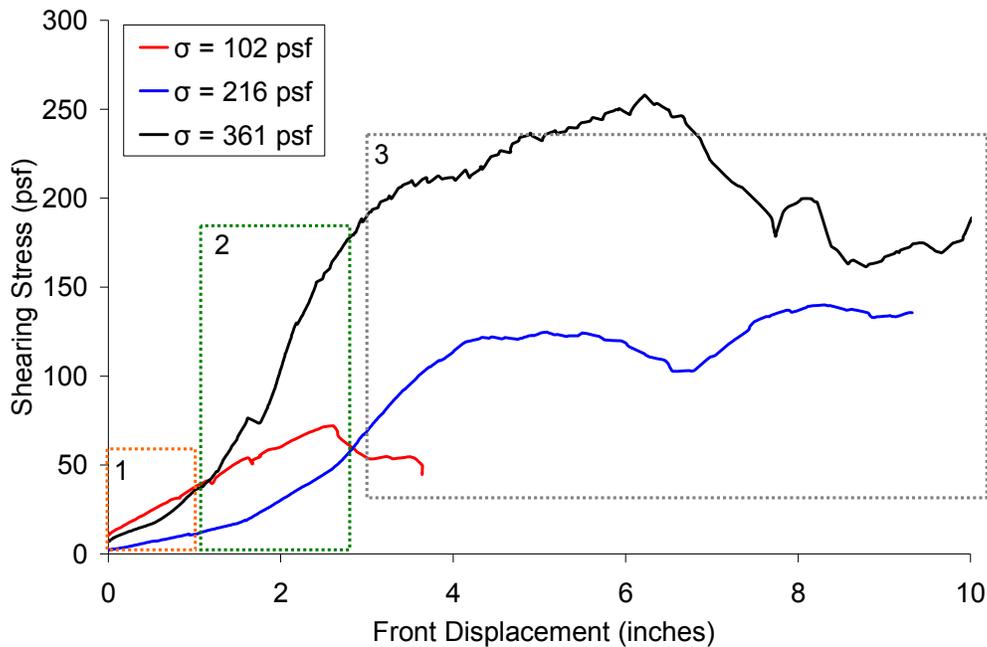
Figure 6.11: Stress-Displacement Curves for the Direct Shear Testing of the Tire Bale Only Interface (Interface Wetted Before Placement)

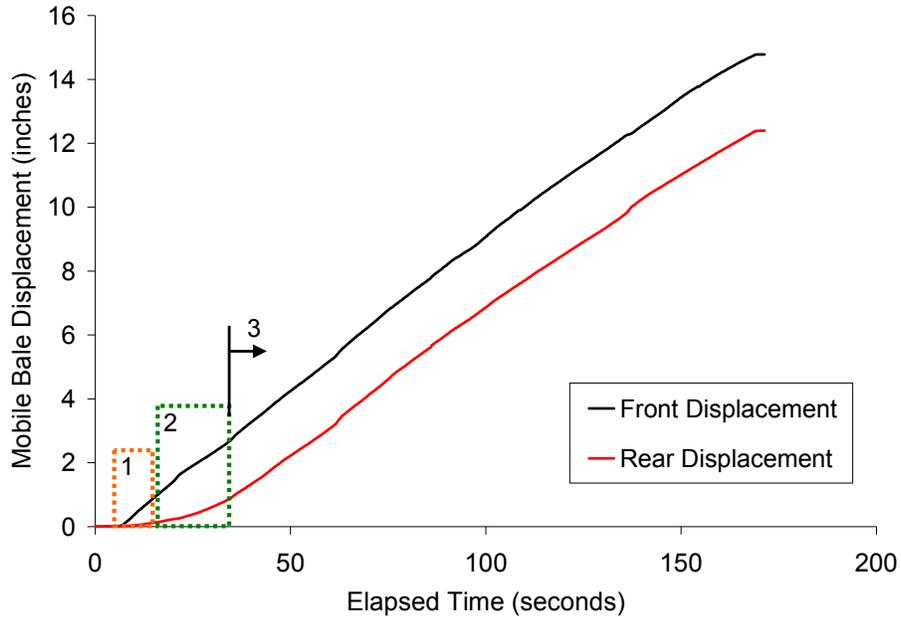
Figure 6.12: Typical Bale Displacement versus Elapsed Time Curve for a Dry Tire Interface

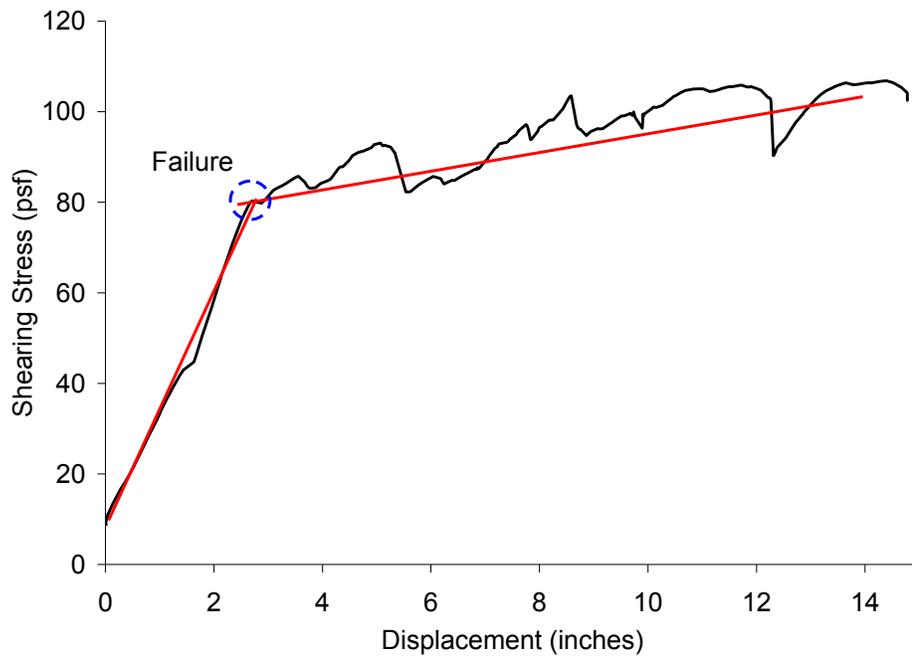
Figure 6.15: Illustration of the Bi-Linear Method to Determine Peak Interface Strength

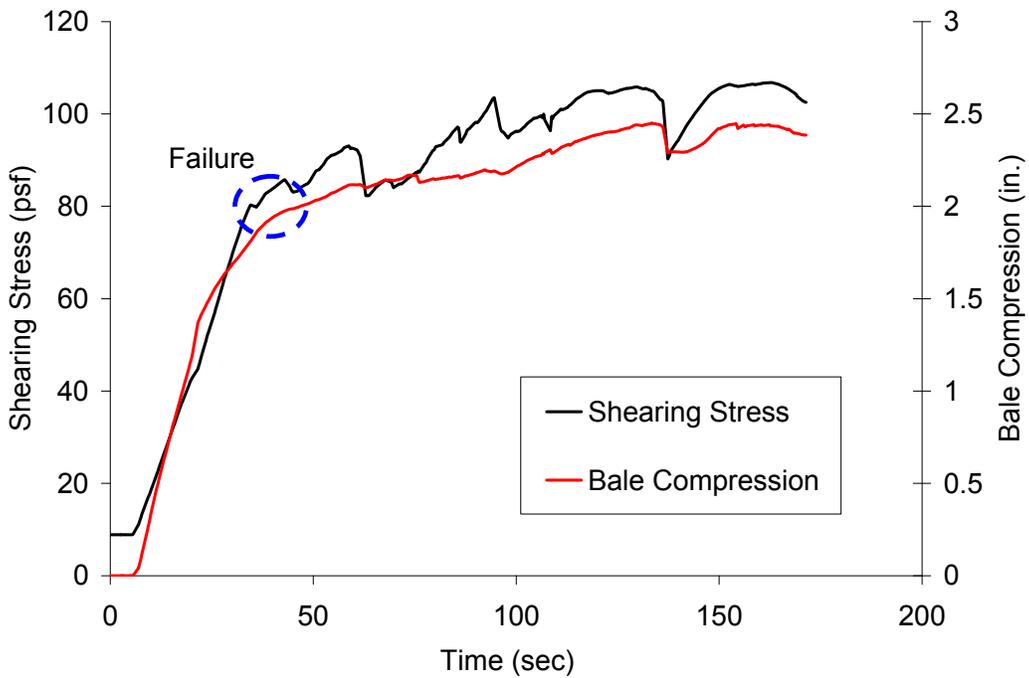
Figure 6.16: Maximum Bale Compression to Determine Peak Interface Strength

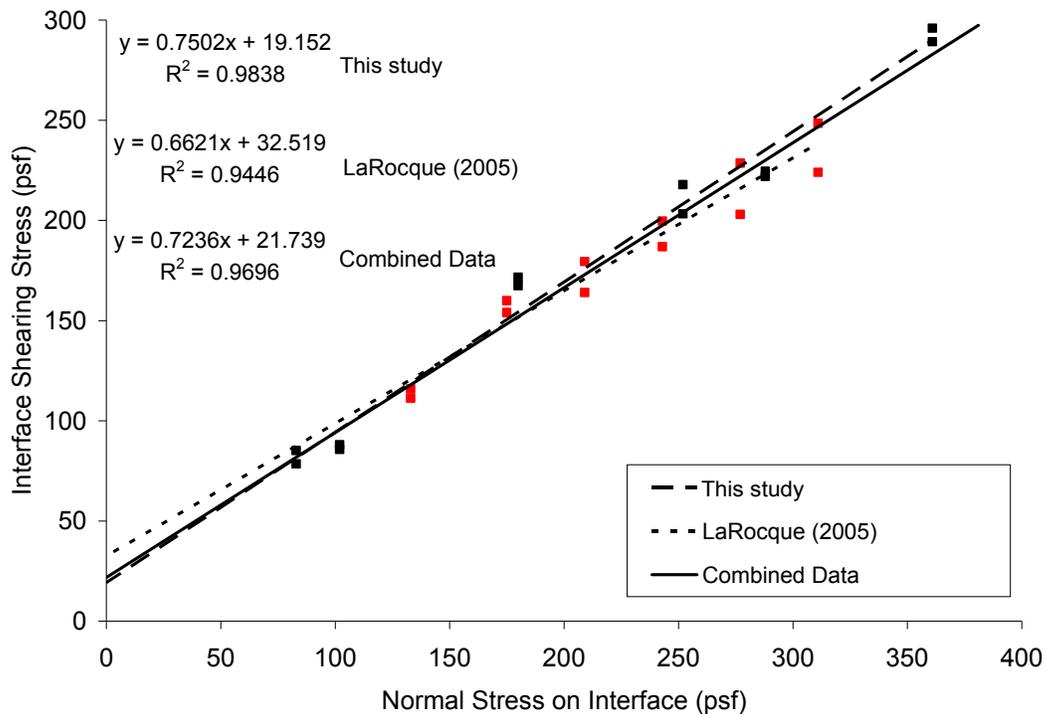
Figure 6.17: Failure Envelopes for the Dry Tire Bale Only Interface

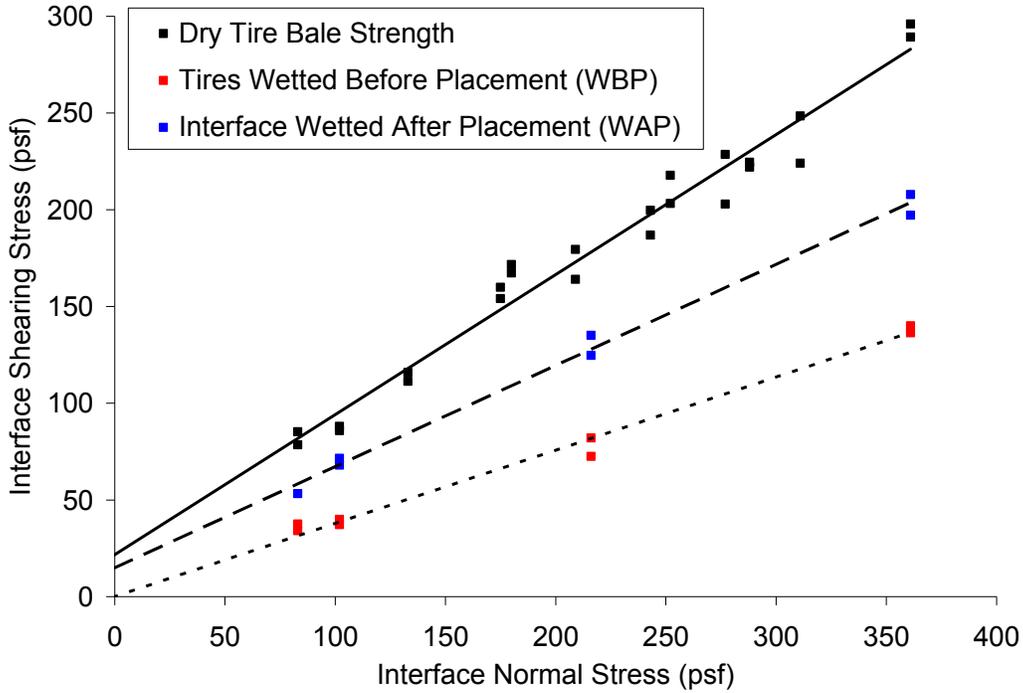
Figure 6.18: Failure Envelopes for the Dry and Wet Tire Bale Only Interfaces

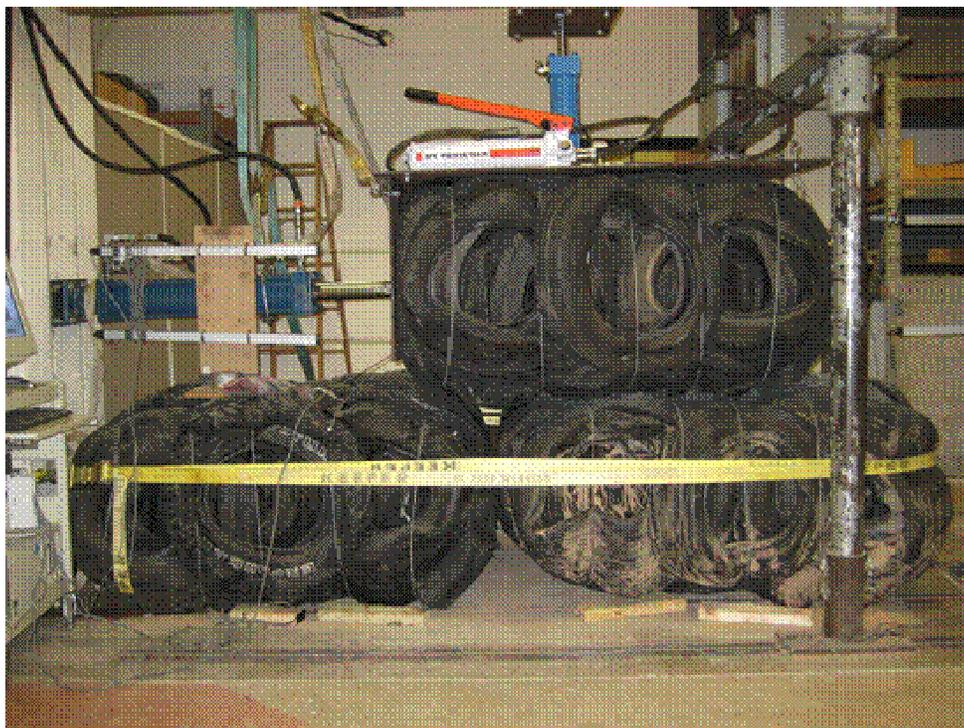
*Figure 6.19: Anisotropic Tire Bale Direct Shear Testing Setup*

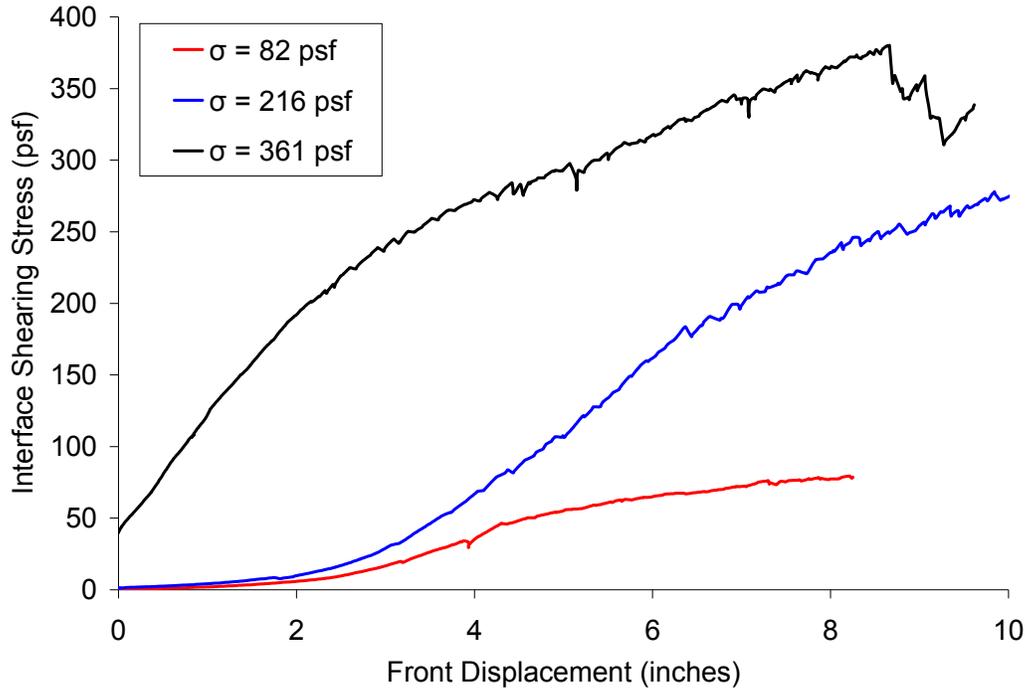
Figure 6.22: Interface Shearing Resistance versus Front Displacement of the Mobile Bale for Anisotropic Direct Shear Testing of Tire Bales (Dry Interface)

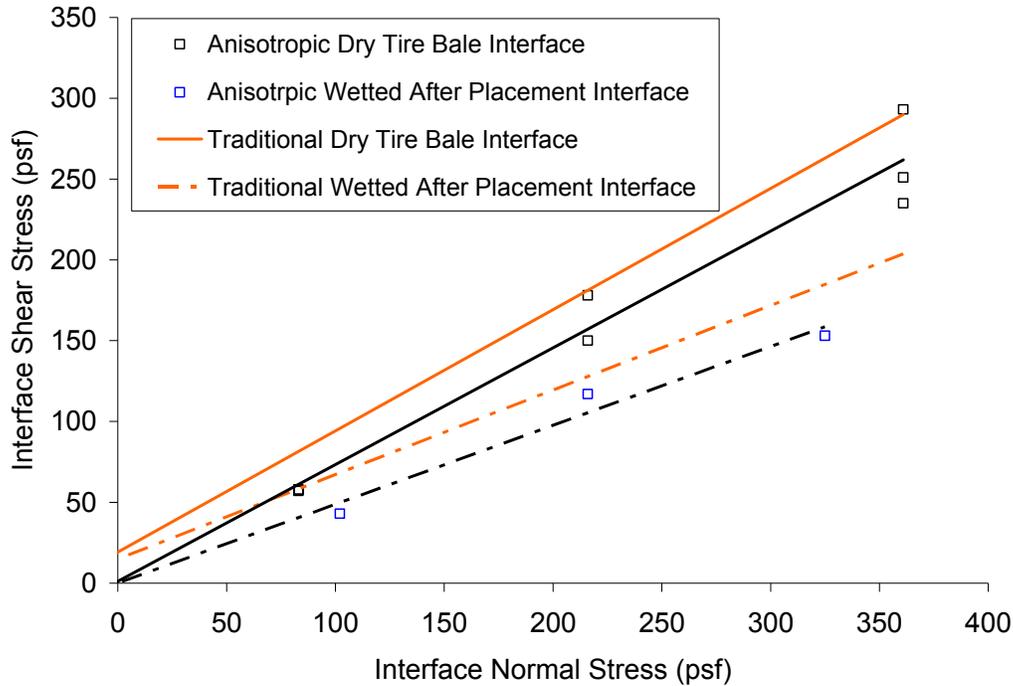
Figure 6.23: Failure Envelopes for the Dry and Wetted After Placement Tire Bale Interfaces for Traditional and Anisotropic Direct Shear Testing

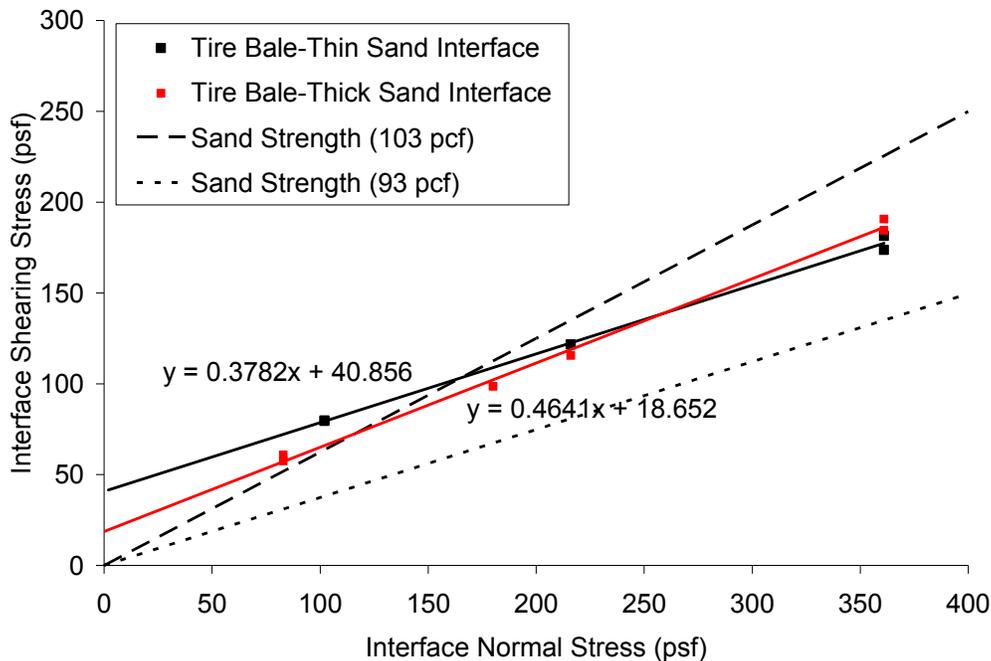
Figure 6.30: Failure Envelopes for the Thin Sand Fill and Thick Sand Interface Large Scale Direct Shear Tests and Sand Strength from Direct Shear Testing

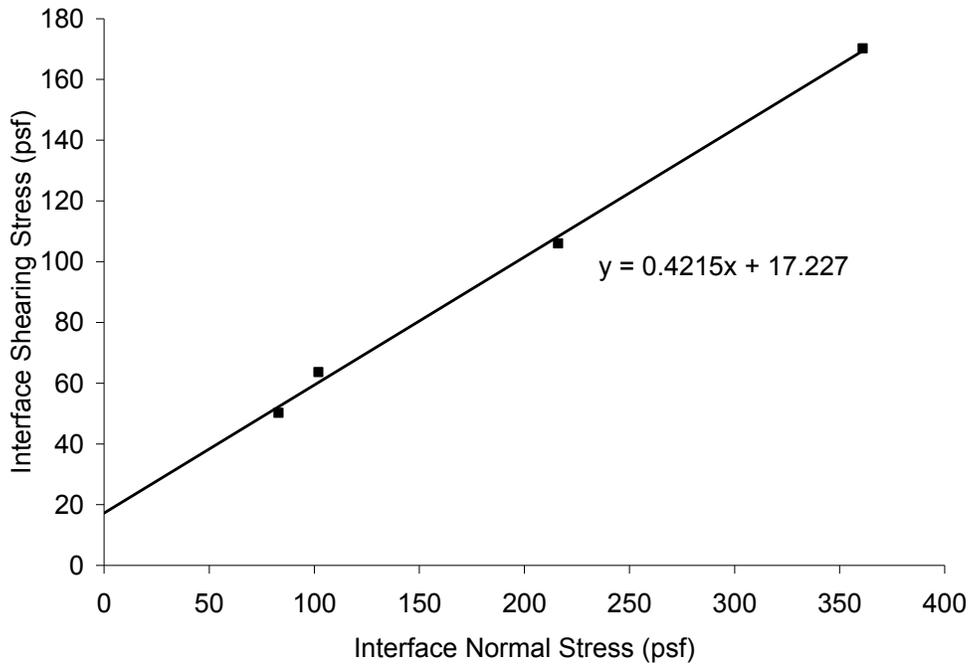
Figure 6.31: Failure Envelopes for the Tire Bale-Thick Clay Interface Direct Shear Tests
