1. Report No. FHWA/TX-10/0-5517-1		2. Government Accession No.		3. Recipient's Catalog No.	
4. Title and Subtitle Mechanical Properties of Tire Bales for Highway Applications				5. Report Date October 2008; Revised December 2009

## **Mechanical Properties of Tire Bales for Highway Applications**

CTR Technical Report:	0-5517-1
Report Date:	October 2008; Revised December 2009
Project:	0-5517
Project Title:	Beneficial Use of Scrap Tire Bales in Highway Projects
Sponsoring Agency:	Texas Department of Transportation
Performing Agency:	Center for Transportation Research at The University of Texas at Austin

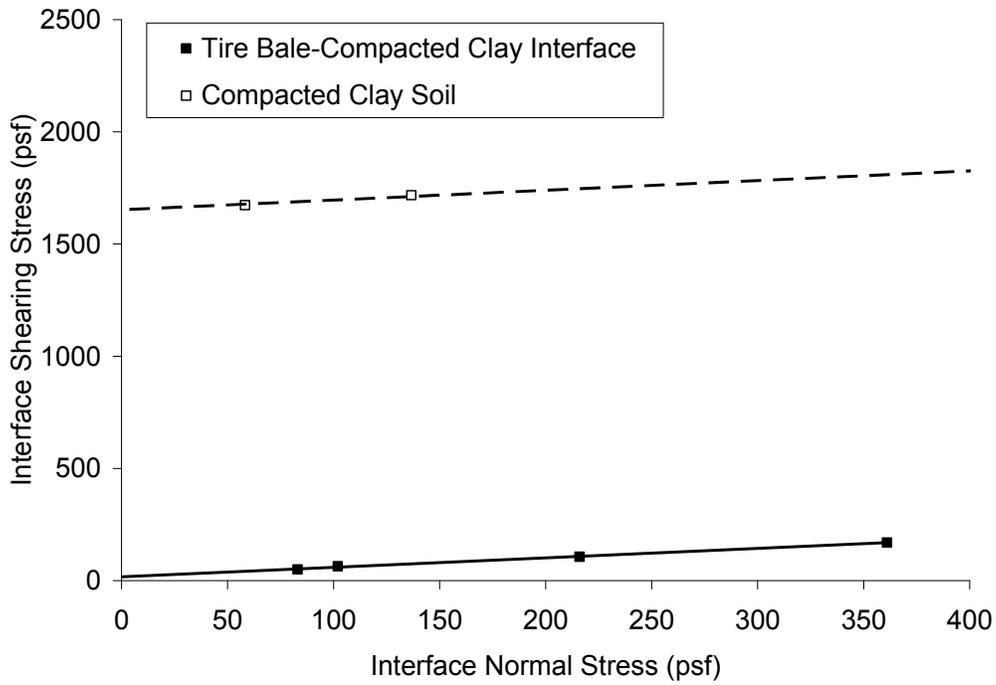
Figure 6.32: Comparison of the Clay Strength from Undrained Direct Shear and the Tire Bale-Clay Interface Testing

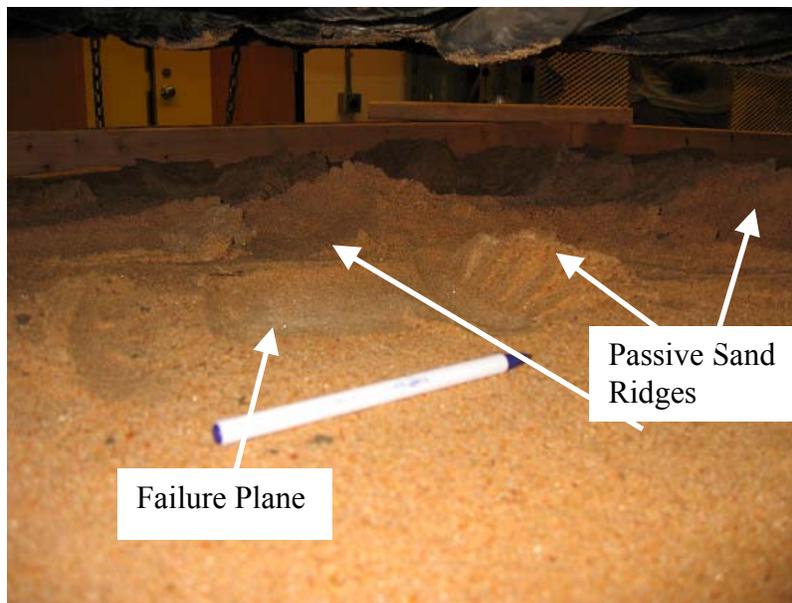
Figure 6.38: Photograph of a Failure Plane and Soil Ridge along the Interface

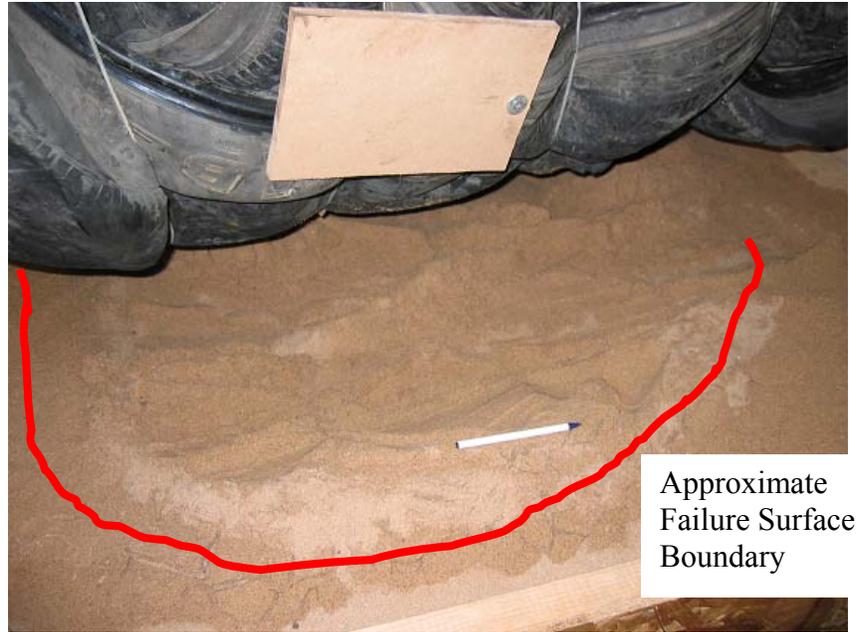
*Figure 6.40: Approximate Failure Surface for the Tire Bale-Sand Interface for an Applied Normal Stress of 88 psf (Self Weight of Bale Only)*

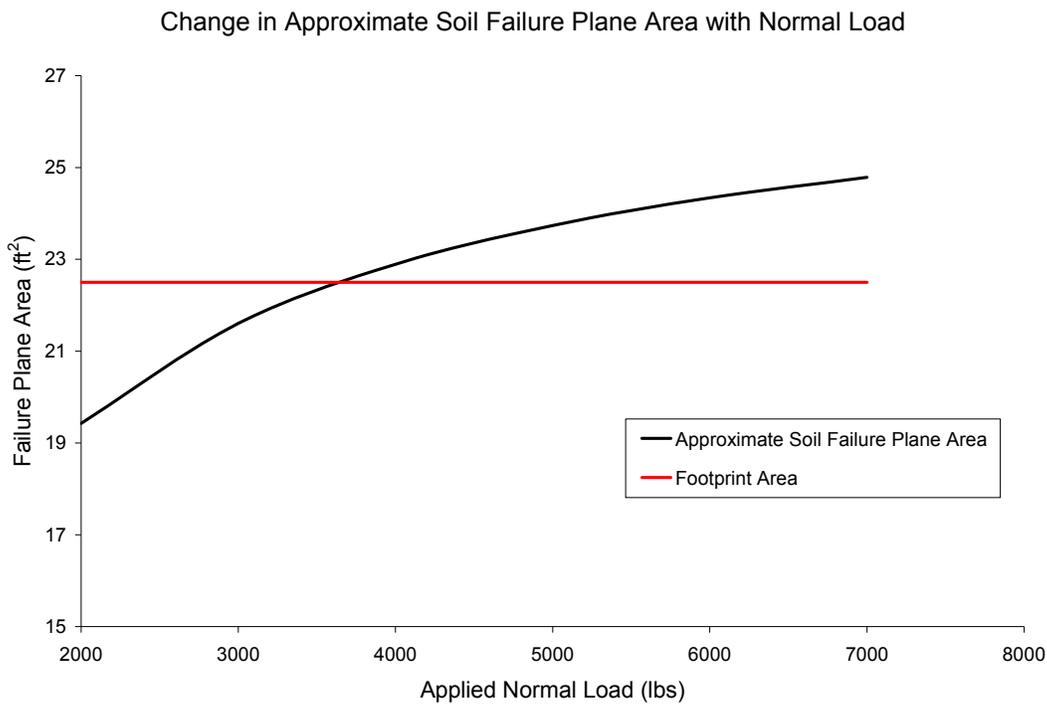
Figure 6.43: Change in the Sand Failure Plane Area with Applied Normal Load

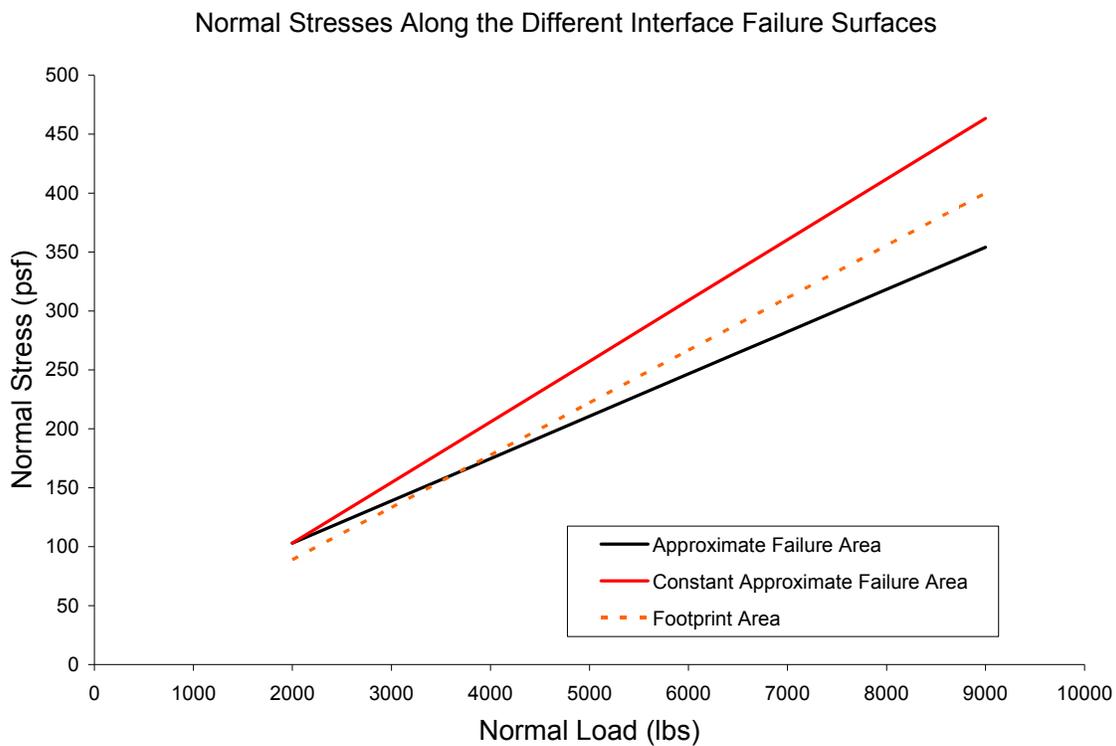
Figure 6.44: Different Normal Stresses Along the Interface for the Assumed Contact Areas

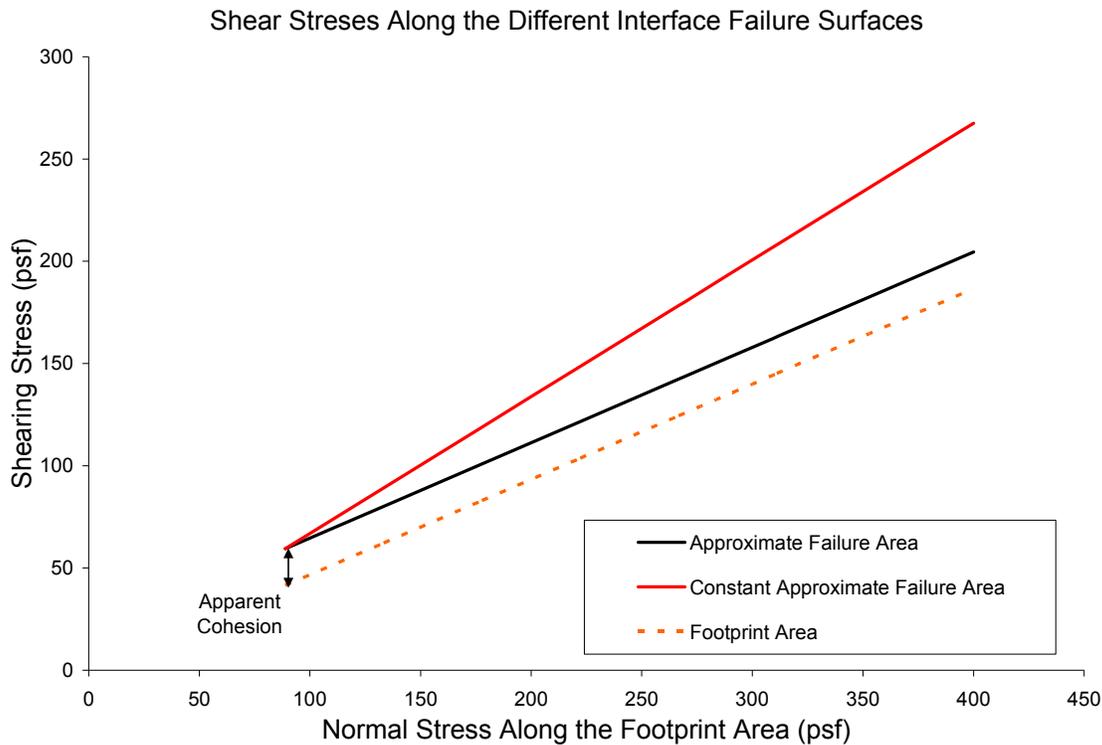
*Figure 6.45: Failure Envelopes for the Different Interface Contact Areas*

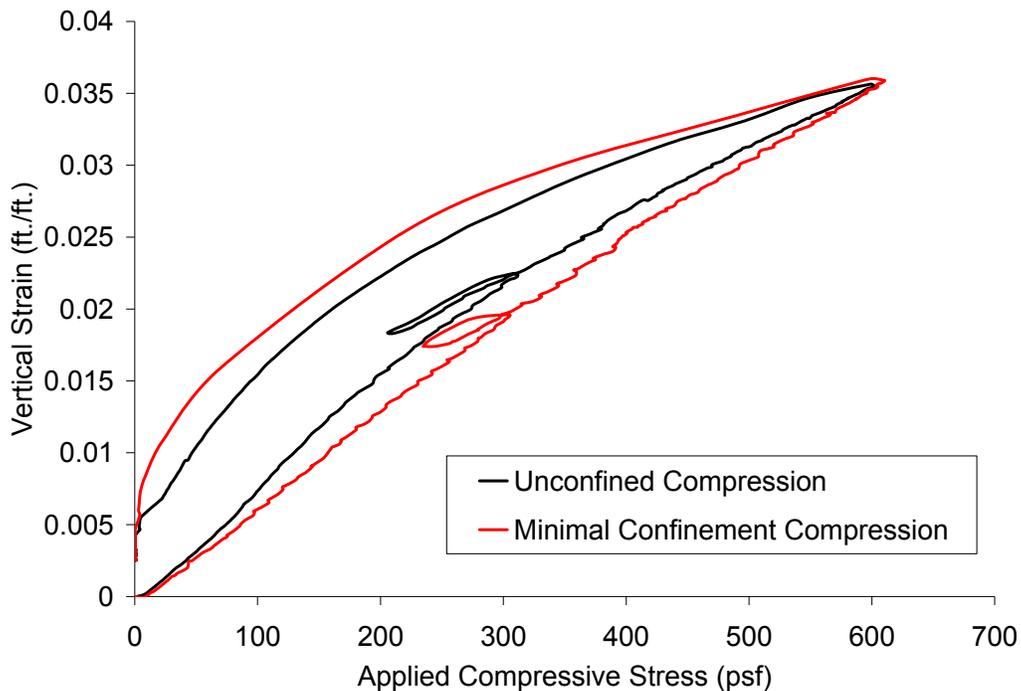
Figure 7.17: Comparison of the Unconfined and Minimally Confined Compression Curves for the Equivalent Tire Bale Mass

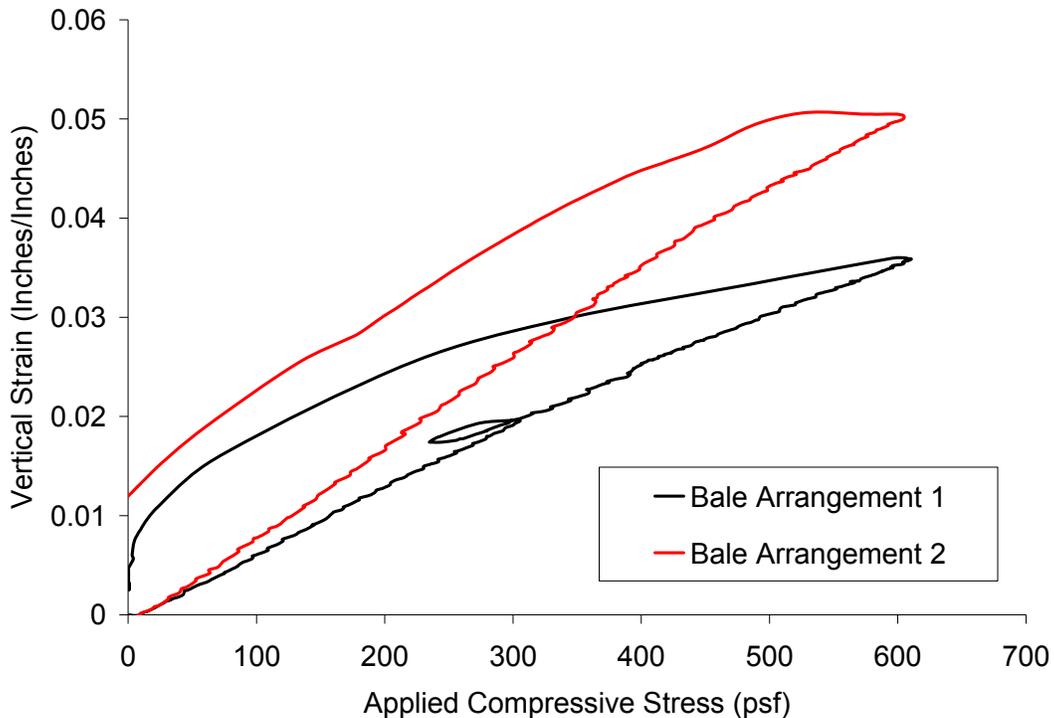
*Figure 7.18: Compression Curves for the Equivalent Tire Bale Mass for Tire Bale Arrangements 1 and 2 (Confined Conditions)*

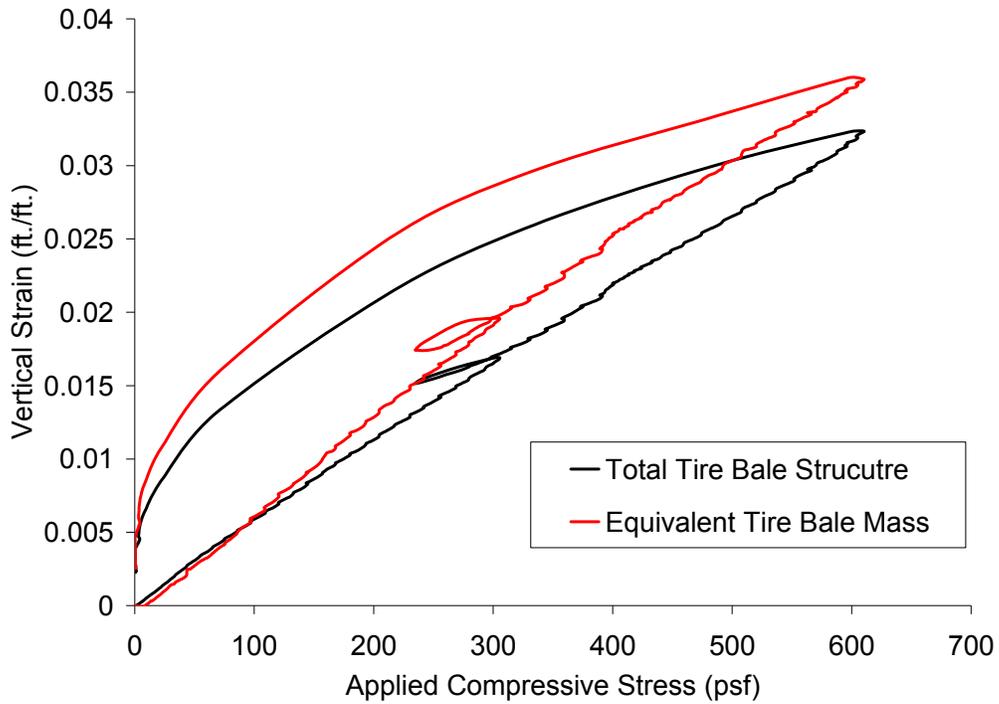
Figure 7.19: Compression Curves for the Total Bale Structure and the Equivalent Tire Bale Mass (Tire Bale Arrangement 1) for Confined Conditions

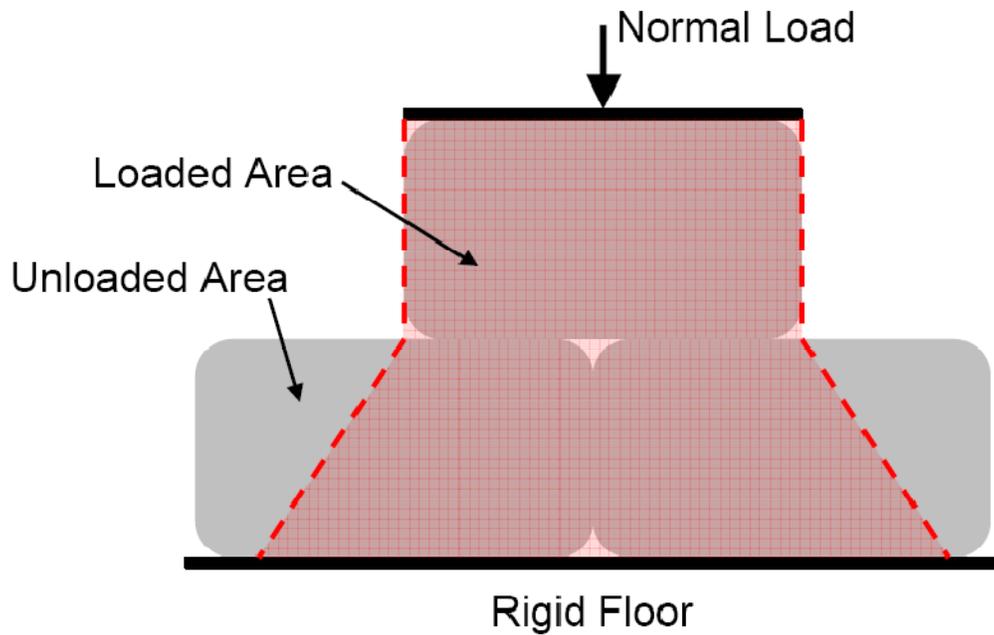
Figure 7.20: Estimated Stress Distribution within the Tire Bales for the Three Tire Bale Structure

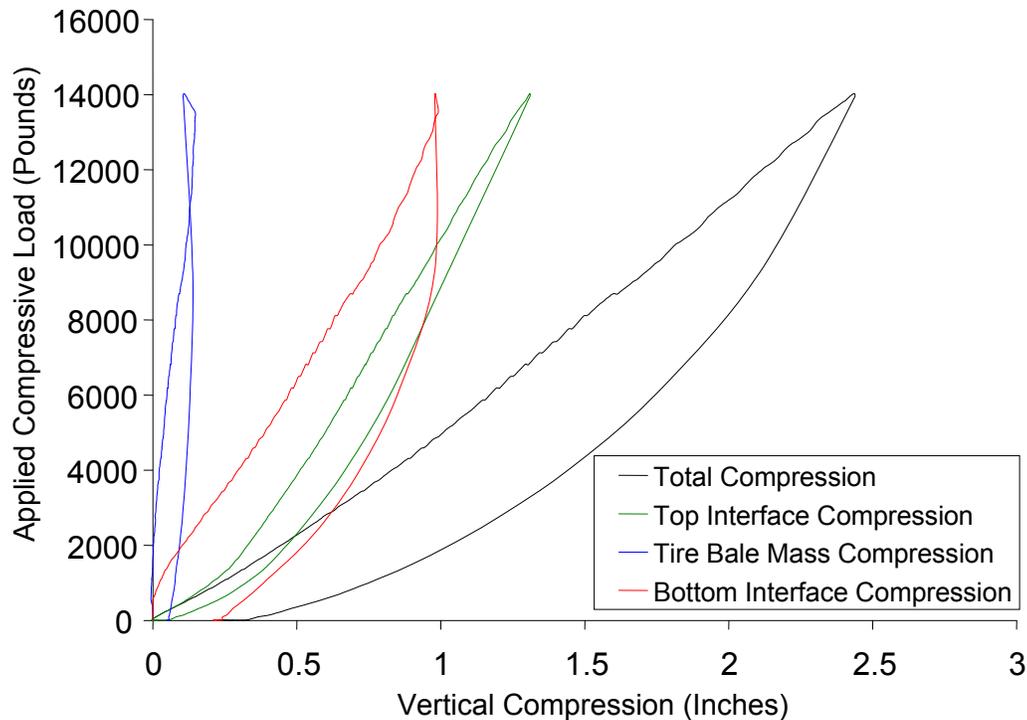
Figure 7.21: Tire Bale Section Compressions for the 2 Bale Arrangement

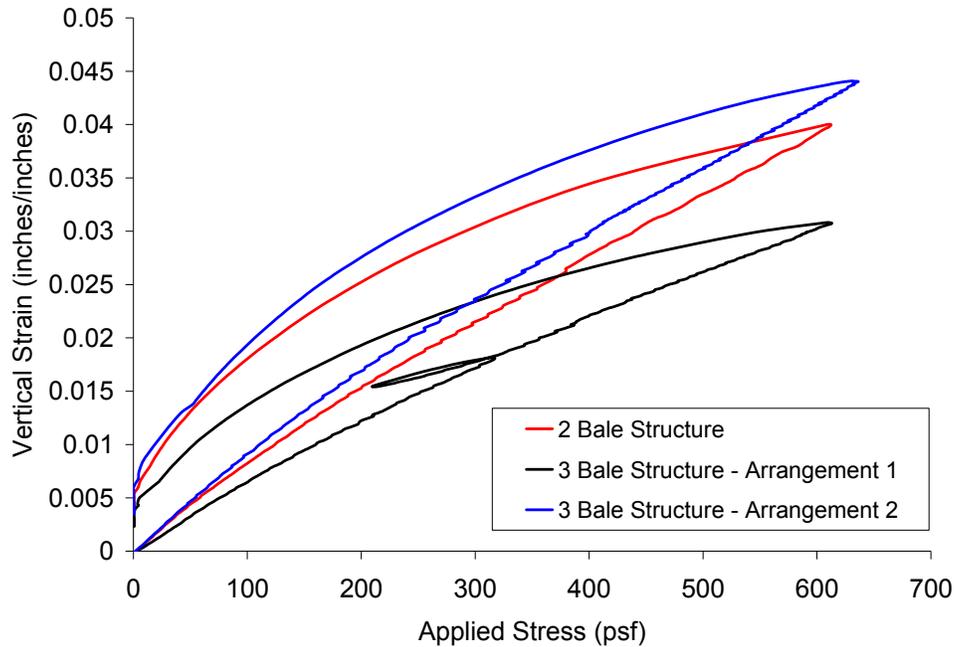
Figure 7.22: Comparison of the Stress-Strain Curves for the 2 and 3 Bale Arrangements

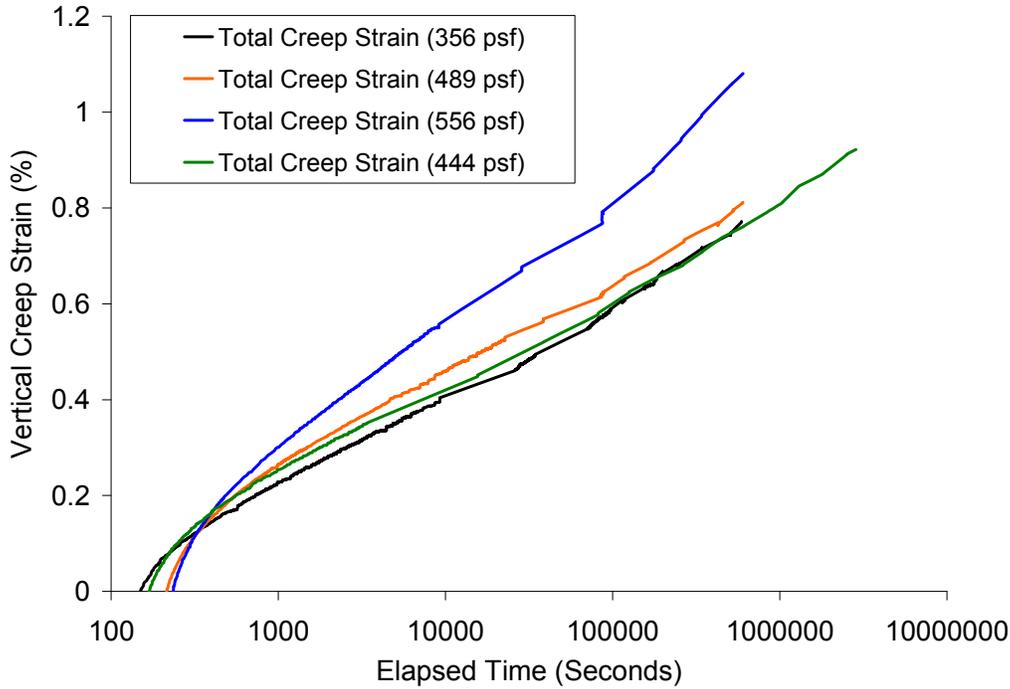
Figure 7.28: Creep Strains versus Log Elapsed Time for the Four Sustained Loading Tests

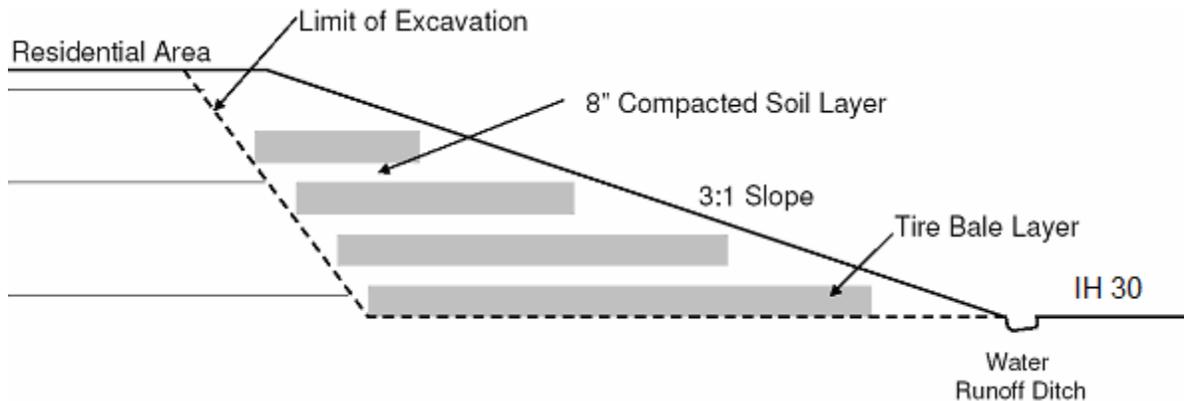
*Figure 8.7: Tire Bale Reinforced Embankment Geometry*

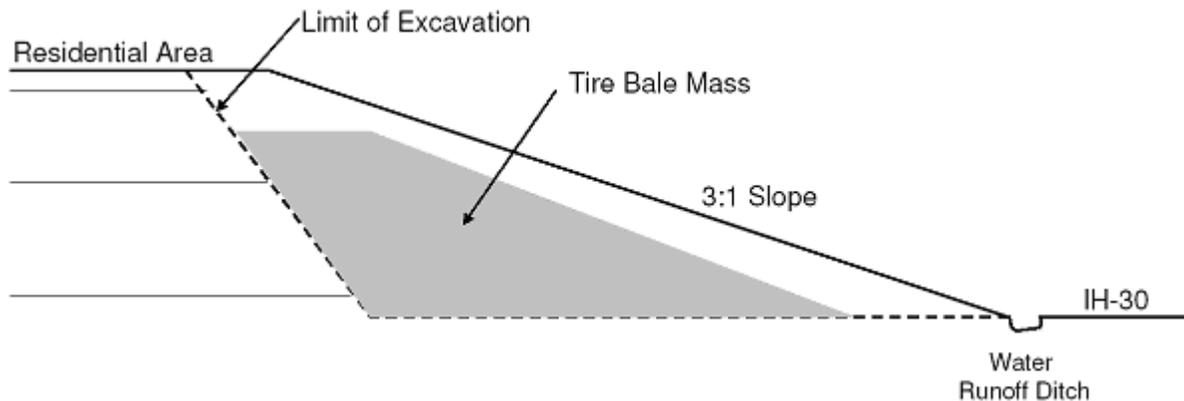
*Figure 8.8: Tire Bale Only Embankment Geometry for IH 30 Site*

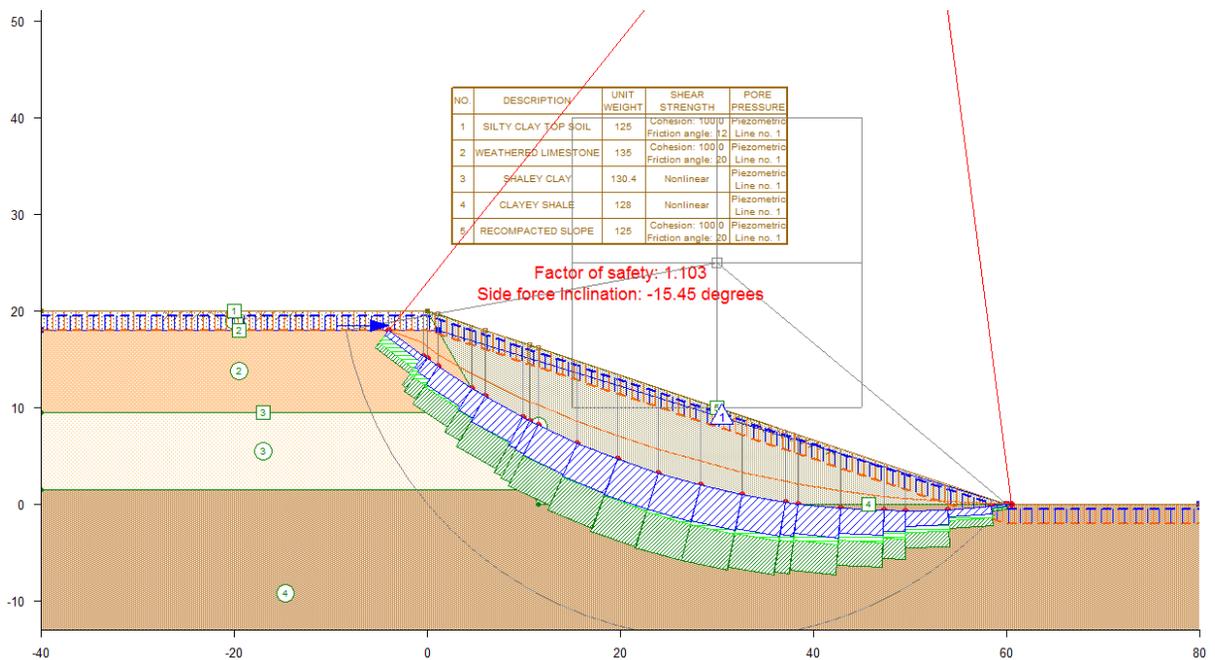
Figure 8.10: Limit Equilibrium Analysis of Re-Compacted Soil Slope without Drainage

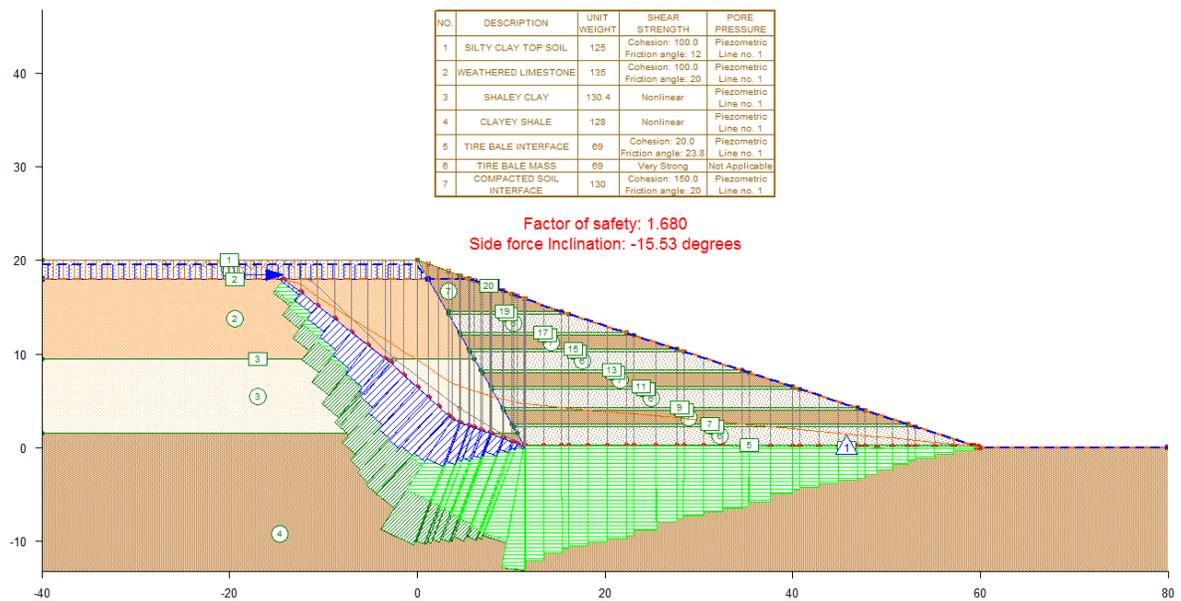
Figure 8.12: Limit Equilibrium Analysis of the Tire Bale Reinforced Soil Slope with Drainage

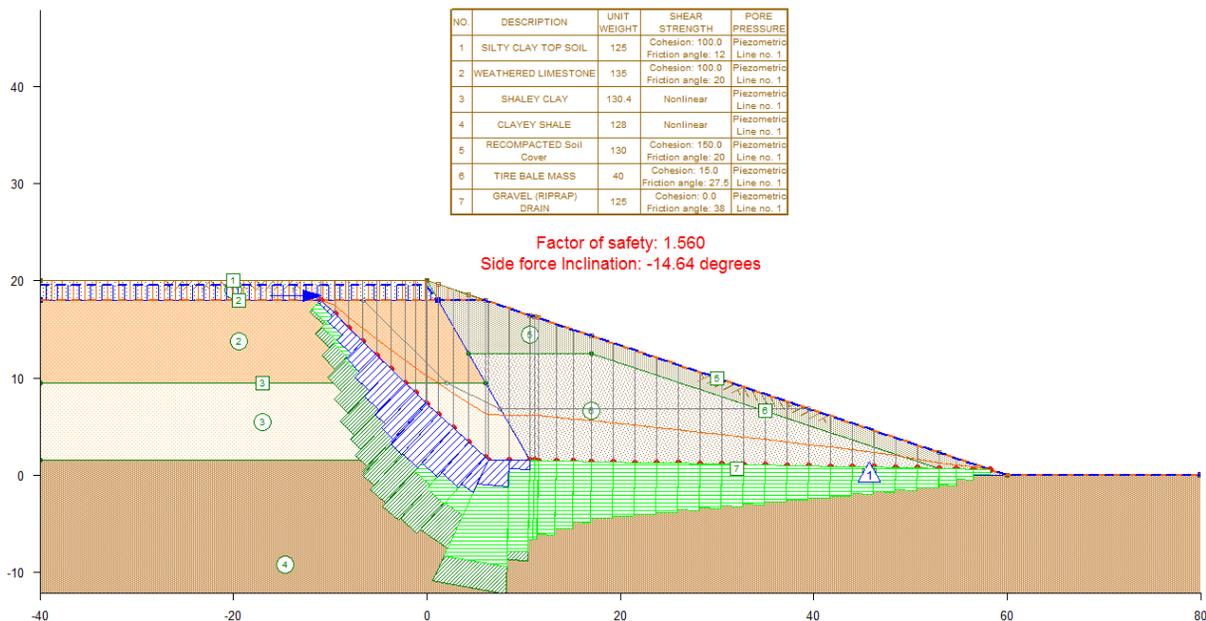
Figure 8.13: Limit Equilibrium Analysis of the Tire Bale Fill Soil Slope with Drainage

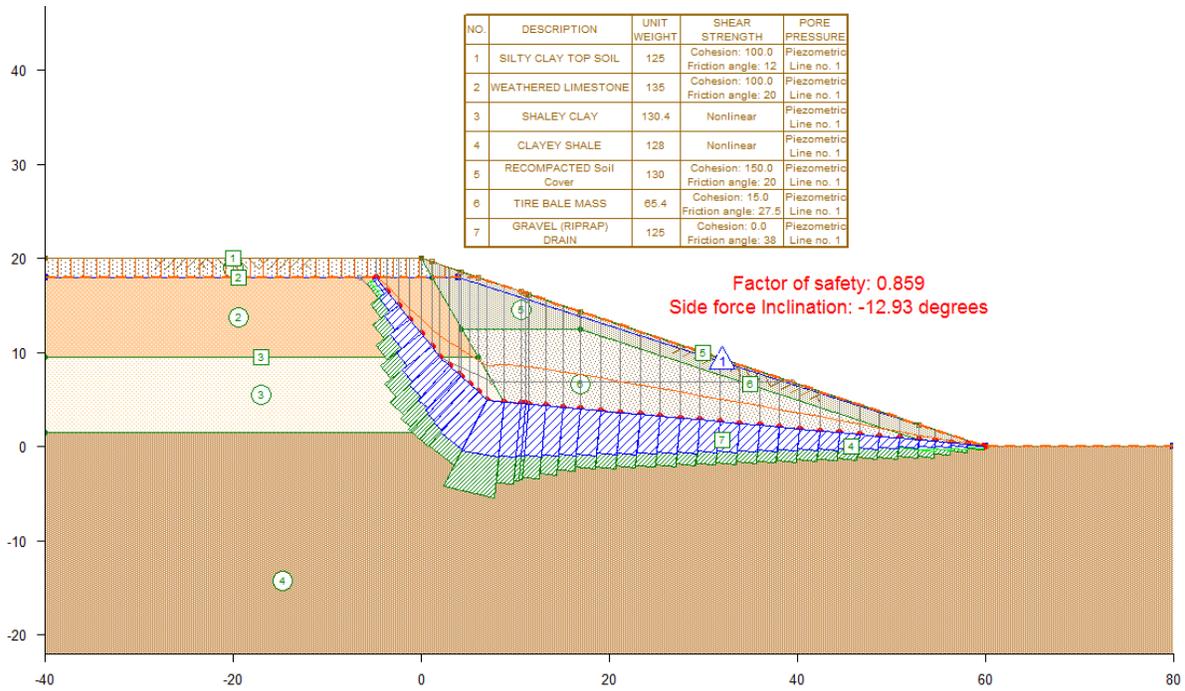
Figure 8.14: Limit Equilibrium Analysis of the Tire Bale Fill Soil Slope without Drainage (Piezometric Line at the Top of the Limestone Layer)

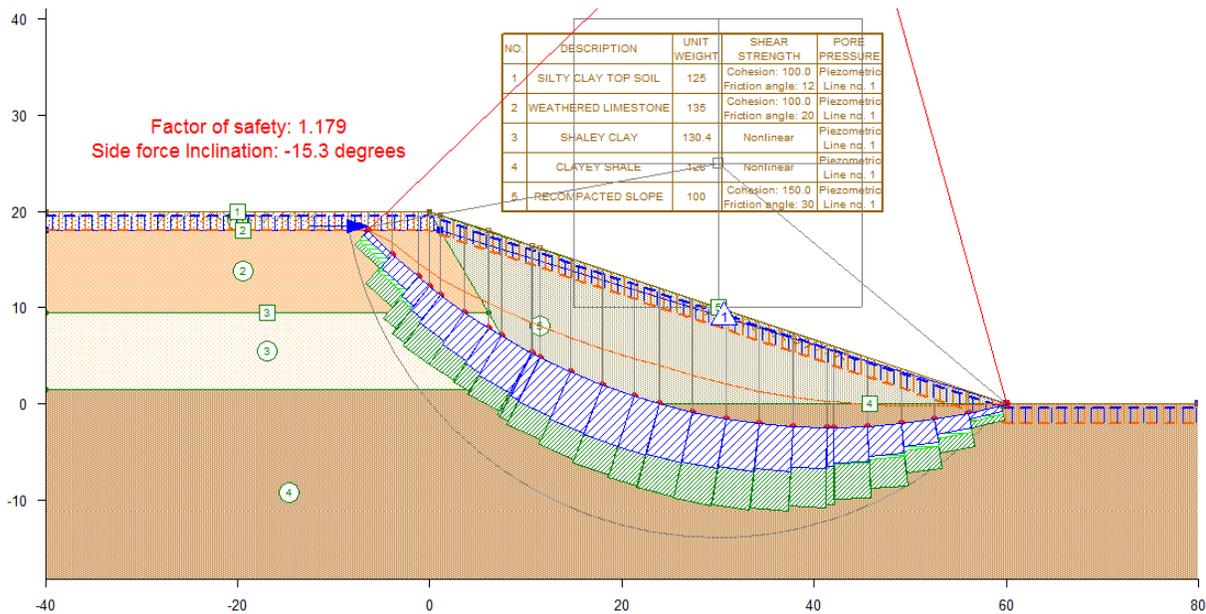
Figure 8.18: Limit Equilibrium Analysis of the Tire Shred Reinforced Re-Compacted Soil Embankment

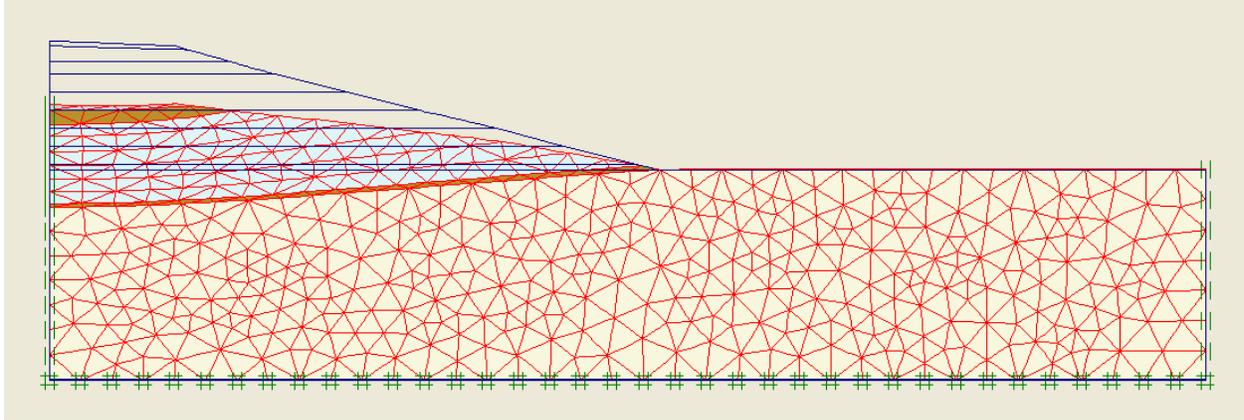
*Figure 8.22: Deformed Finite Element Mesh for the Soil Only Overpass*

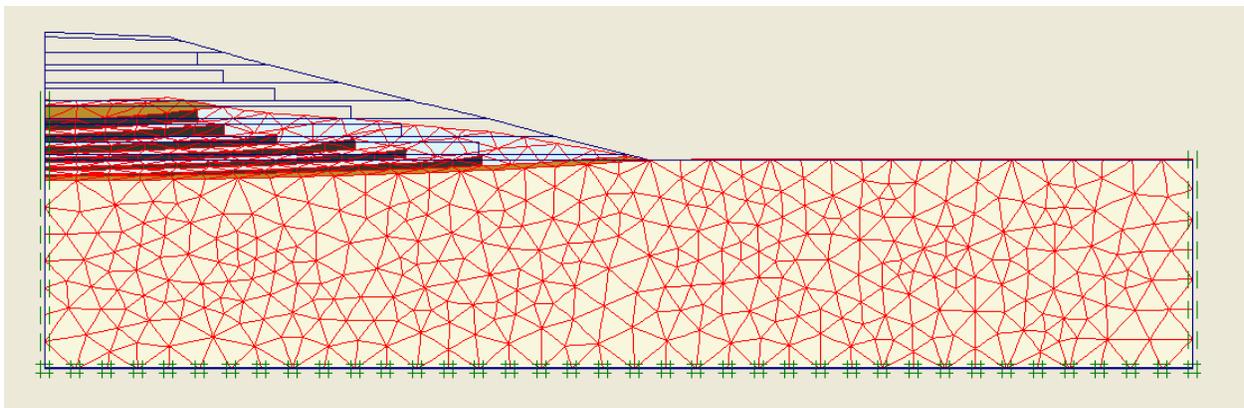
*Figure 8.23: Deformed Finite Element Mesh for the Tire Bale Reinforced Overpass*

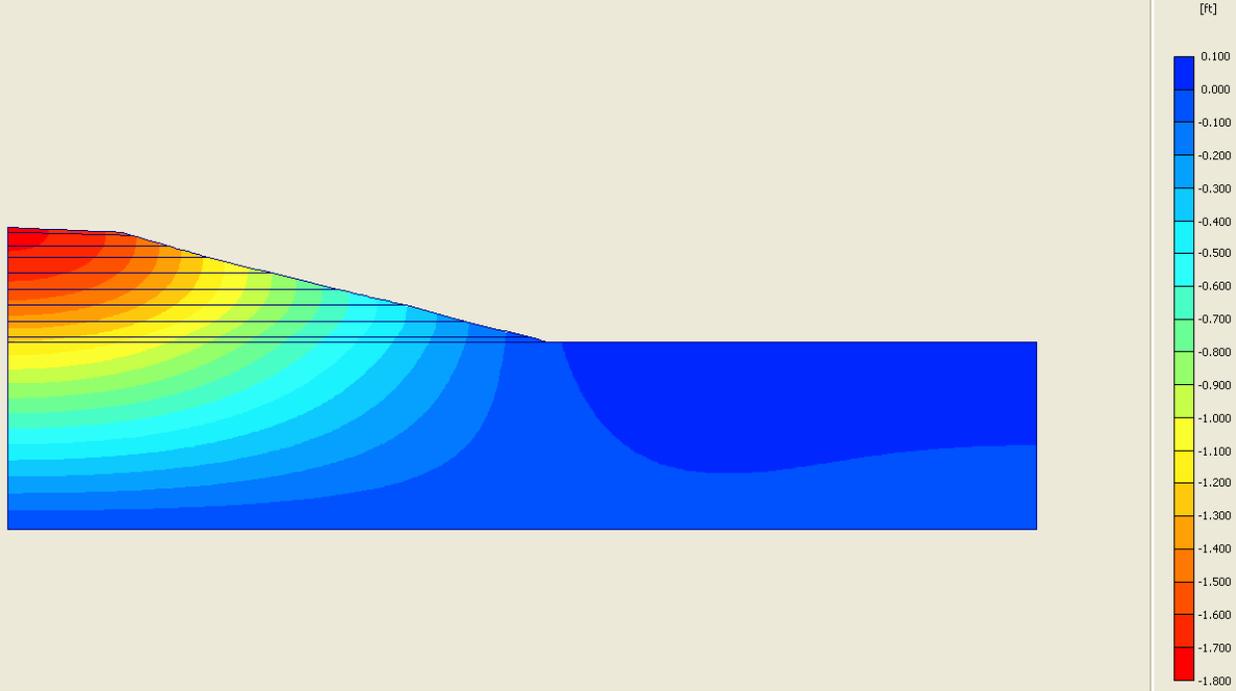
Figure 8.24: Vertical Compression of the Soil Only Overpass (Stiff Clay Foundation)

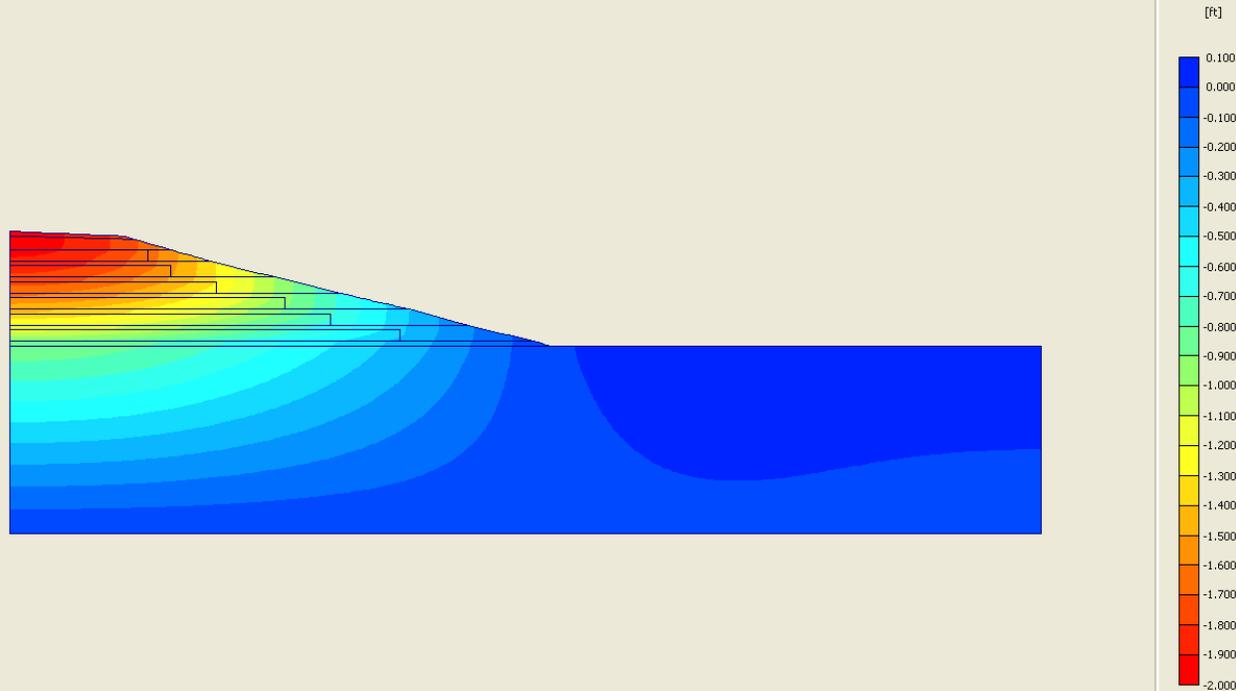
Figure 8.25: Vertical Compression of the Tire Bale Reinforced Overpass (Stiff Clay Foundation)

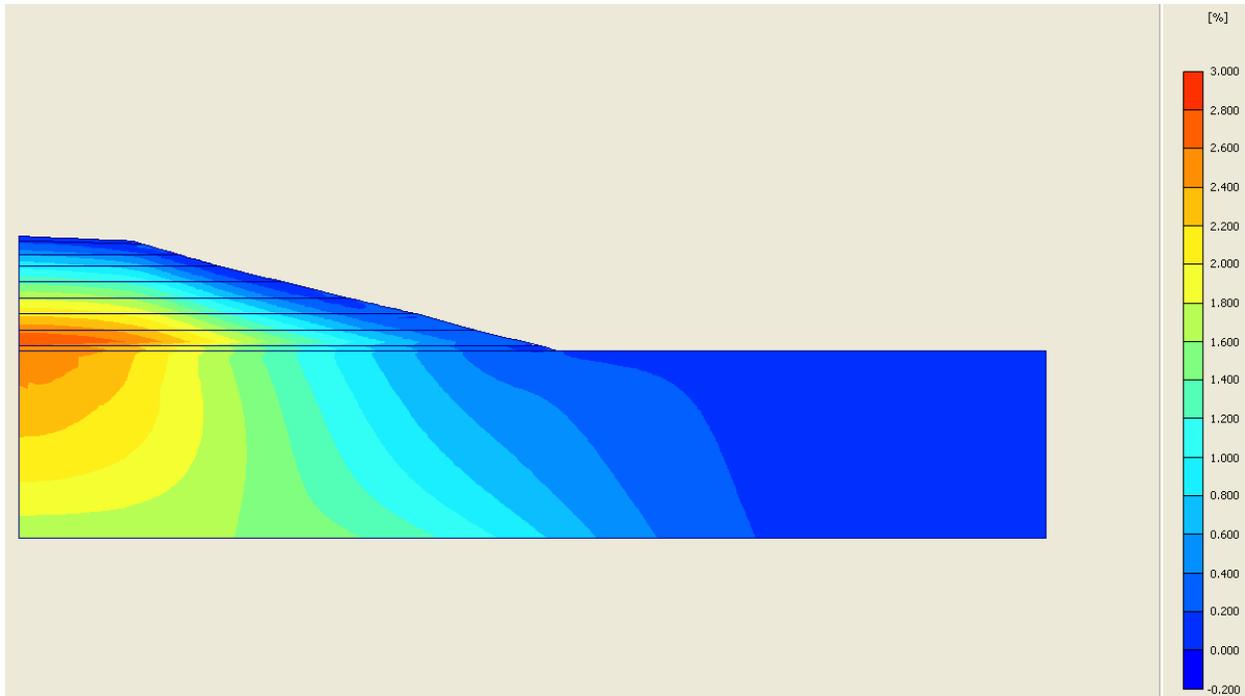
Figure 8.26: Shear Strains within the Soil Only Overpass

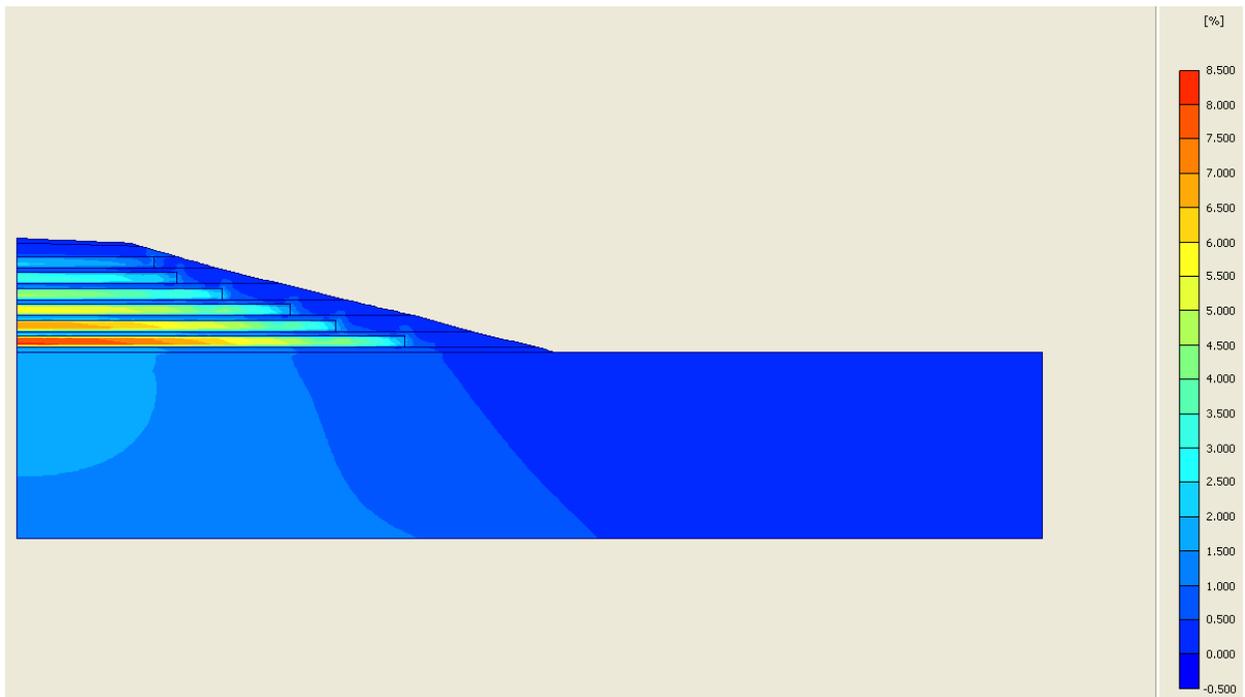
Figure 8.27: Shear Strains within the Tire Bale Reinforced Overpass

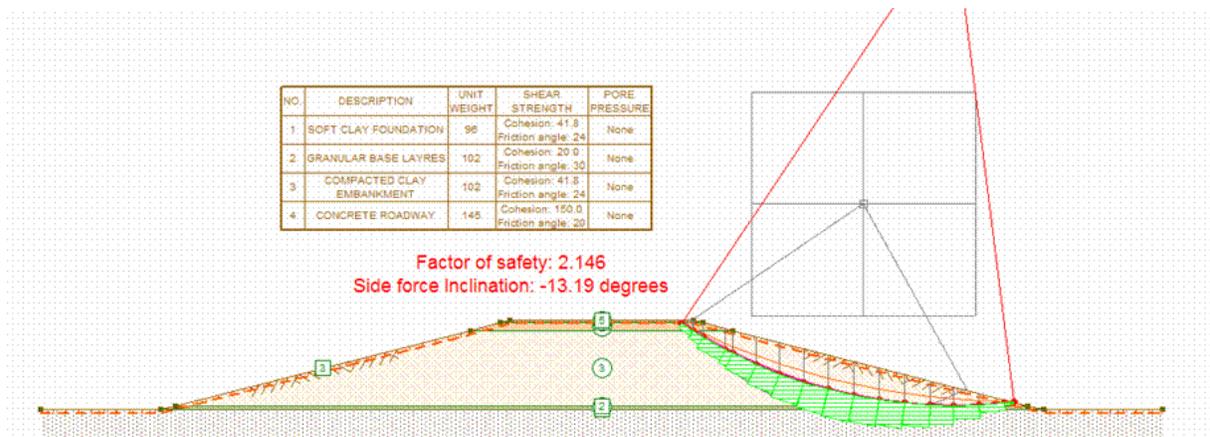
Figure 8.29: Predicted Failure Plane and Factor of Safety from Limit Equilibrium Analysis (UTEXAS4) for Soil Only Overpass

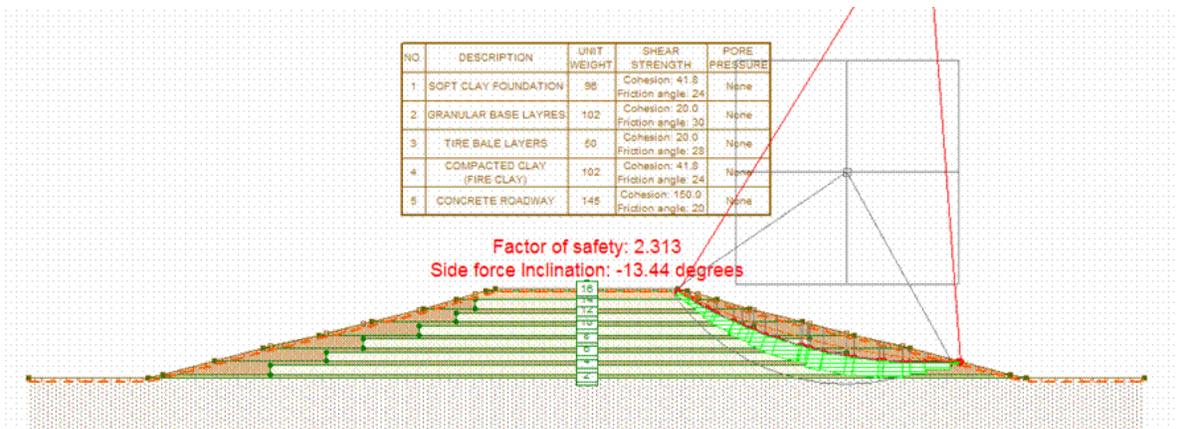
Figure 8.31: Predicted Failure Plane and Factor of Safety from Limit Equilibrium Analysis (UTEXAS4) for Tire Bale Reinforced Overpass

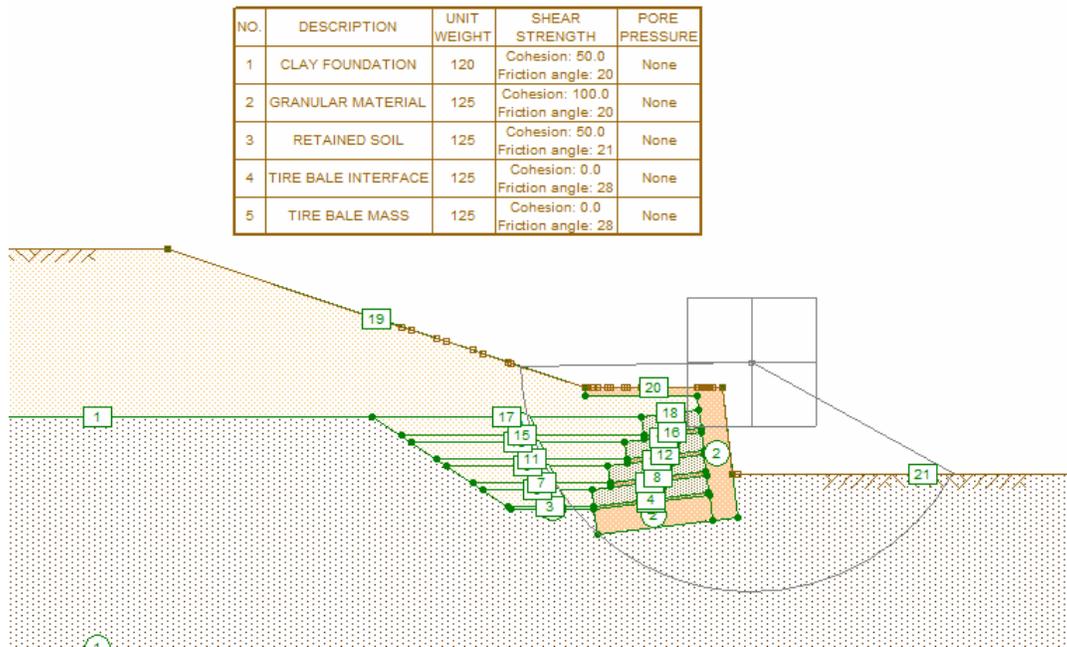
Figure 8.34: Gabion Wall Geometry used in UTEXAS4 for the Global Stability Analysis

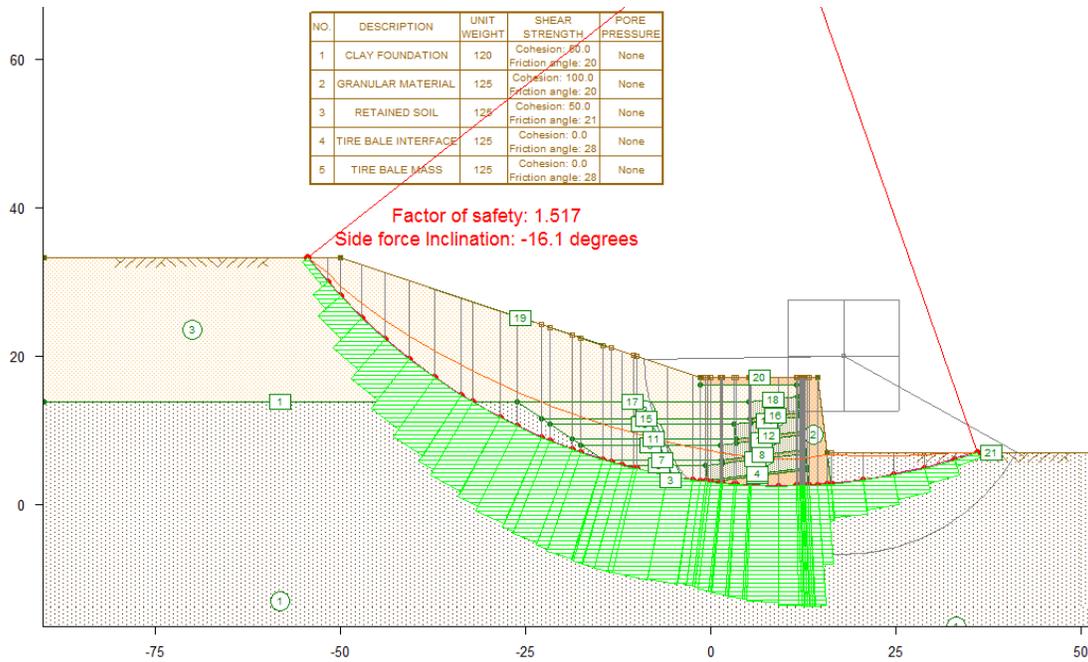
Figure 8.35: Global Stability Analysis for the Traditional Gravel Gabion Retaining Wall for Dry Conditions

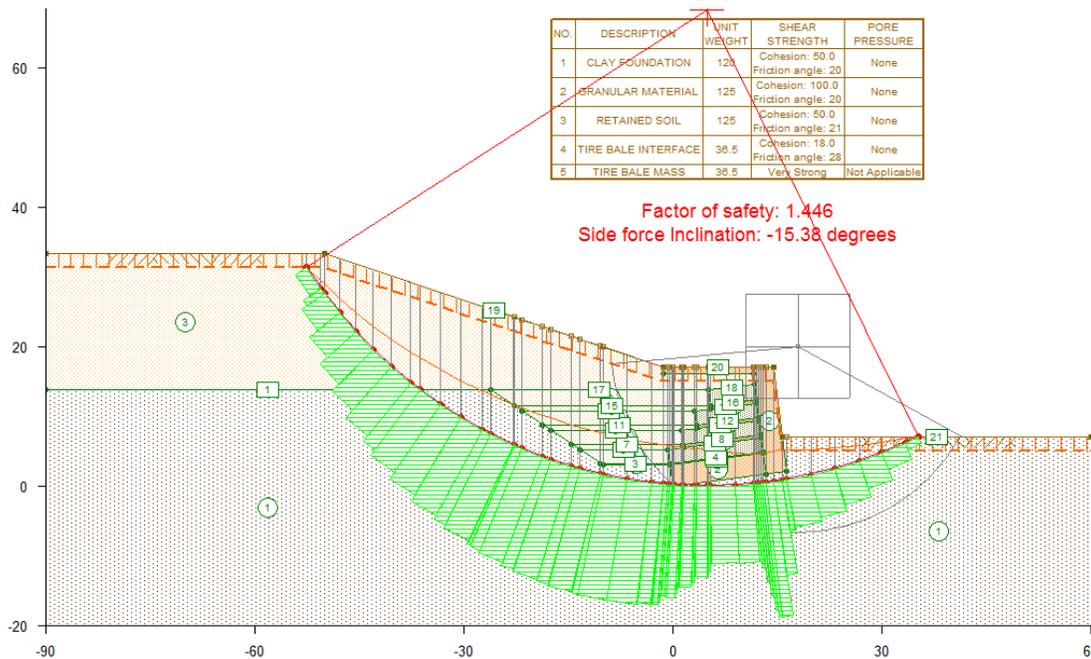
Figure 8.36: Global Stability Analysis for the Tire Bale Gabion Retaining Wall for Dry Conditions

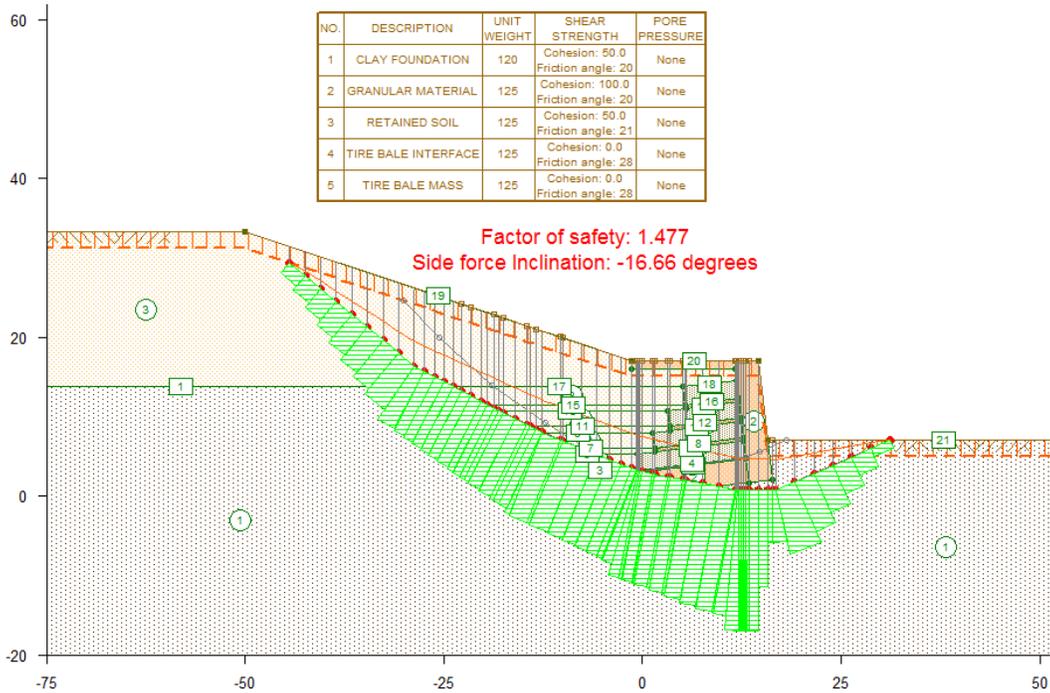
Figure 8.37: Sliding Stability Analysis for the Traditional Gravel Gabion Retaining Wall for Dry Conditions
