1. Report No. FHWA/TX-10/0-5517-1		2. Government Accession No.		3. Recipient's Catalog No.	
4. Title and Subtitle Mechanical Properties of Tire Bales for Highway Applications				5. Report Date October 2008; Revised December 2009

## **Mechanical Properties of Tire Bales for Highway Applications**

CTR Technical Report:	0-5517-1
Report Date:	October 2008; Revised December 2009
Project:	0-5517
Project Title:	Beneficial Use of Scrap Tire Bales in Highway Projects
Sponsoring Agency:	Texas Department of Transportation
Performing Agency:	Center for Transportation Research at The University of Texas at Austin

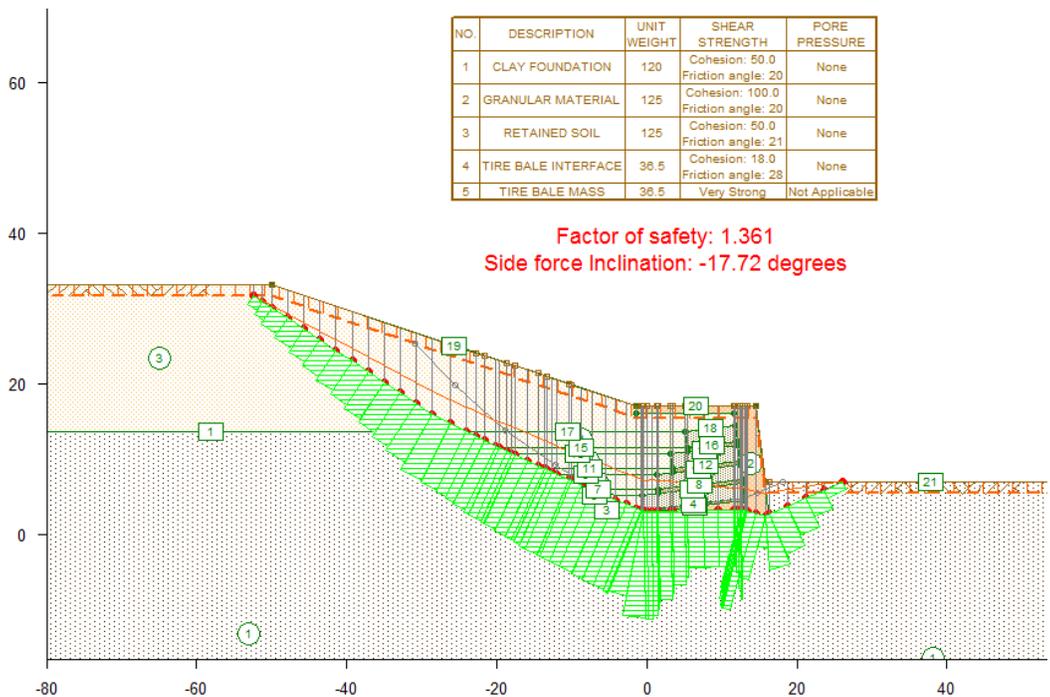
Figure 8.38: Sliding Stability Analysis for the Tire Bale Gabion Retaining Wall for Dry Conditions

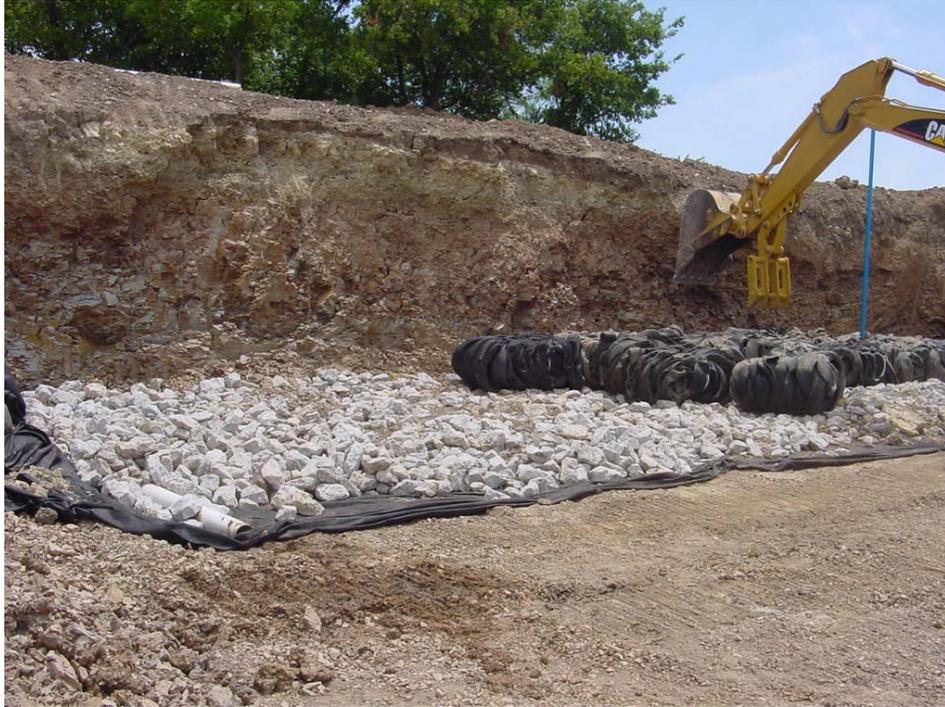
*Figure 9.1: Gravel Drainage Layer and Pipe Drain for the Phase Two Remediation*

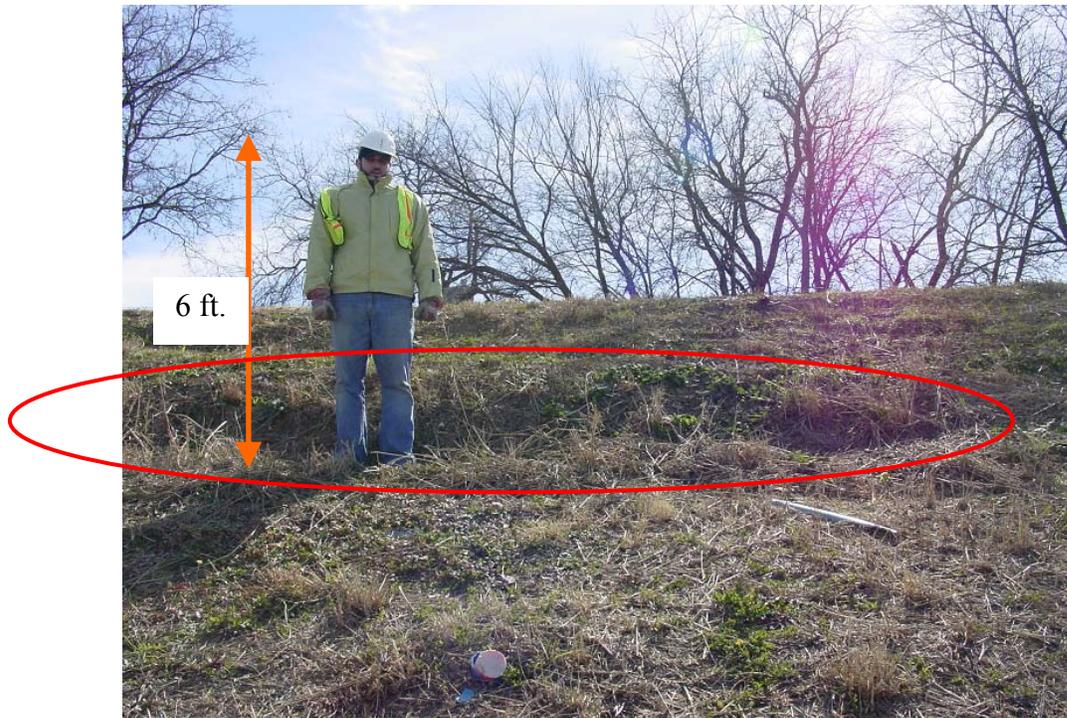
*Figure 9.12: Soil Slump Observed at the Upper East Corner of the Tire Bale Slope*

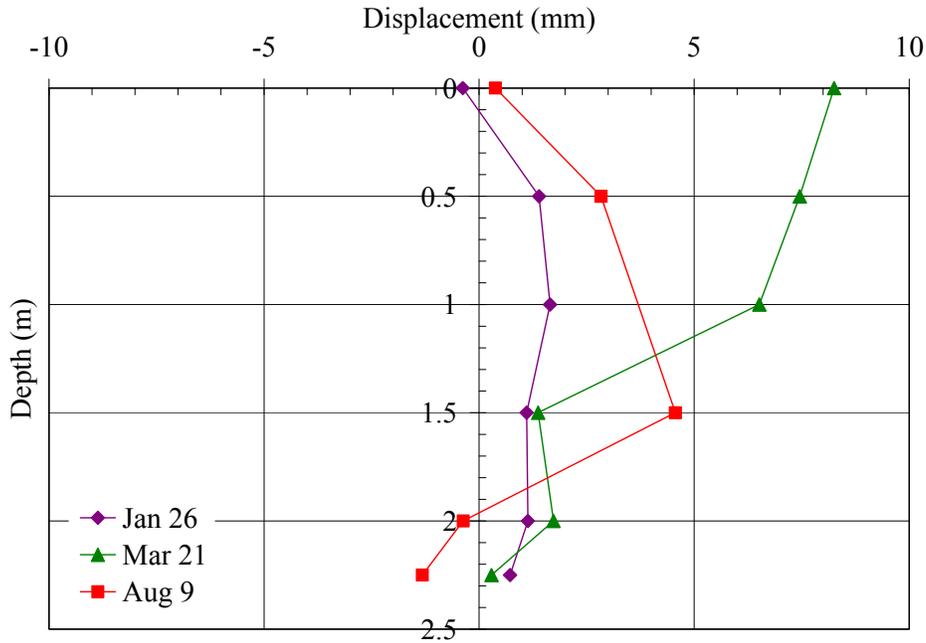
Figure 9.15: Inclinometer Readings for the East Hole “A” Direction for a Dry-Wet-Dry Cycle

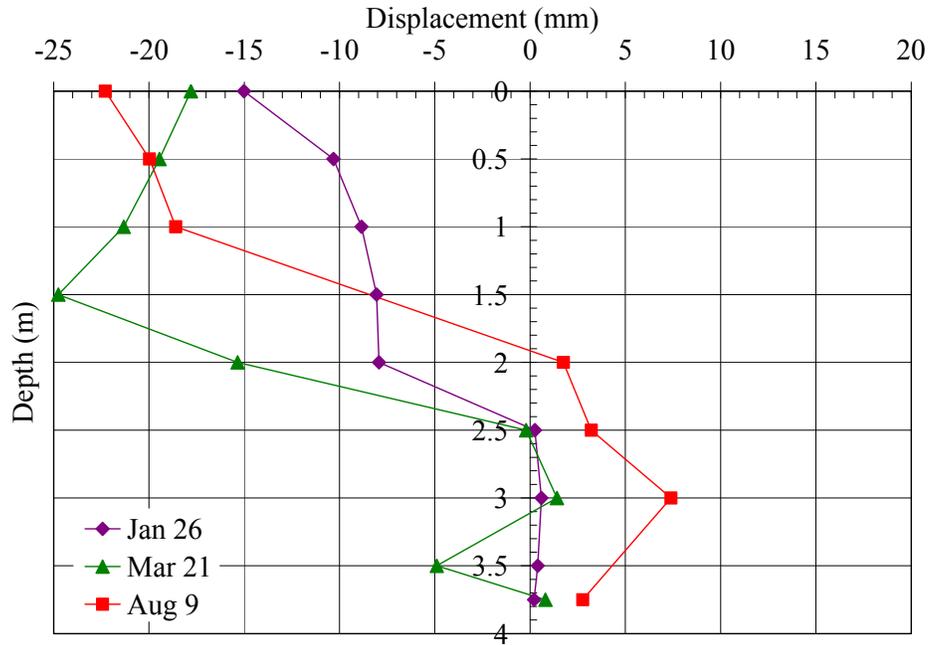
Figure 9.16: Inclinometer Readings for the West Hole “A” Direction for a Dry-Wet-Dry Cycle
